# Eton FRX3 Dynamo Unit Replacement

Replace the dynamo unit in the Eton FRX3.

If the hand crank of the Eton FRX3 isn't working, the dynamo unit may have worn, stripped or ceased gears and will need to be replaced.

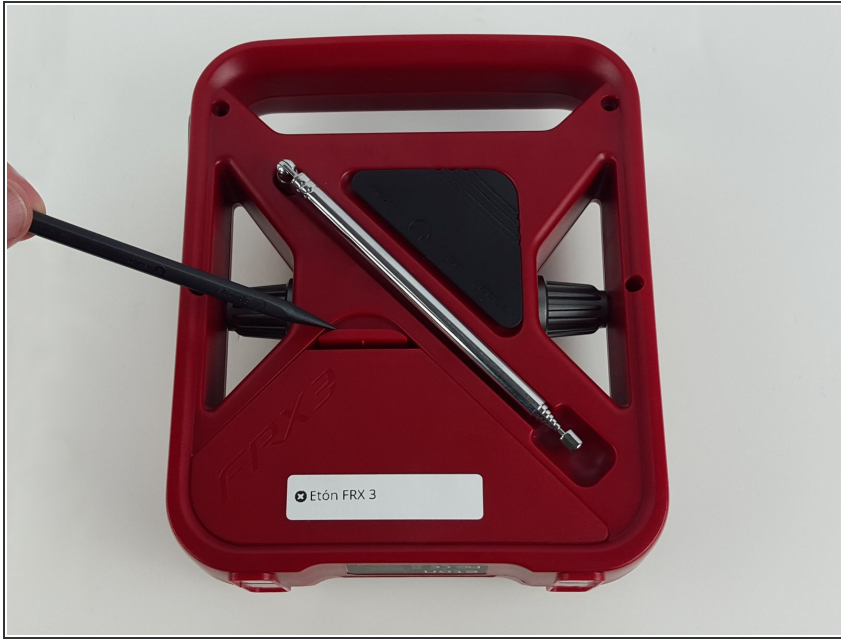
## Step 1 — Rechargeable Battery Pack

- Pull the plastic tab on the battery compartment cover panel to loosen it, then pull the panel off.

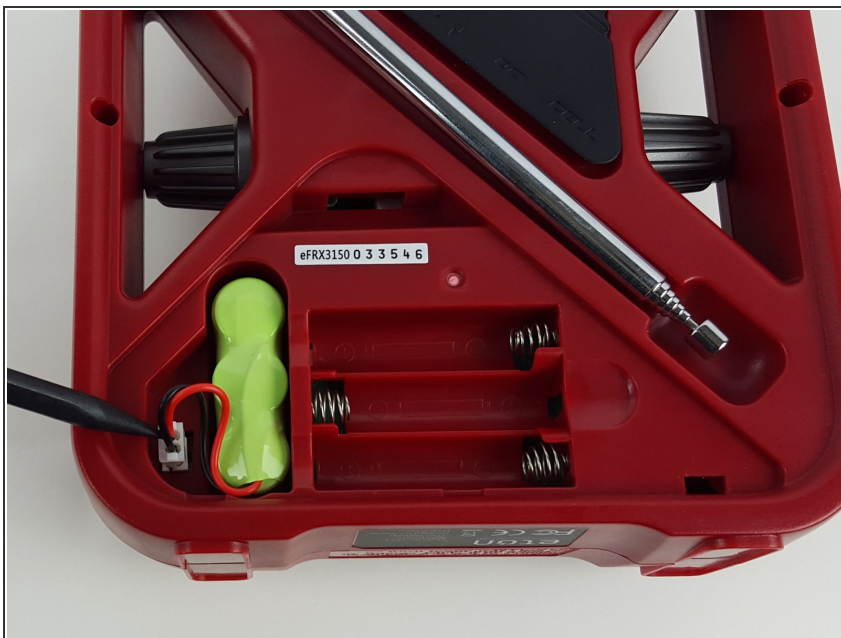
## Step 2

- Disconnect the battery pack wires from the device and remove the battery pack.

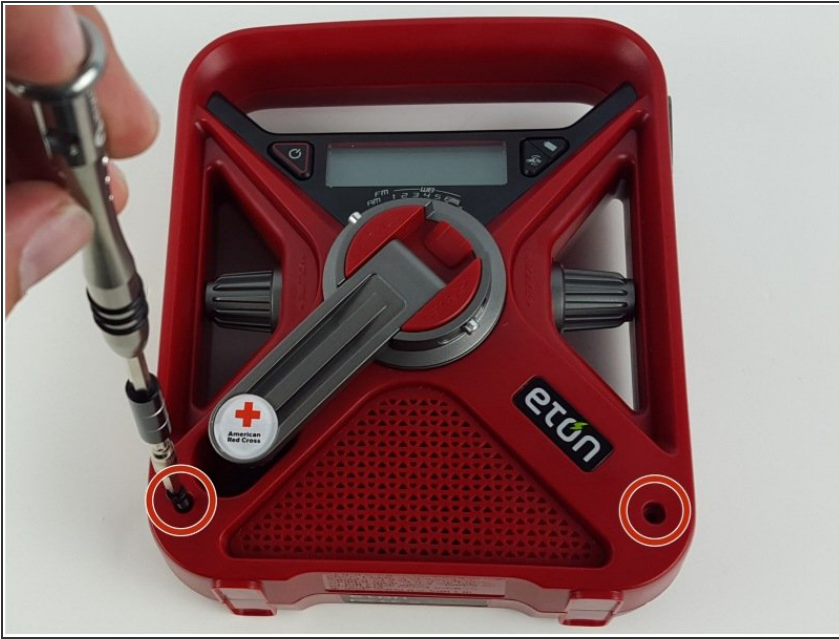
## Step 3 — Case Assembly

- On the bottom of the device case's face are two T10 screws. Use a T10 Torx screwdriver to remove the two screws.

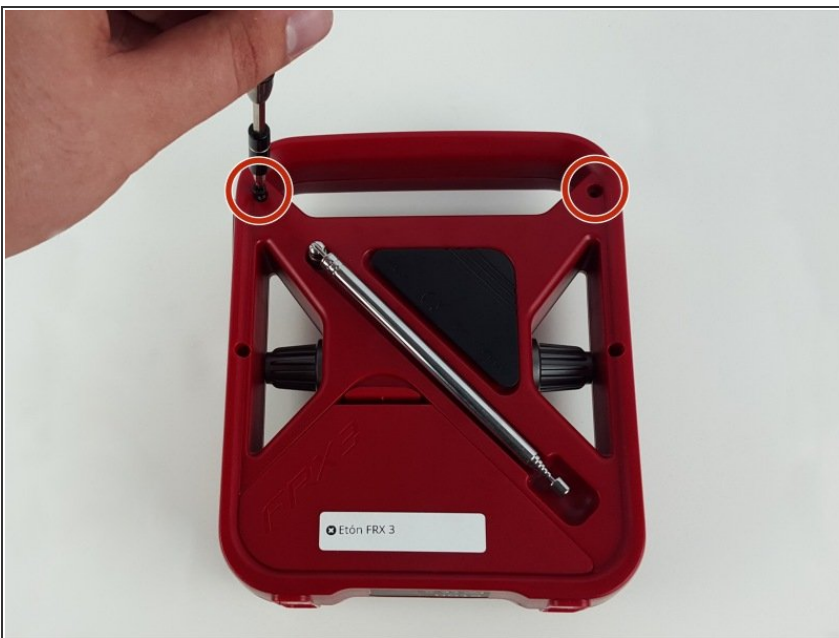
## Step 4

- While using the T10 screwdriver, remove the two T10 screws on the back of the device's case.

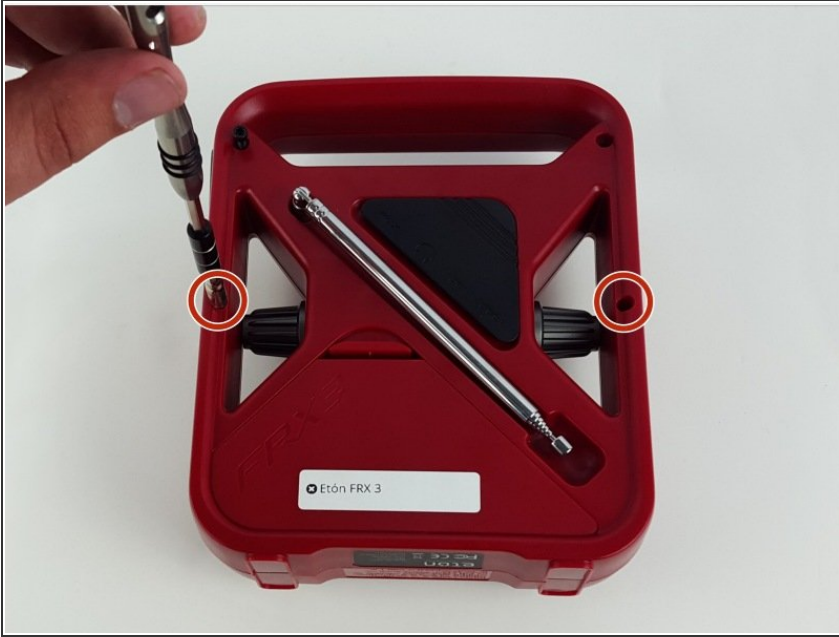
## Step 5

- Remove the two Phillips #00 screws located in the center of the back of the device.
- ⓘ You will need to use a thin shafted screwdriver or a female hexagonal bit that is found in the iFixit 54 bit toolkit to extend the reach of the Phillips #00 bit.

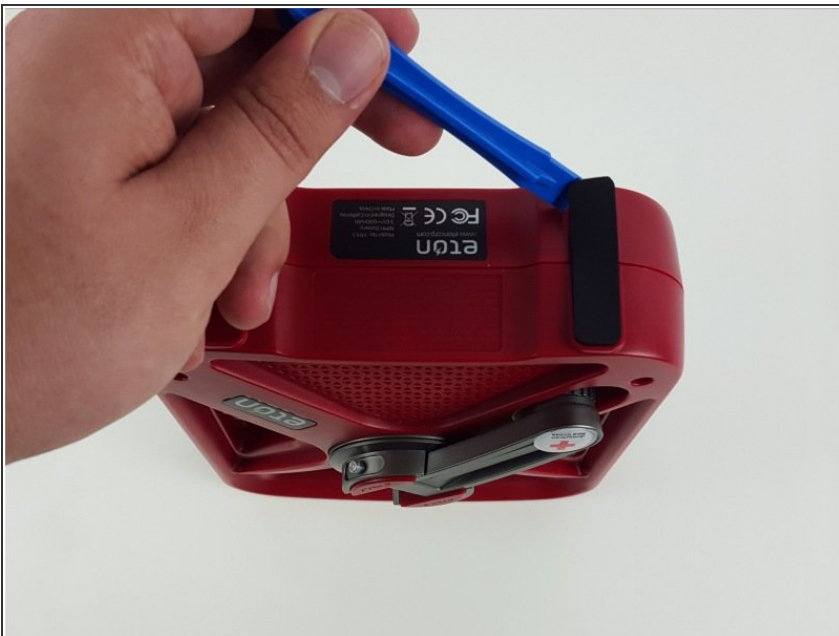
## Step 6

- On the bottom of the device's case there are two rubber feet. Pry the rubber feet off of the case.
- ★ Try to keep the adhesive on the rubber feet as clean as possible to insure that they can be reattached during reassembly.

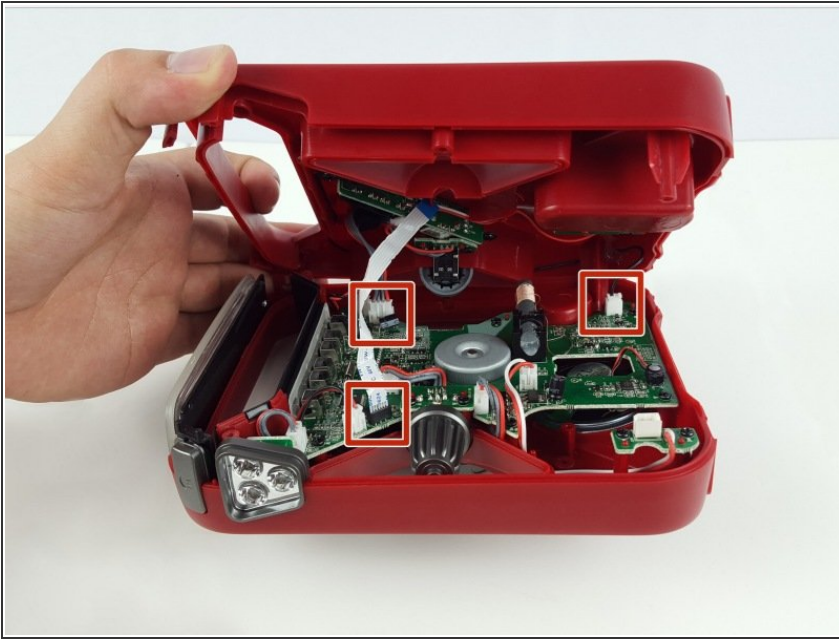
## Step 7

- Pull the two halves of the device's case apart.
- ⚠ Take care when pulling the two halves apart. There are three cables that connect components of the device to the motherboard. Disconnect these cables in order to separate the two halves of the device's case.

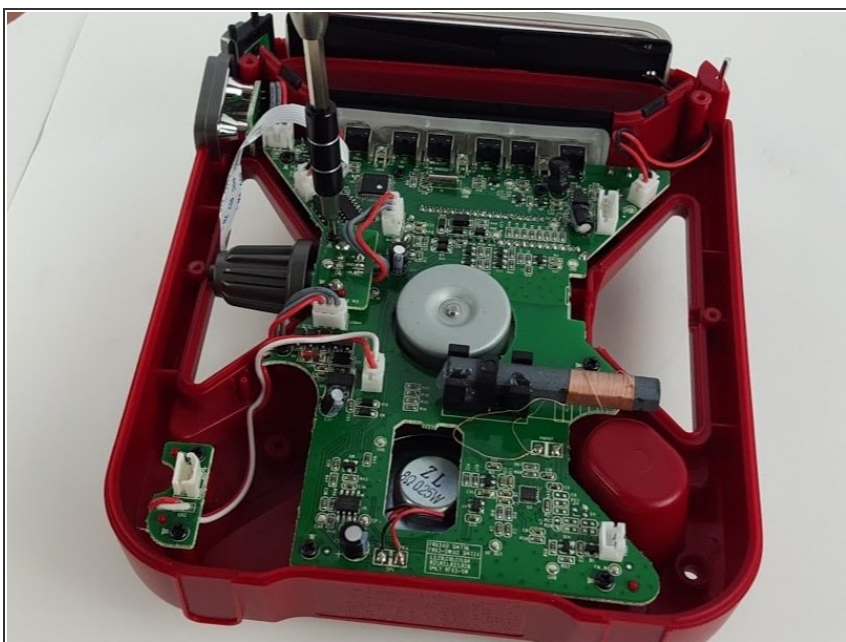
## Step 9

- Remove the two 1 cm Phillips #0 screws that secure the tuning dial panel to the motherboard.
