Black and Decker LDX172C LED Power Indicator Replacement

Use this guide to replace the LED Power Indicator your Black and Decker LDX172C cordless drill

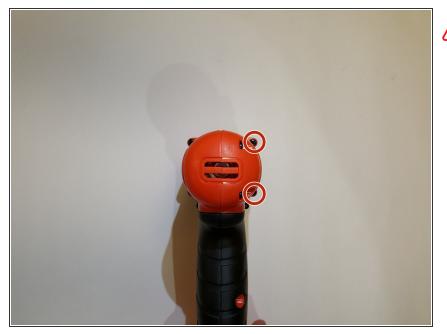
Step 1 — LED Power Indicator

- Before beginning, make sure the motor direction switch is in the neutral position.
 - Place the drill on the work surface with the chuck facing downward.
 Locate and remove the two #2 X 10mm Phillips screws located right of the motor.

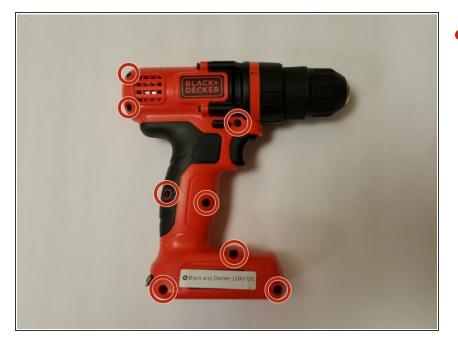
Step 2

Rotate the drill to it's left side - the chuck should be facing rightward.
Locate and remove the eight #2 X 5mm Phillips fasteners from the body of the drill.

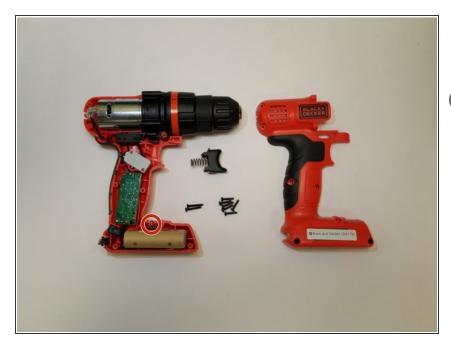
Step 3

- Carefully remove the right half of the body from the drill.
- (*i*) The trigger mechanism is spring loaded and may eject from the drill when the body is removed.
 - Locate the LED power indicator located just above the battery pack.
