Pebble Steel failure of screen

Repairing the screen issue in the Pebble Steel smart watch. The unreadable screen is fixed with this simple solution.

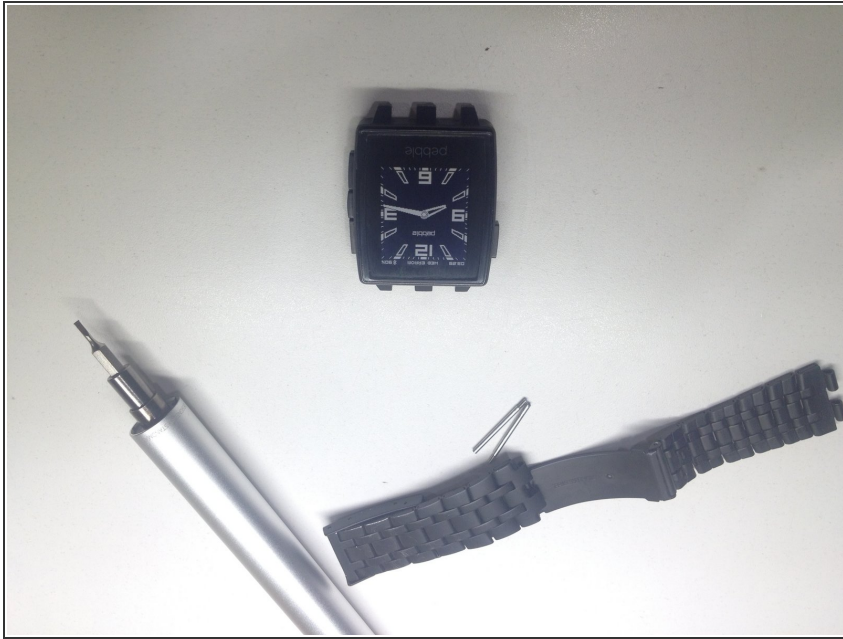
Step 1 — Disassemble Strap

- The first step is to remove the strap. To do this, we will use a 1.5mm flathead screwdriver.

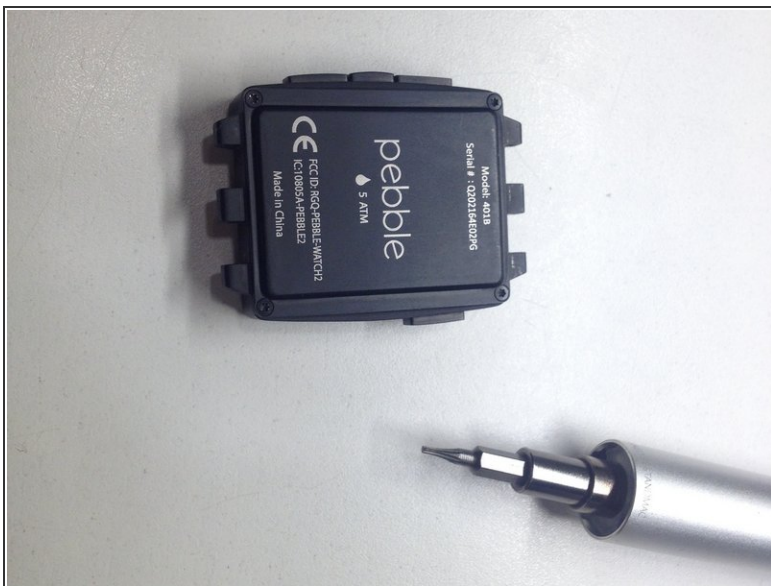
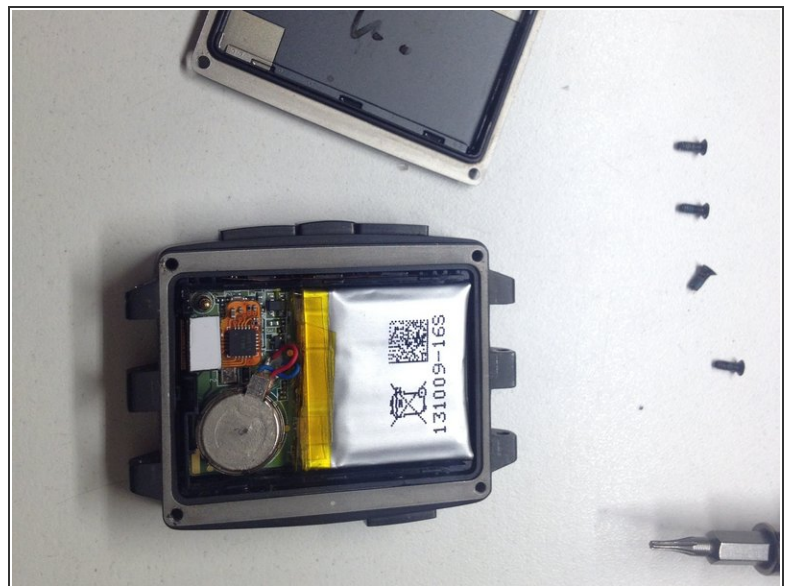
Step 2 — Remove back cover

- We will disassemble the cover of the clock using a screwdriver T-5, and being careful with the rubber gasket that has, we will remove the metallic cover.

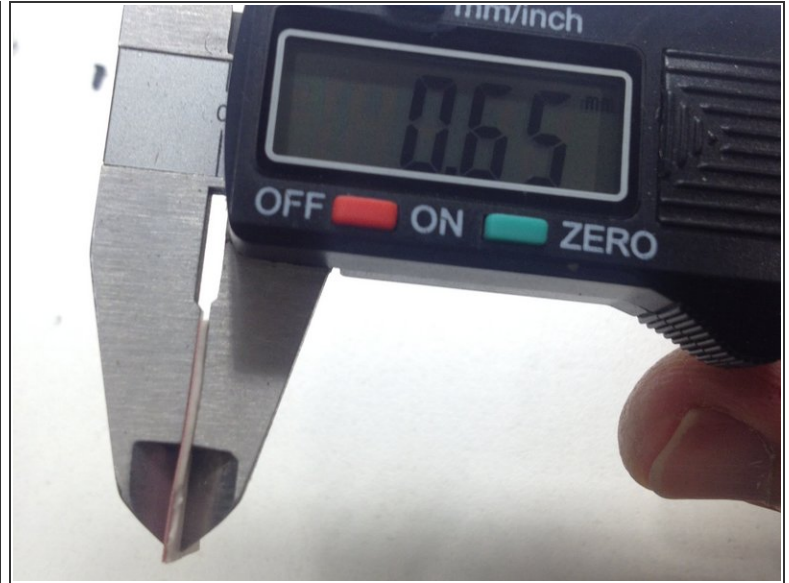
Step 3 — Find and cut a soft rubber

- In this step we will look for a dissipative silicone of those that carry the laptops for the microprocessor. If you do not have it, you could use a piece of soft rubber that does not exceed 0.65mm thick.

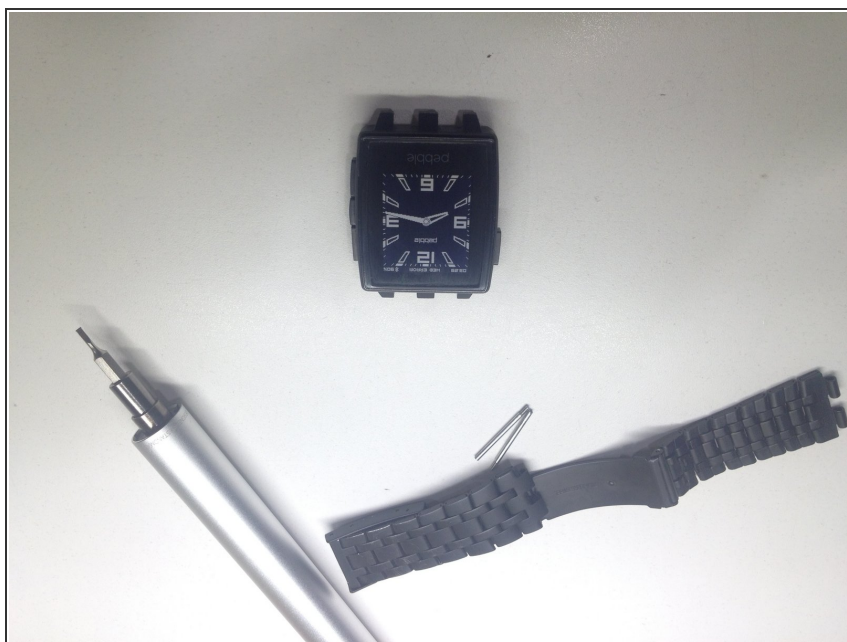
Step 5 — Close and READY !!!!

- Finally we assemble the clock reversing the steps. '++ It is important when placing the cover to put first the two screws above and then the two screws below.' (This forces the entire internal chassis, thus exerting a pressure on the rubber contact of the screen.)
