# Hamilton Beach 70730 Drive Shaft Replacement

Replace the drive shaft of your Hamilton Beach 70730 food processor.

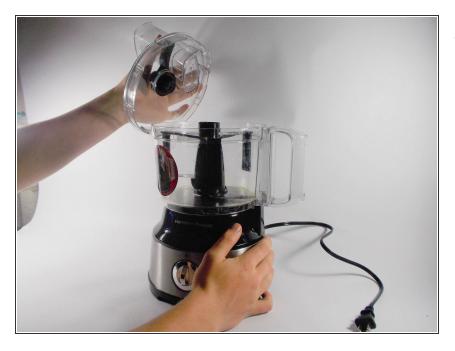
#### Step 1 — Bowl

• Unscrew the cover by turning it counterclockwise.

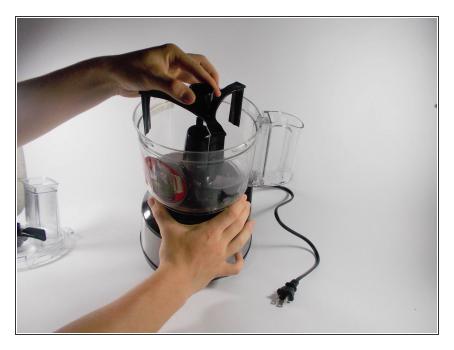
### Step 2

• Grab the scraper by the midsection to remove.

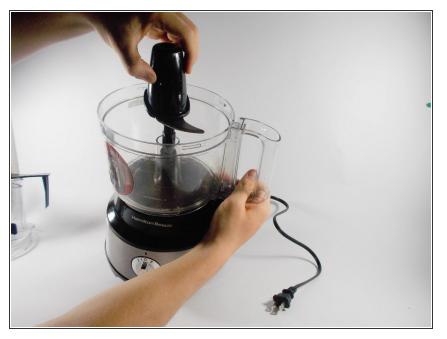
• Carefully remove the blades by lifting them off of the blade shaft.

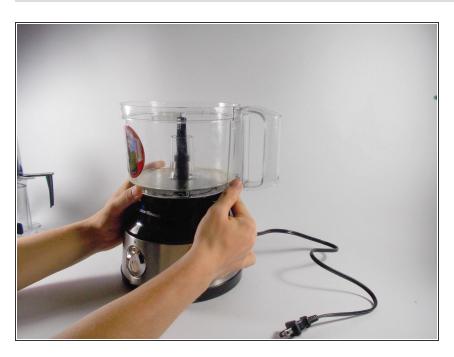
### Step 4

• Rotate the bowl counterclockwise to release it from the base.

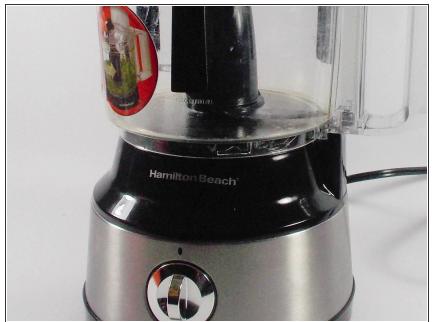
(i) Make sure there is no food or grime along the outside of the bowl or the base.

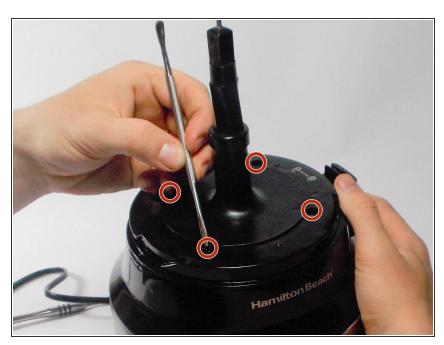
#### Step 6 — Drive Shaft

- Using the metal spudger, remove the four adhesive plastic covers that hide the screws.
- (i) These covers are adhered to the screws.

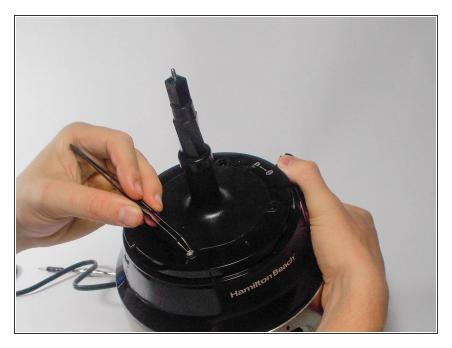
Remove any excess glue that is adhered to the screws with the precision tweezers.

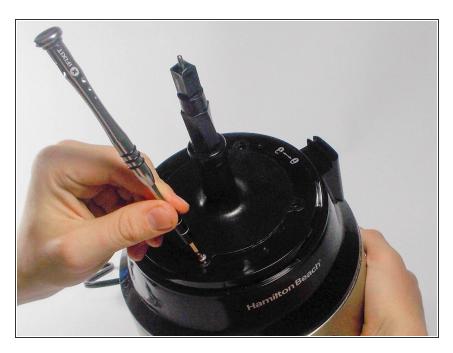
### Step 8

• Using a JIS #1 driver, remove the four 10 mm screws.

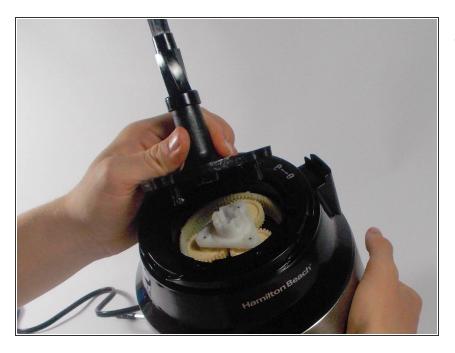
• Lift the driveshaft off of the base.
