Alan 48 Excel no or bad reception

Check Q104 and replace if necessary.

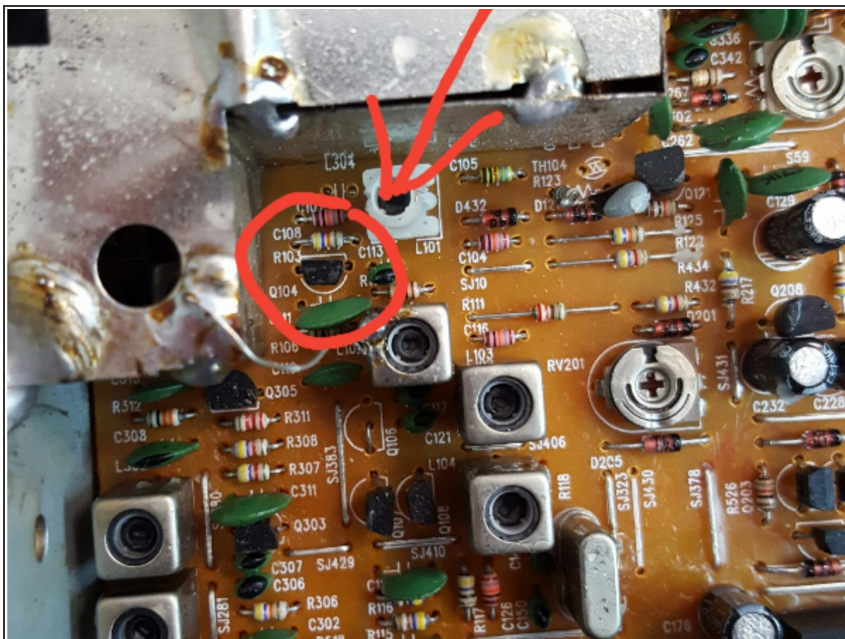
Step 1 — Transistor receiver

- Place of Q104 (KTK 161)
- Replace transistor.

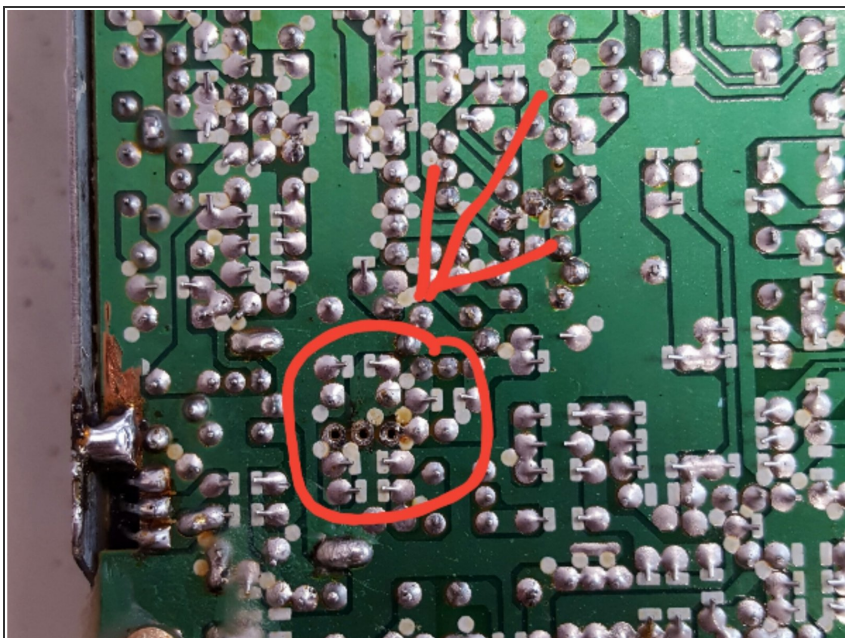
Step 2

- Unwrap here
