HP 310-1037 Hard Drive Replacement

Very straight forward repair with only a few common tools.

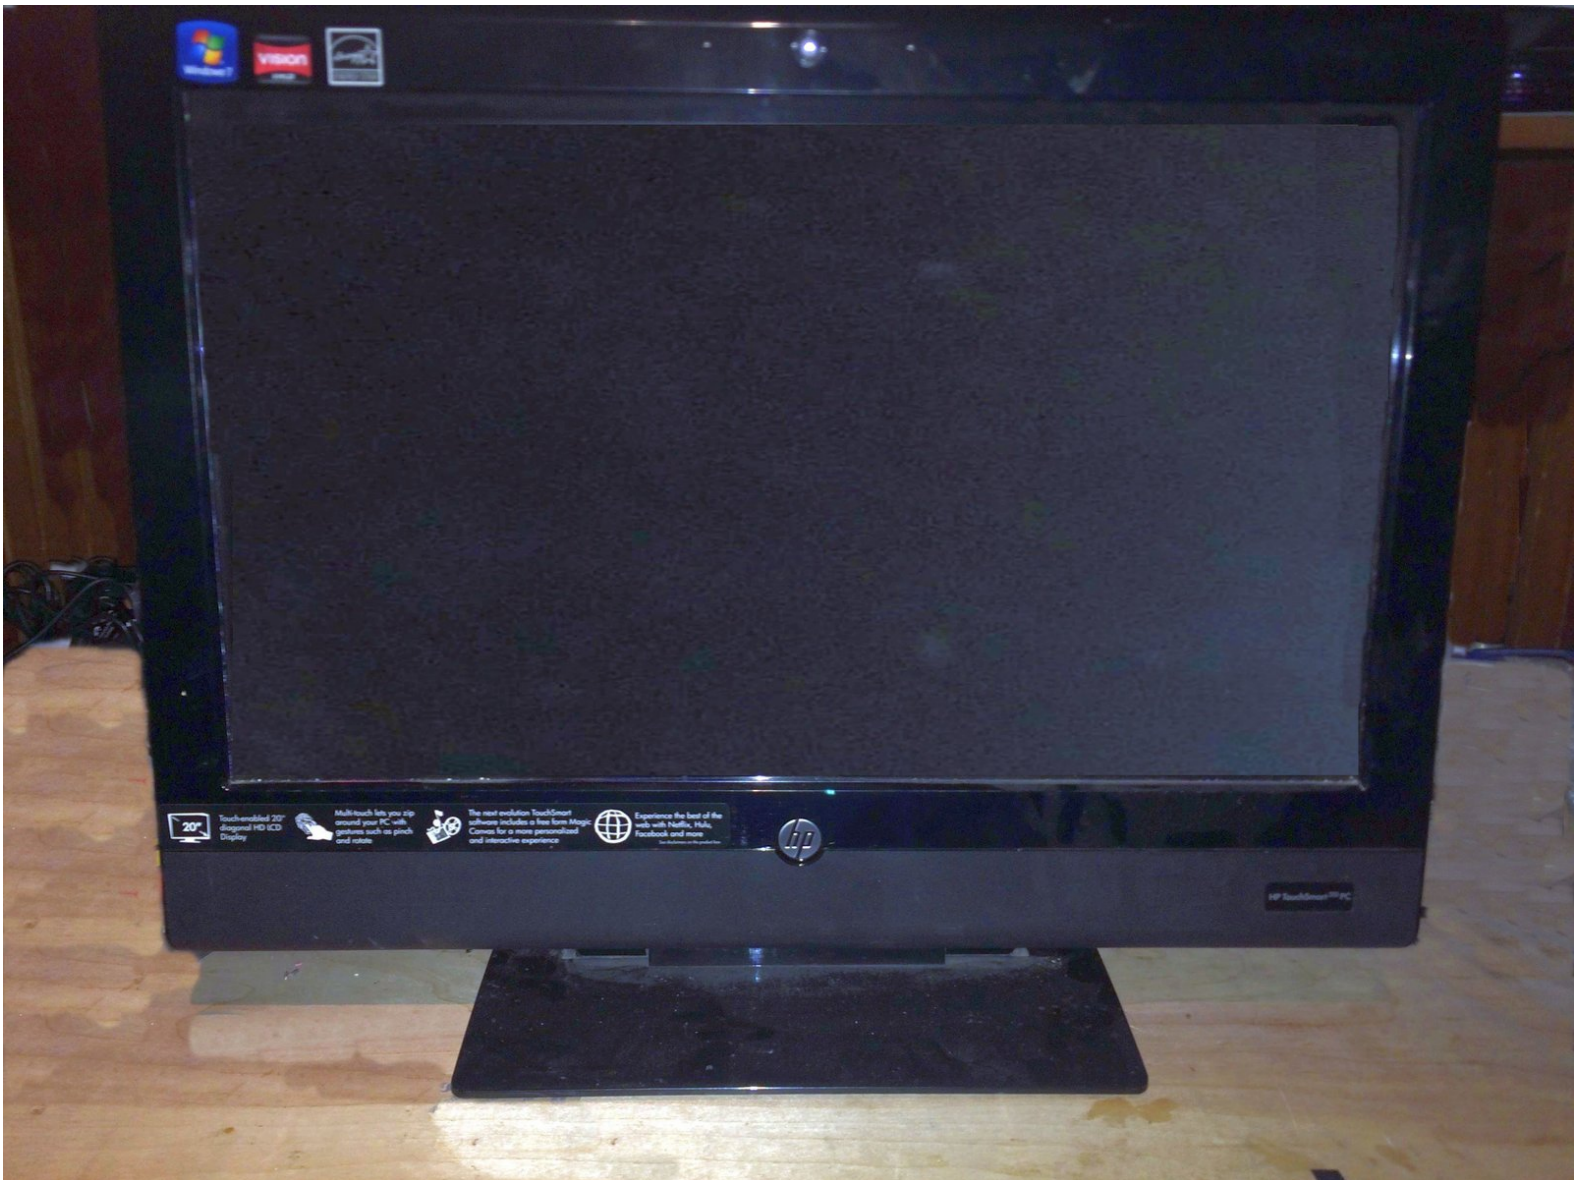
Here is a HP 310-1037 with a failed hard drive. The Hitachit 1TB hard drive is a common item to fail. The repalcement is very easy and not hidden screws or adhesive. All that is needed is a flathead screwdriver and a Phillips screwdriver.

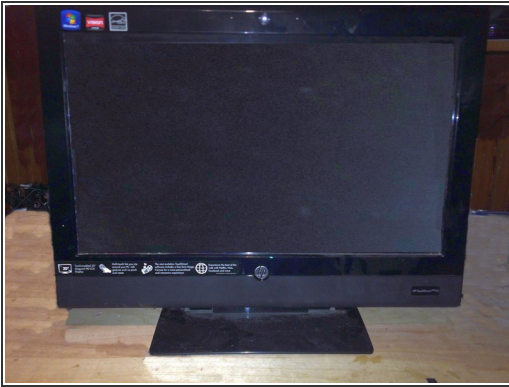
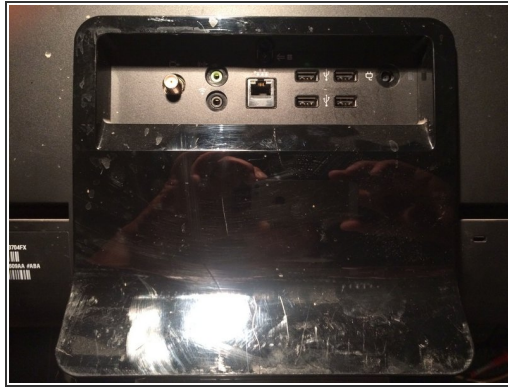
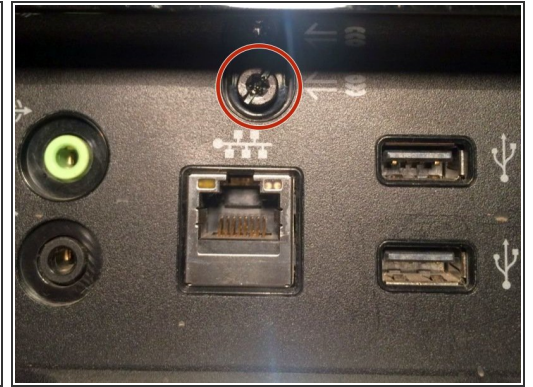
Step 1 — Hard Drive

- HP310-1037 Touchsmart PC with a dead hard drive. The hard drive is located behind the stand cover.
- Lay the PC flat on the front to gain access to the stand cover
- Remove the single screw that holds the stand cover to the chassis with a flat tip screwdriver

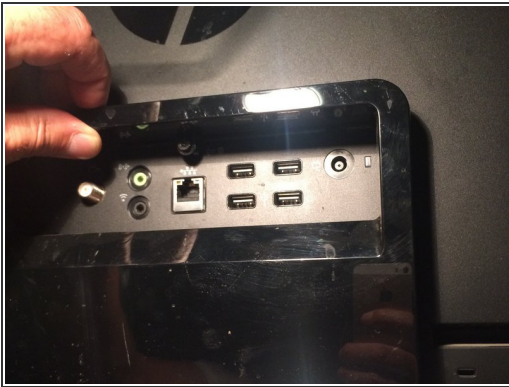
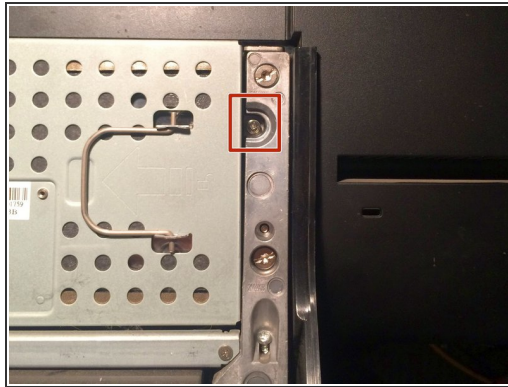
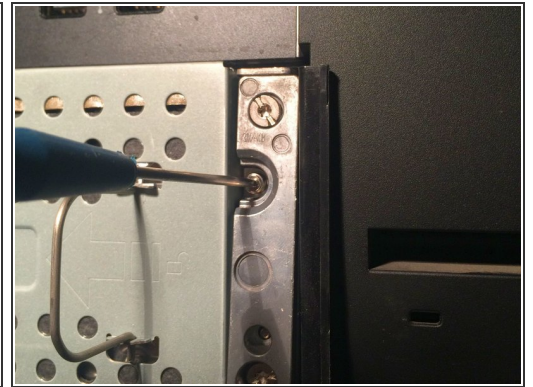
Step 2

- Remove the stand cover
- The hard drive caddy is held in place with 1 Phillips screw
- Use a #0 Phillips screwdriver to remove that screw

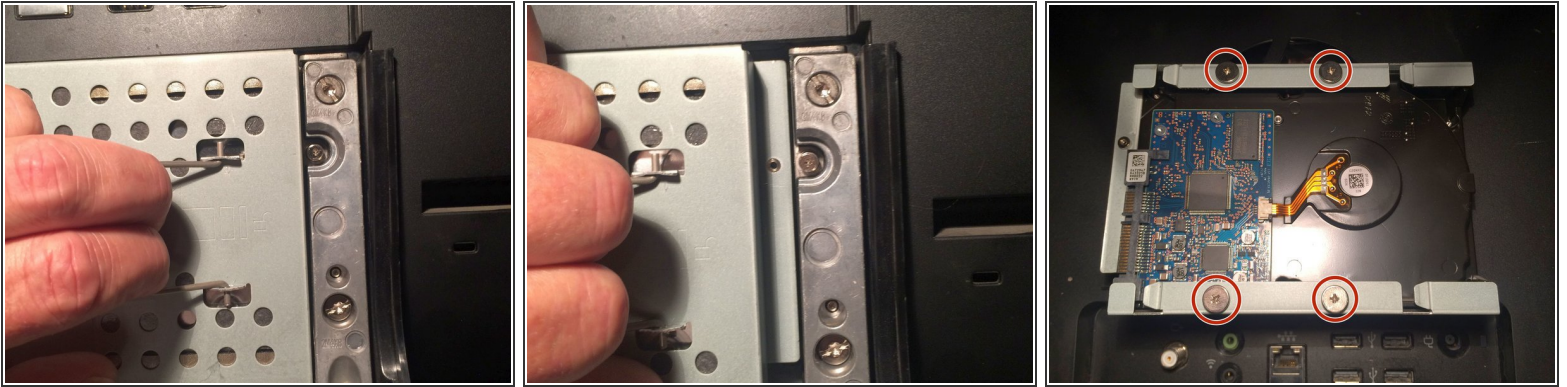
Step 3

- Lift the handle on the hard drive caddy
- and pull it to the backside. This will remove the hard drive caddy from the computer.
- To remove the hard drive from the caddy, turn it over. There are four Phillips screws that hold the hard drive in place.

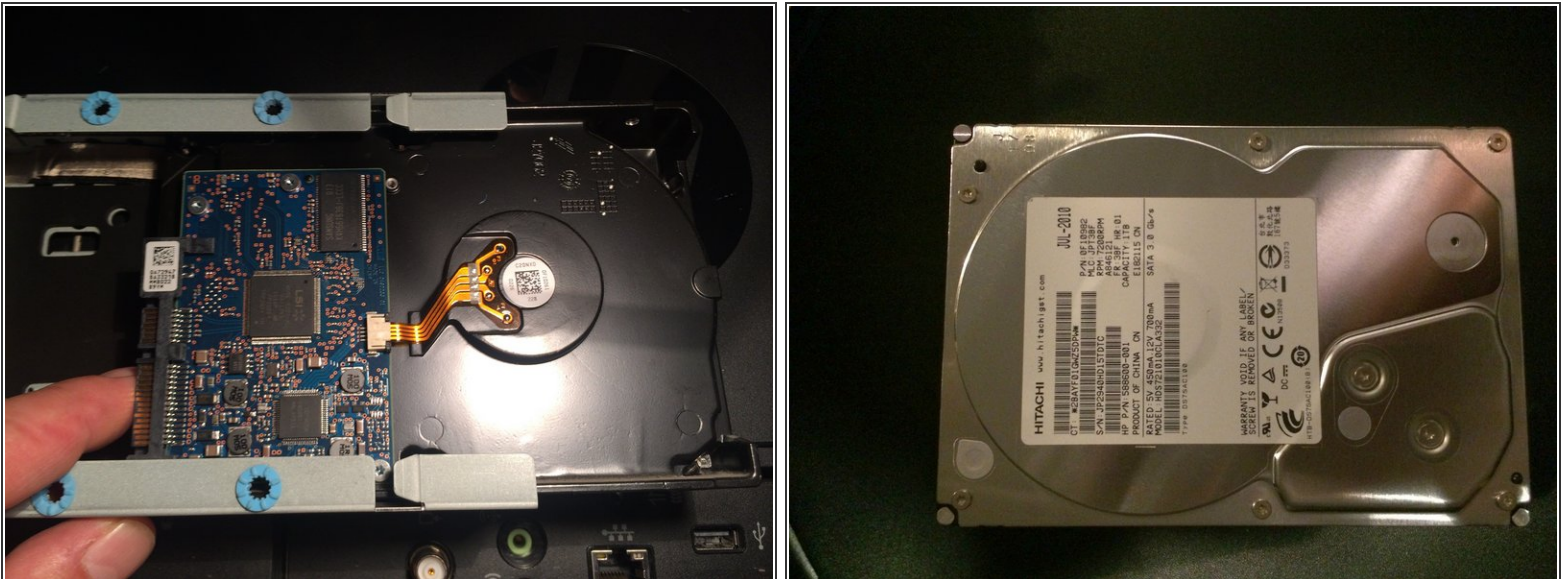
Step 4

- Once the four screws are removed, slide the hard drive out of the caddy.
- Here is the failed drive. It is a Hitachi HDS721010CLA332. Failure with this drive is all too common.

To reassemble your device, follow these instructions in reverse order.
