Insignia Flex 10.1 NS-P16AT10 Camera Replacement

If the camera is not working properly or takes distorted photos, you may need to replace the camera on your Insignia Flex 10.1 NS-P16AT10 tablet.

This guide will show you how to replace the camera on your Insignia Flex 10.1 tablet.

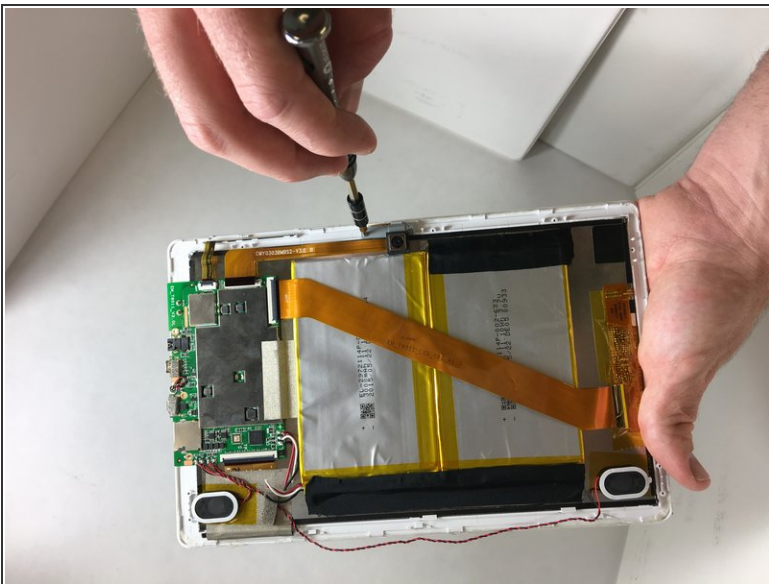
Step 3

- Use a #00 Phillips head screwdriver to remove the two screws that hold the camera down to the front case.
