# Leader Impression i10A-LE Speakers Replacement

This repair guide is for the Leader Impression i10A-LE speaker replacement. This replacement will take 15 minuets to complete.

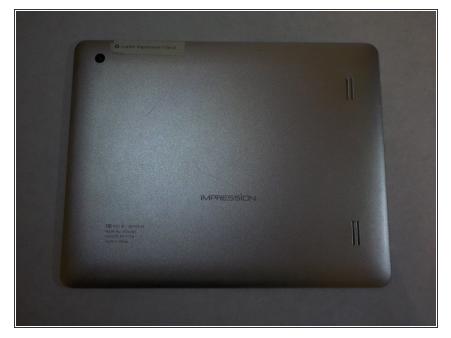
#### Step 1 — Speakers

Start with your Leader Impression i10A-LE with the word "Impression" closest to you and the camera in the top left corner.
