# Garmin Nuvi 2589LMT Motherboard Replacement

A simple guide to replace your Garmin Nuvi 2589LMT motherboard.

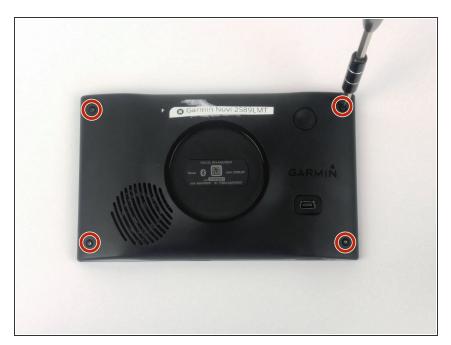
# **Step 1** — Back Panel Assembly

Using the T5 Torx Screwdriver, remove all 4 of the 5.7mm screws from the back of the device.

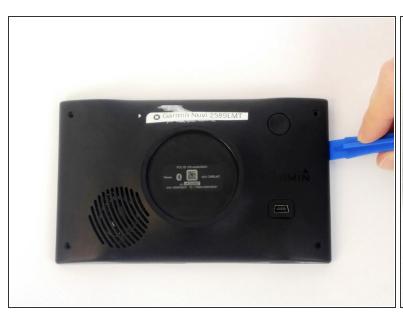
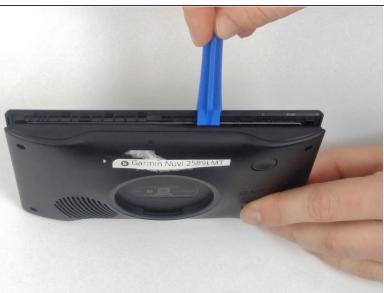
### Step 2

- Using the plastic opening tools, pry the shorter sides of the device apart.
- Once a gap has formed at the top of the device, insert the opening tool into the gap and slide it along the top of the device. Repeat for the bottom edge of the device to separate the LCD screen from the back.
- ⚠ Do not disconnect or tear the ribbon wiring, located at the bottom of the motherboard, when removing the back of the device.

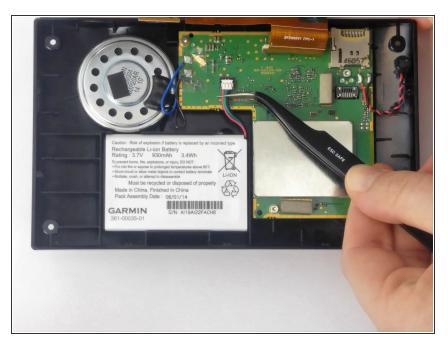
### Step 3 — Motherboard

Using the angled tweezers, grip the red, black, and green wires connecting the battery to the motherboard, then gently lift away from the motherboard.

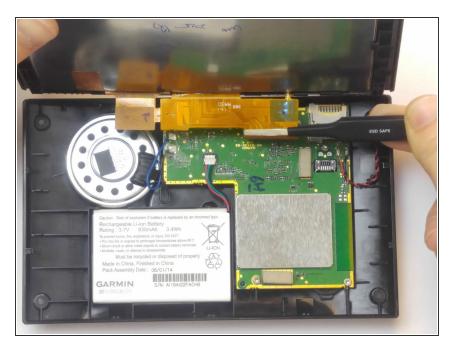
# Step 4

Using the tweezers, gently pull the ribbon wiring near where it connects to the motherboard to disconnect it from the motherboard.

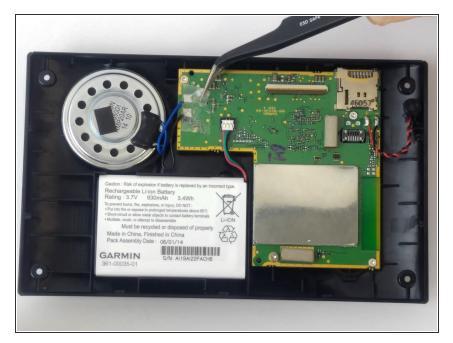
# Step 5

Using tweezers, remove the tape covering the speaker connection to the motherboard.

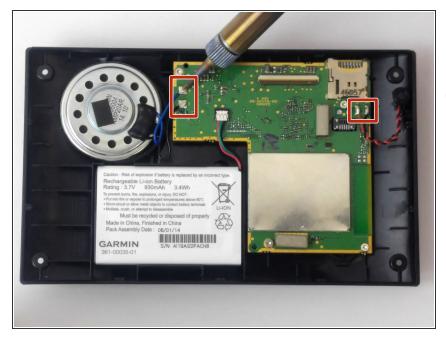
# Step 6

- Using a soldering iron, desolder all connections to the motherboard.
- Learn how to solder and desolder here.

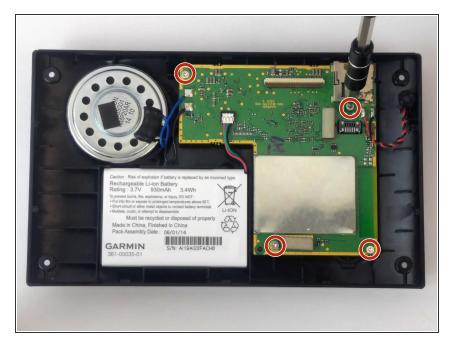
# Step 7

Using the T5 Torx Screwdriver, remove all 4 of the 4.0 mm screws from the motherboard.

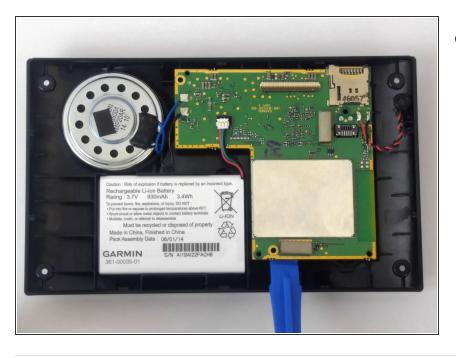
### Step 8

Using the plastic opening tools gently pry the motherboard away from the case.
