# Garmin Nuvi 2589LMT Speaker Replacement

A simple guide to replace your Garmin Nuvi 2589LMT speaker.

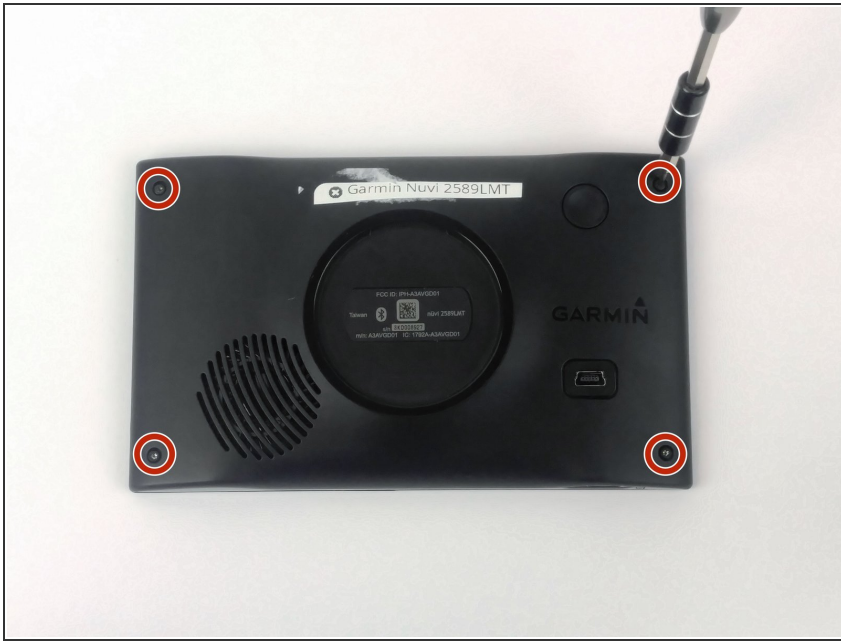
## Step 1 — Back Panel Assembly

- Using the T5 Torx Screwdriver, remove all 4 of the 5.7mm screws from the back of the device.

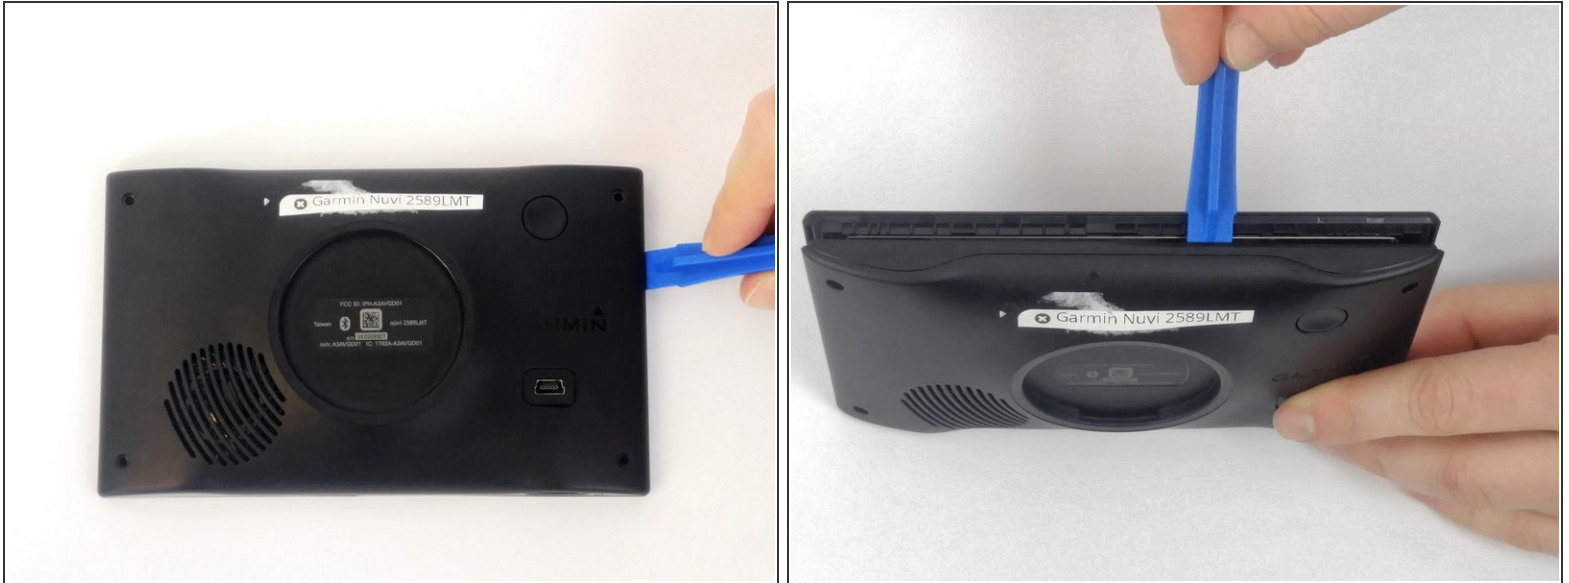
## Step 2

- Using the plastic opening tools, pry the shorter sides of the device apart.
  - Once a gap has formed at the top of the device, insert the opening tool into the gap and slide it along the top of the device. Repeat for the bottom edge of the device to separate the LCD screen from the back.
- ⚠ Do not disconnect or tear the ribbon wiring, located at the bottom of the motherboard, when removing the back of the device.

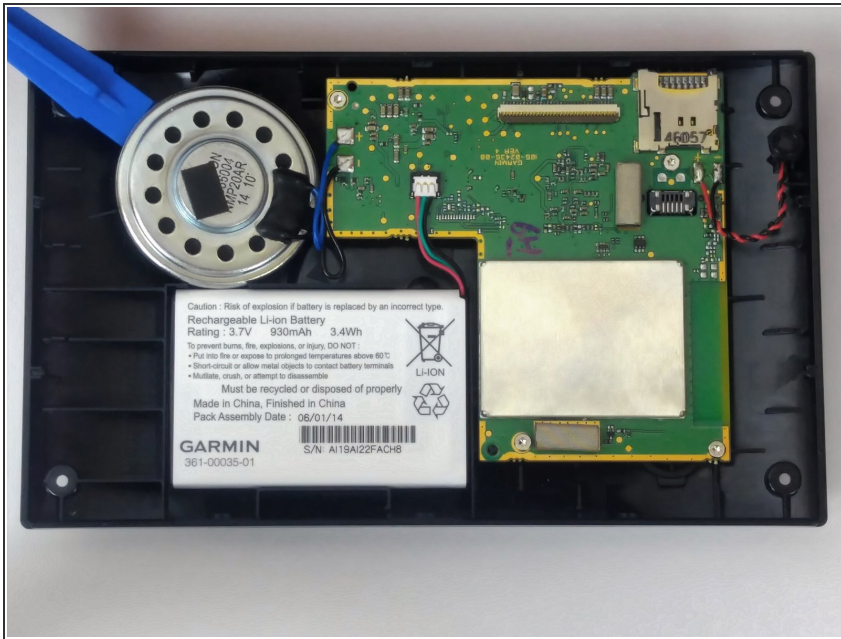
## Step 3 — Speaker

- Wedge the speaker from the device, using the small plastic opening tool.
- ❗ The speaker is held in place by adhesive tape on the outer rim. Because the speaker is still connected to the motherboard, pry the speaker away from the device gently.

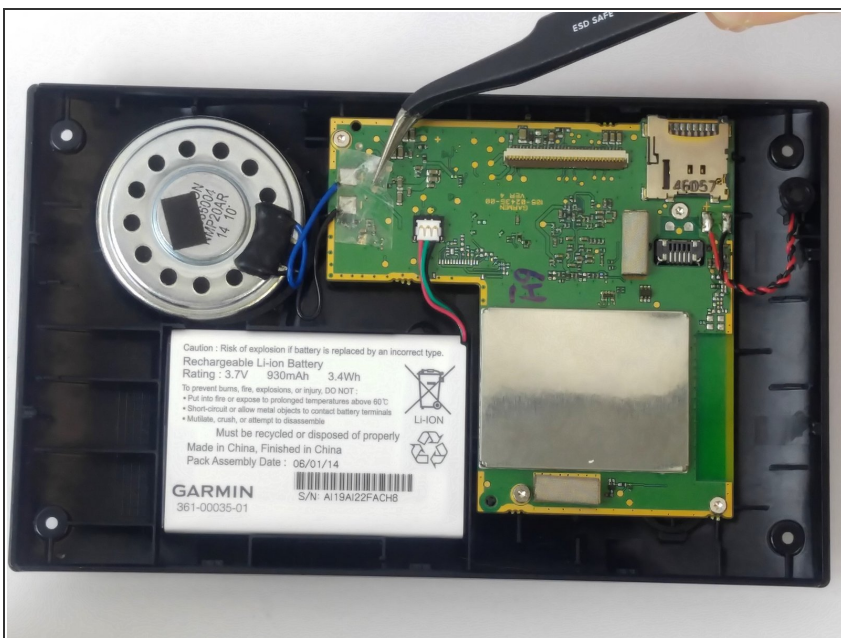
## Step 4

- Using tweezers, remove the tape covering the speaker connection to the motherboard.

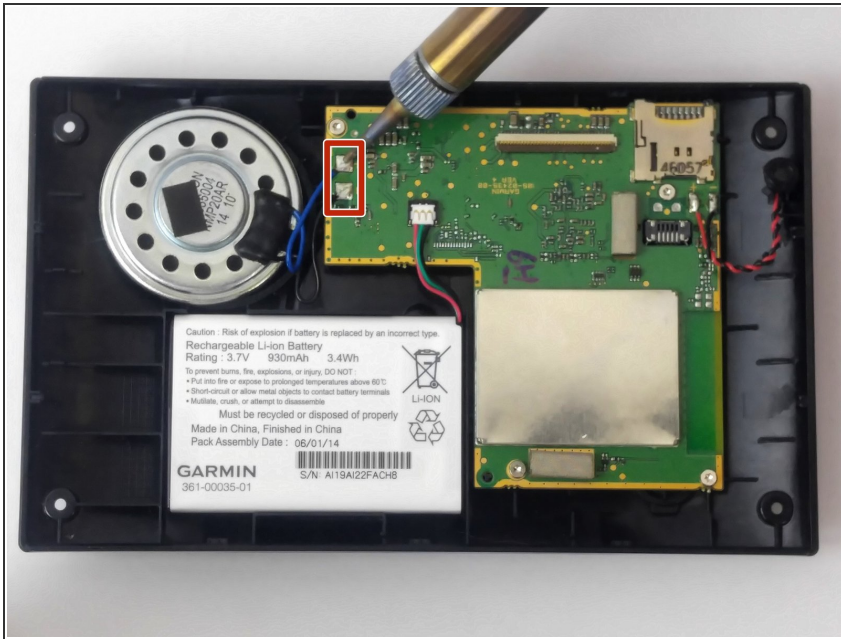
## Step 5

- Using a soldering iron, desolder the wire connection at the soldering points between the speaker and the motherboard to remove.
- ⓘ Learn more about soldering and desoldering connections [here](#).
