# Garmin Nuvi 2589LMT Power Button Replacement

If your power button is not responding, use this guide to replace a defective power button on your Garmin NUVI 2589LMT device. Replacing the power button should fix any response issues you are experiencing with the button, but if it does not you may be experiencing a motherboard issue.

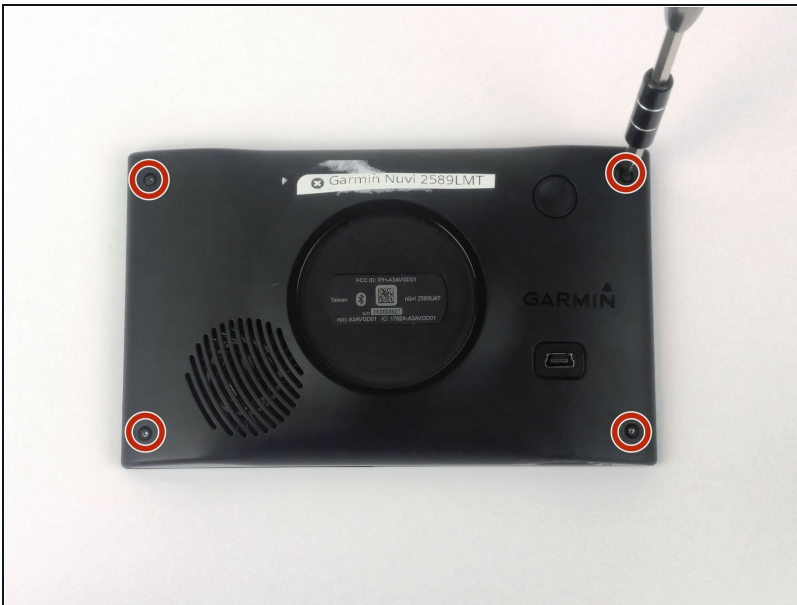
## Step 1 — Back Panel Assembly

- Using the T5 Torx Screwdriver, remove all 4 of the 5.7mm screws from the back of the device.

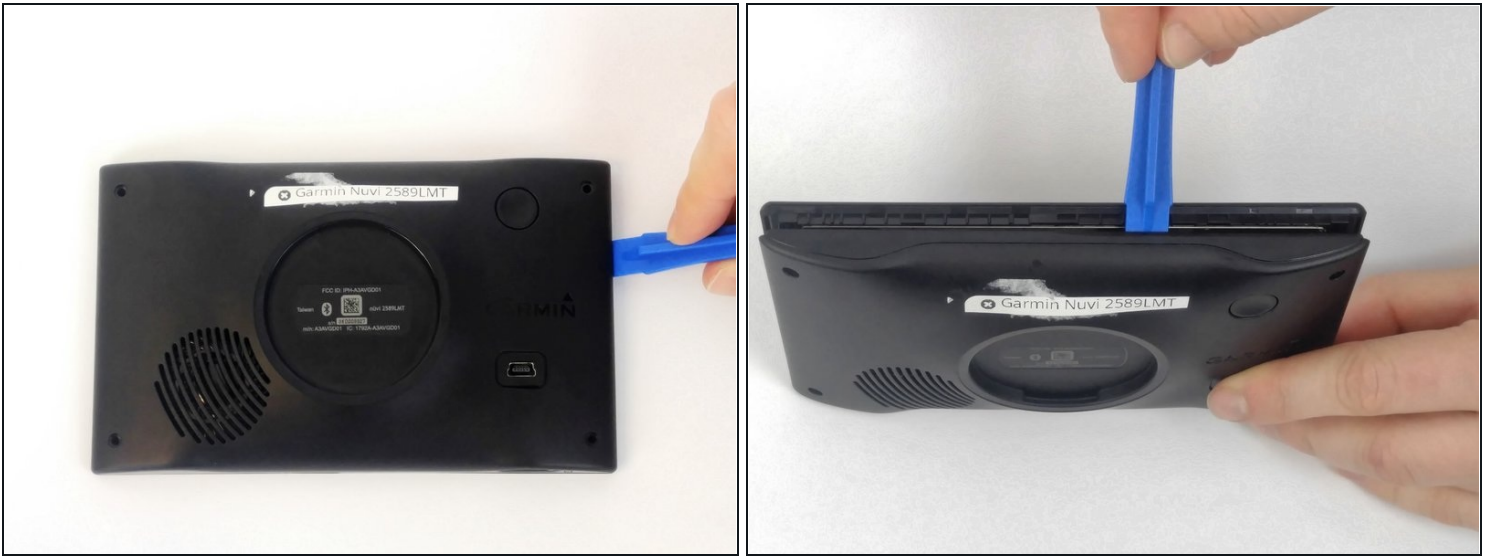
## Step 2

- Using the plastic opening tools, pry the shorter sides of the device apart.
- Once a gap has formed at the top of the device, insert the opening tool into the gap and slide it along the top of the device. Repeat for the bottom edge of the device to separate the LCD screen from the back.

⚠ Do not disconnect or tear the ribbon wiring, located at the bottom of the motherboard, when removing the back of the device.

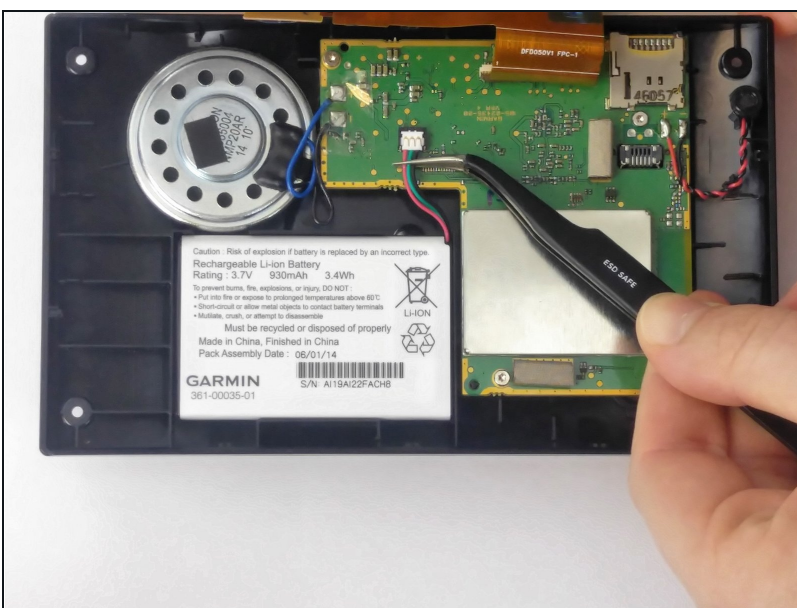
## Step 3 — Power Button

- Using the angled [tweezers](#), grip the red, black, and green wires connecting the battery to the motherboard, then gently lift away from the motherboard.

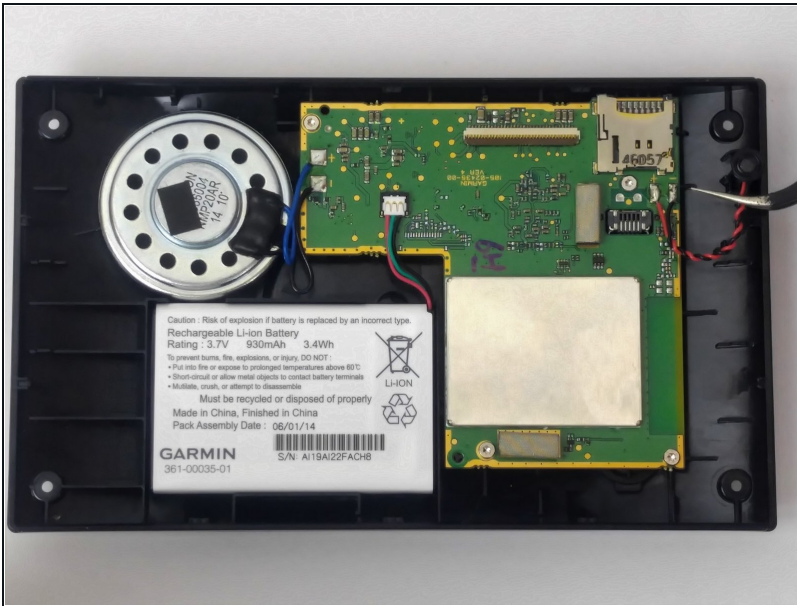
## Step 4

- Using the angled tweezers, grab the microphone wires and gently pull to remove the microphone from the device.

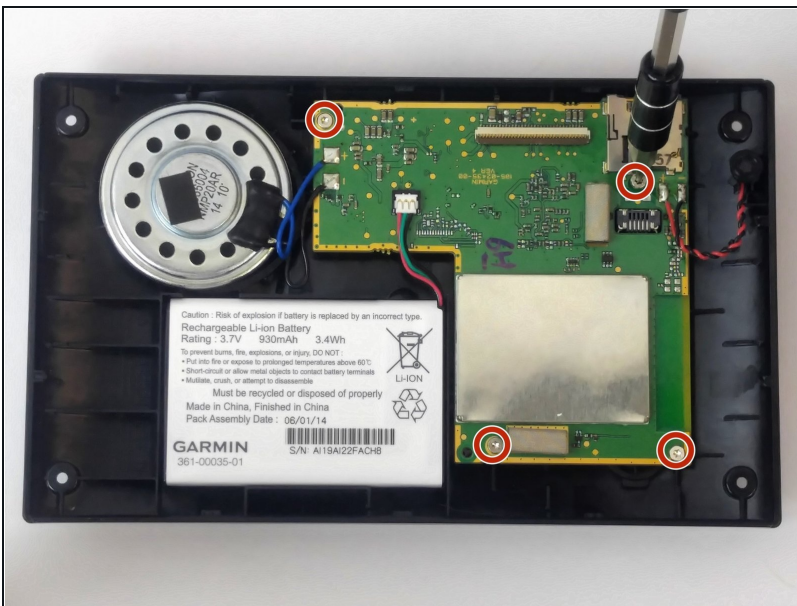
## Step 5

- Using the T5 Torx Screwdriver, remove all 4 of the 4.0 mm screws from the motherboard.

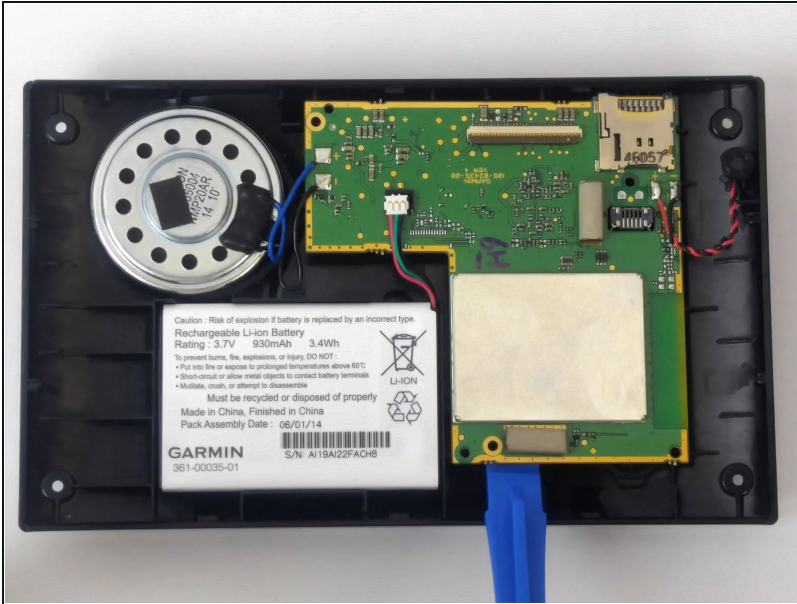
## Step 6

- Using the plastic opening tools gently pry the motherboard away from the case.
- ❗ There is no need to desolder any connections because the motherboard only needs to be moved out of the way enough to get to the button.
