Garmin Nuvi 2597LMT Microphone Replacement

Use this guide to replace the microphone within your Garmin Nuvi 2597LMT.

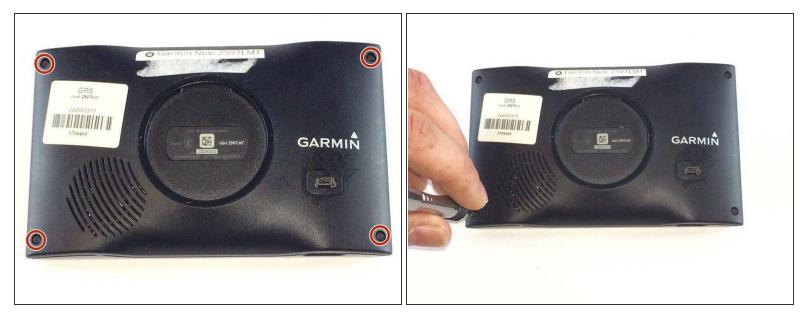
Step 1 — Microphone

- Turn your device over so the back is revealed and you can see the screws in the four corners.
- Remove the four 3mm width by 6mm length T5 Torx screws using your screwdriver.

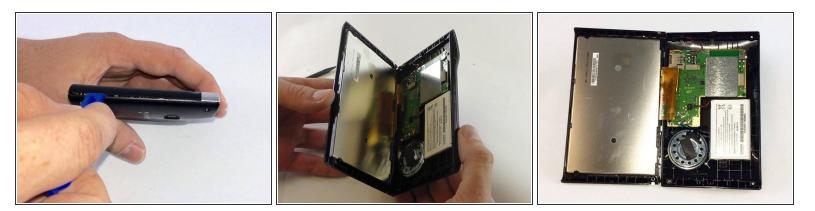
Step 2

- Use the plastic opening tool to pry open the device at the seam where the two halves meet, prying all along all sides if need be.
- Do it slowly so you don't accidently rip the ribbon cable that connects the digitizer to the motherboard, as well as don't completely separate the halves as this can tear the ribbon cable.
- Open your device from the top, so that you don't disconnect the ribbon cable.
