Nokia Lumia 830 Vibrator Replacement

If you have noticed that your phone is not...

Written By: saydeking

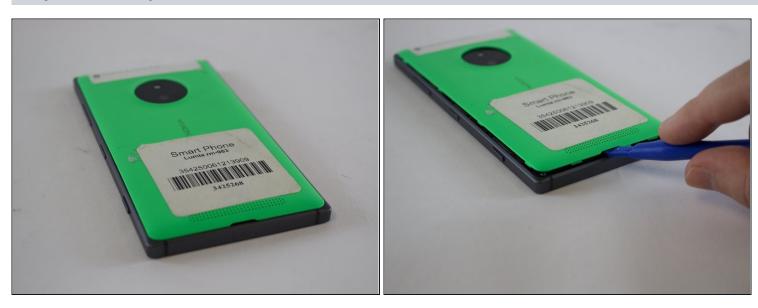
Step 1 — Battery

- Place the phone with the screen facing down.
- Remove the back cover by placing your fingernail or plastic opening tool under the slotted indent at the bottom of the phone.

- Carefully remove the battery by placing the plastic opening tool underneath the indent at the bottom of the battery, and pry it up.
- i There may be adhesive underneath the battery to keep it in place, this may make it a bit difficult to remove the battery.

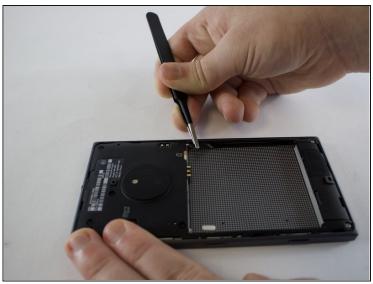
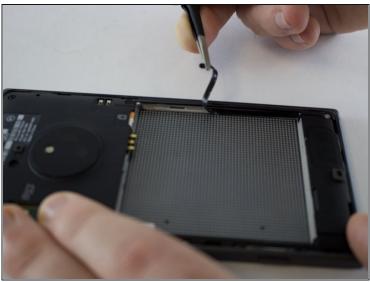
Step 3 — Main Speaker

Remove the black strips on both sides of the battery compartment.

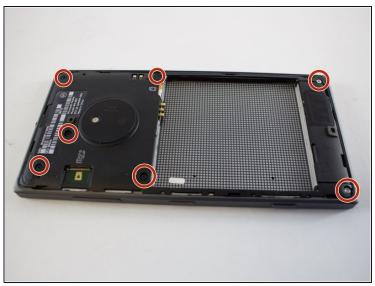
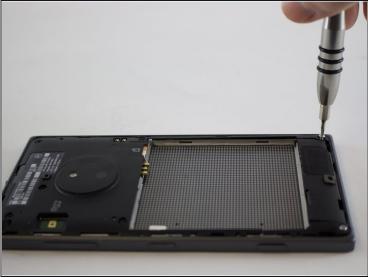
- Remove the two 3.9mm silver screws from the bottom corner of the phone. Then remove the five 2.5mm black screws from top to bottom of the phone.
- (i) All of the screws take a t5 star screwdriver.

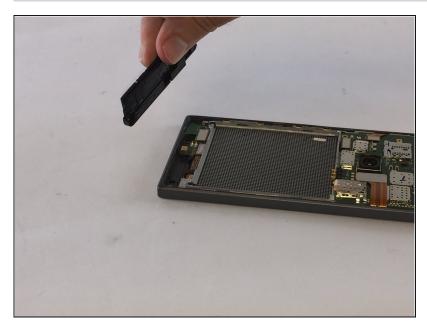
Lift the speaker out of the phone.
 You may need to wiggle the speaker loose.

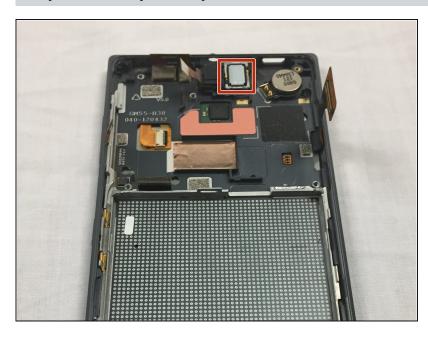
Step 11 — Earpiece Speaker

The speaker is located at the top of the device to the right of the headphone jack.

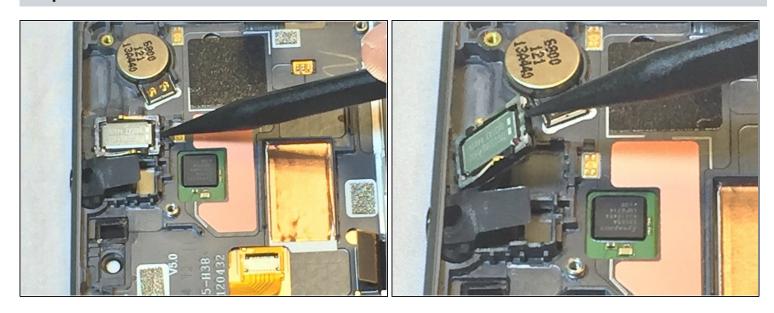
• Use the pointy end of the spudger to firmly lift the earpiece speaker out of the socket.

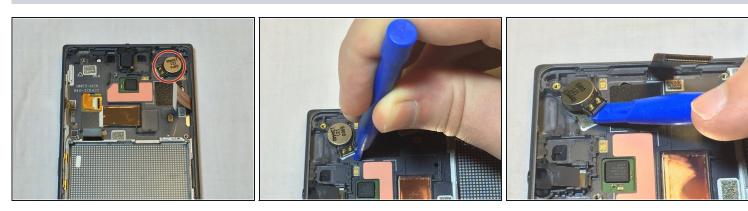
Step 13 — Vibrator

- The vibrator is highlighted in the image provided.
- Use the plastic opening tool to lift the vibrator from the base of the phone.
 - (i) You may need to use a bit of force to lift it up completely
- Remove completely using tweezers.
