# Dyson V6 Motorhead Brush Bar Replacement

Brush bars have a history of failing, issues of them not rotating as well as wearing out.

Written By: Addie Hedge

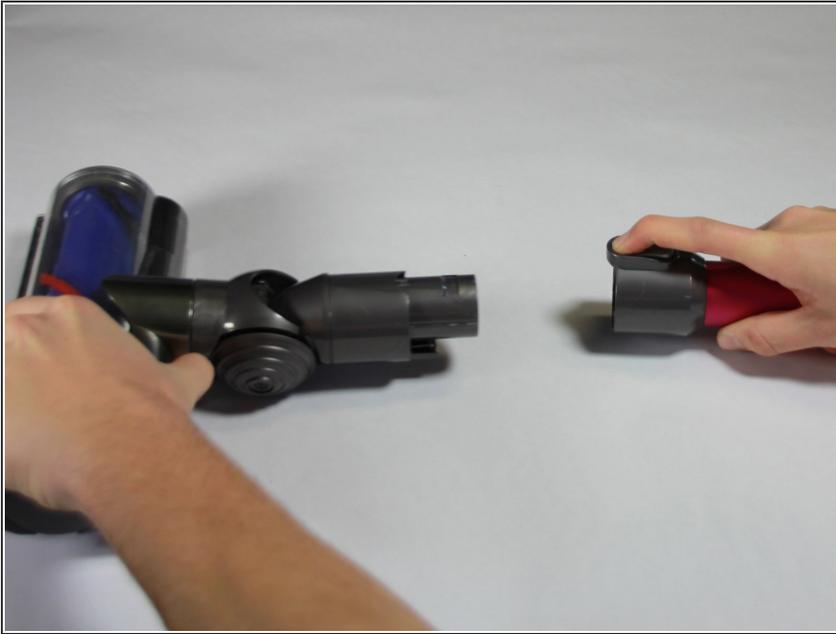
## Step 1 — Brush Bar

- Press the button to disconnect the vacuum head from the connecting pole.

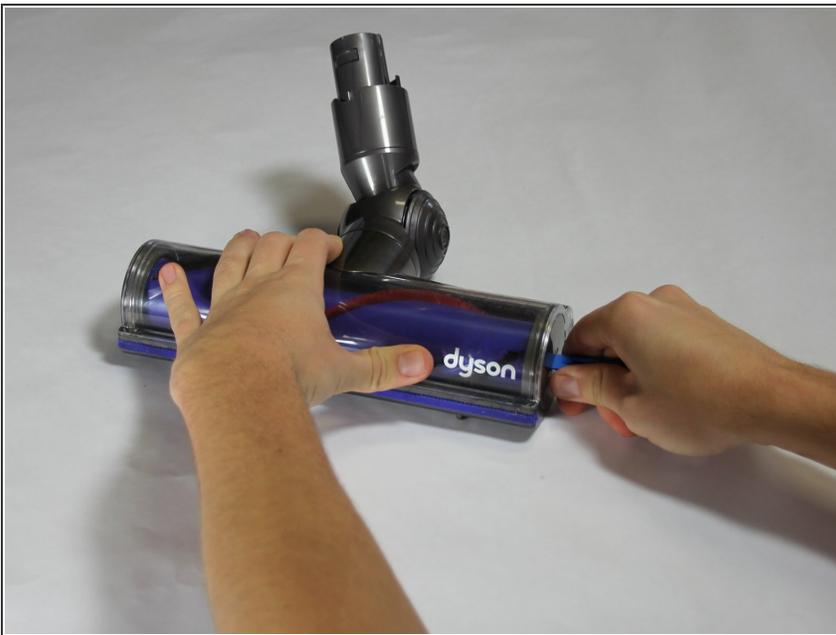
## Step 2

- Turn the end cap counterclockwise using the iFixit Opening Tool.
- ⓘ If you do not have an iFixit Opening Tool, a quarter may be used instead.

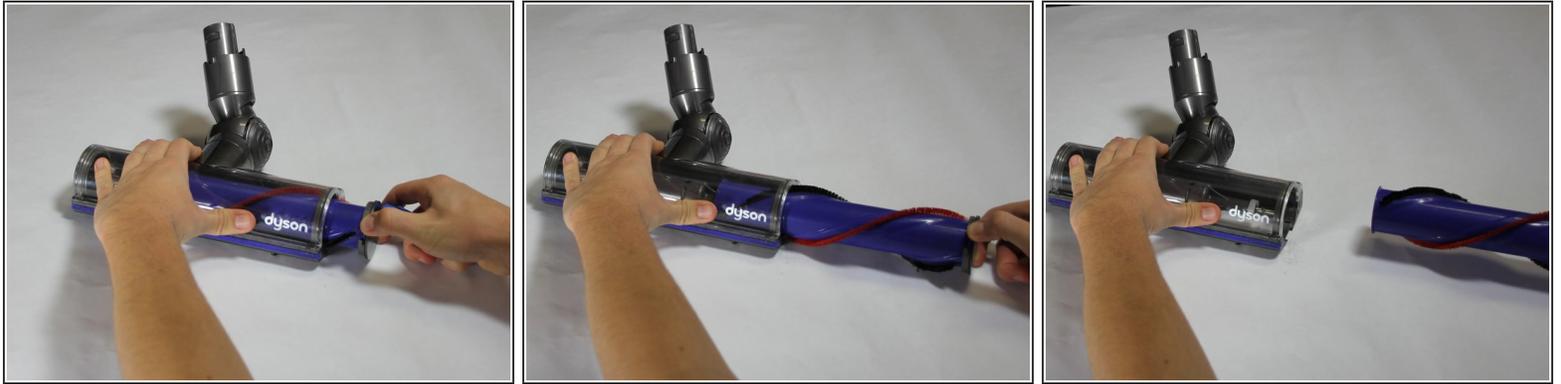
### Step 3

- Pull the brush bar out of the housing.

To reassemble your device, follow these instructions in reverse order.
