Toshiba Satellite C55Dt-A5306 DC Power Jack Replacement

Replace DC power jack on Toshiba Satellite Laptop that is unable to conduct charge.

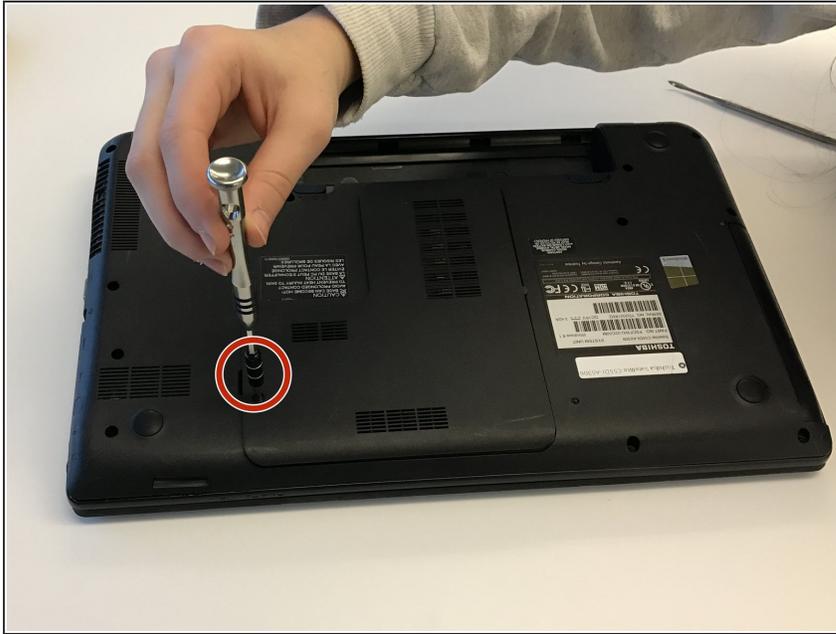
Step 1 — Back Cover

- Using the Phillips Head #0 Screwdriver, remove one 3mm Phillips #0 screw as indicated.

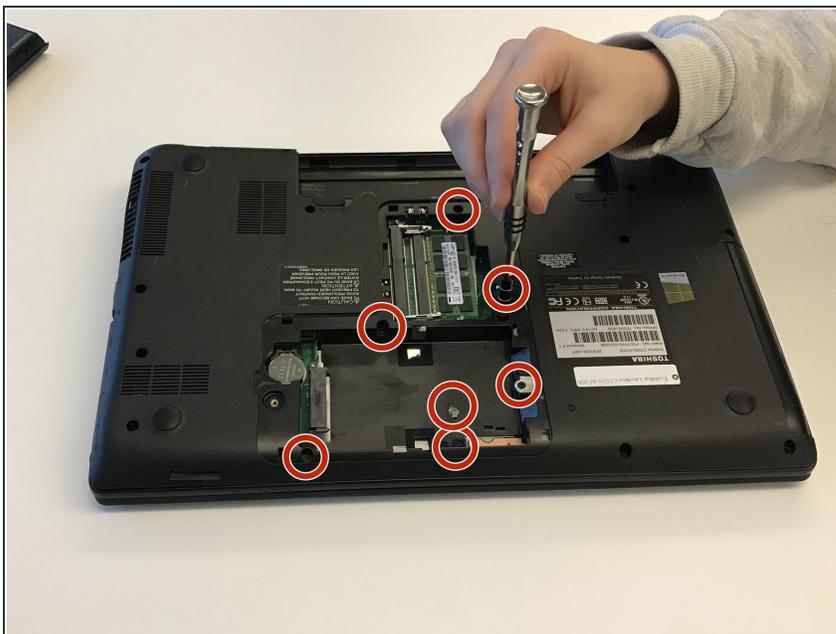
Step 2

- Remove hard drive cover. Using the Phillips Head #0 Screwdriver, remove seven 3mm Phillips #0 screws as indicated.

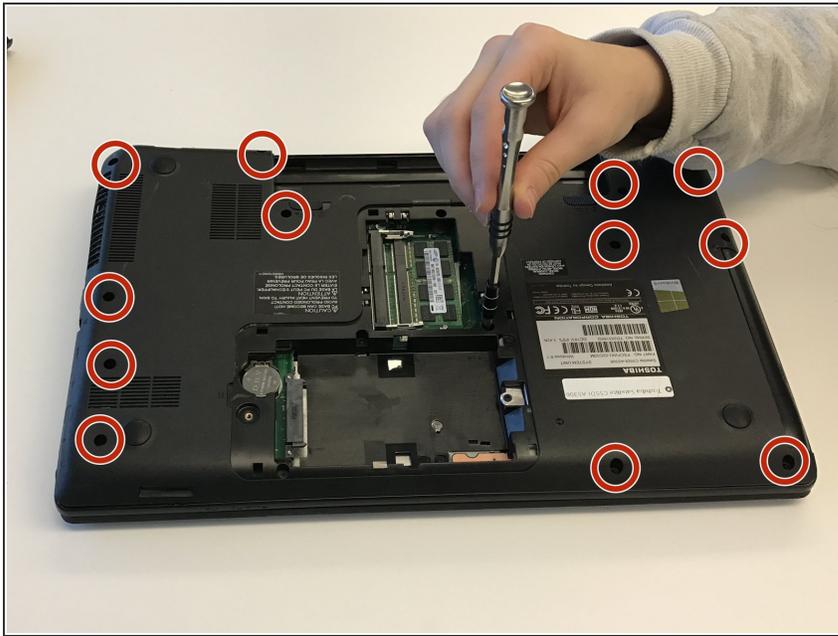
Step 3

- Using the Phillips Head #0 Screwdriver, remove twelve 3mm Phillips #0 screw as indicated.

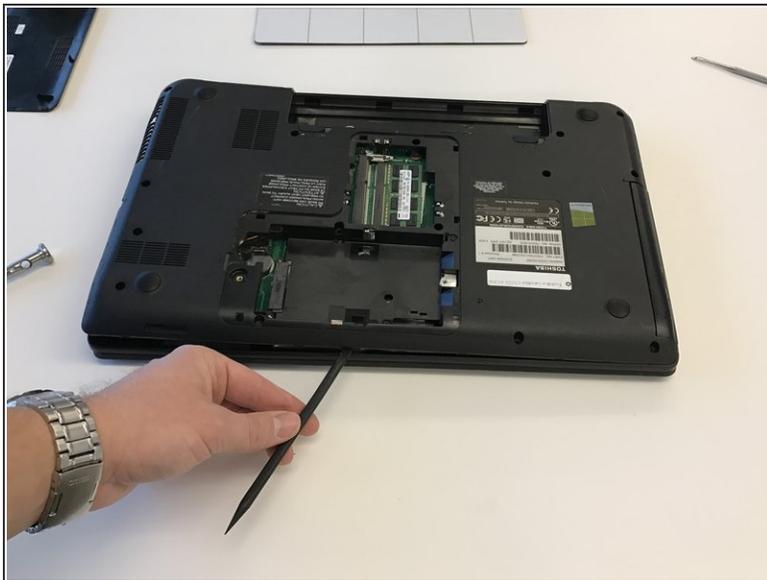
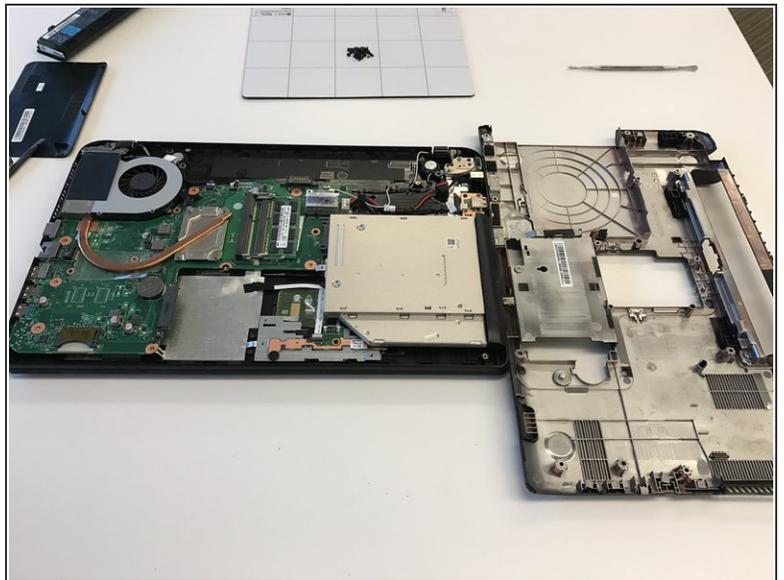
Step 4

- Using the plastic spudger, pry the back off along the periphery of the laptop.

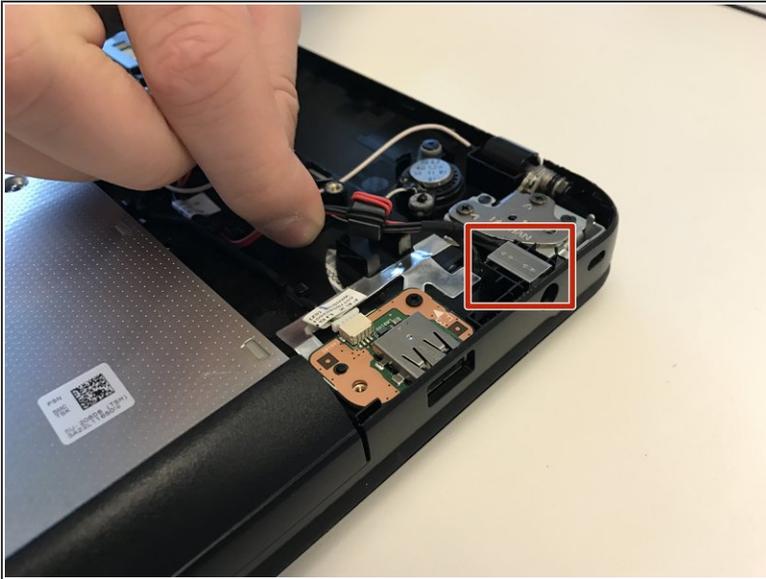
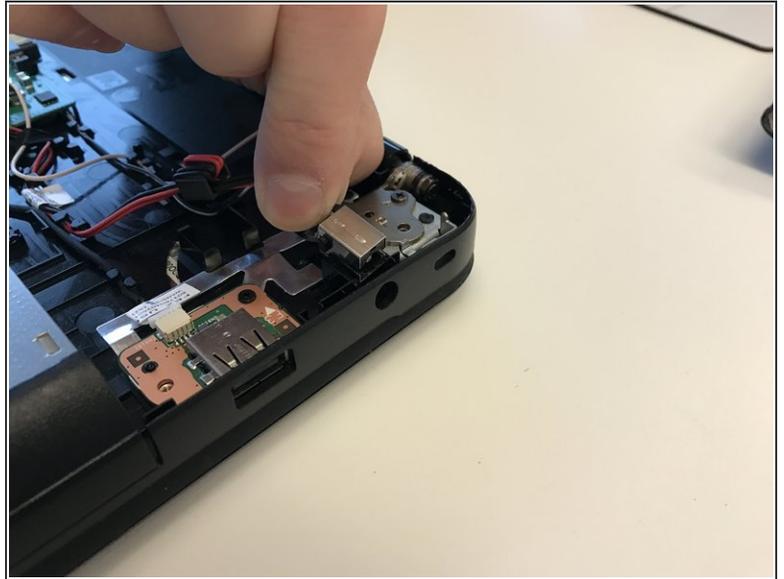
Step 5 — DC Power Jack

- Remove the DC power jack from its plastic retaining piece, just inside of the charger inlet.

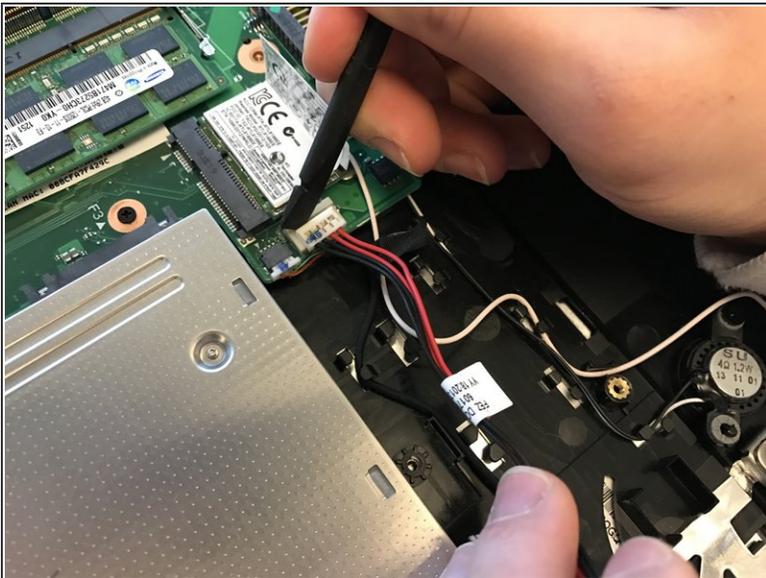
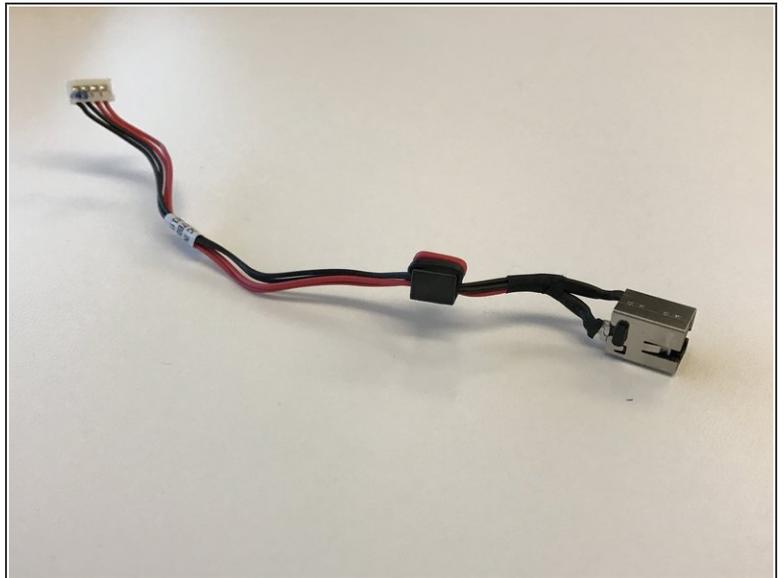
Step 6

- Use the nylon spudger to remove the connecting wires from the motherboard. Insert the spudger between the terminal plastic piece of the wire and its retaining clip on the mother board. The wire should release without much force.

To reassemble your device, follow these instructions in reverse order.
