Garmin Nüvi 52LM USB Charge Port Replacement

This guide will show you how to replace the USB charge port on your Garmin Nüvi 52LM.

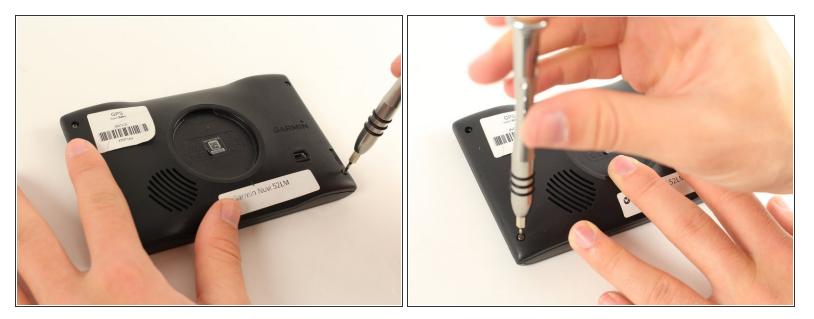
Step 1 — Garmin Nüvi 52LM Disassembly

Place the device face-down, with the screen facing the surface. There are 8.7mm screws located in each of the back 4 corners of the device. Using a T5 Torx screw bit, unscrew all four screws and leave them aside.

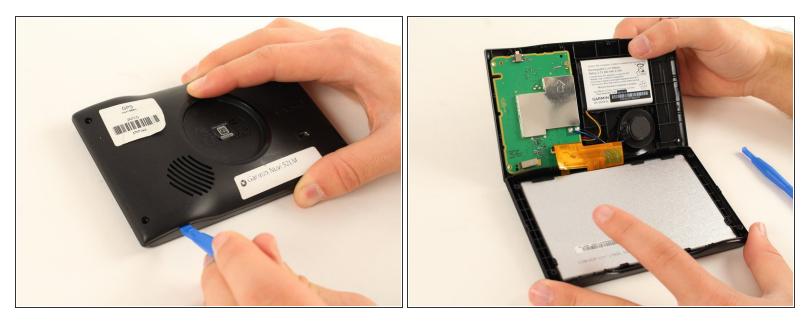
Step 2

- Place a plastic opening tool in the seam between the back and front plates of the device. Using constant pressure, slowly and continuously slide the tool along the seam. The tool should disable each of the hooks holding the two plates together. If unsuccessful, apply slightly more pressure and try again.
- Once all hooks are disabled, slowly separate the two plates, being careful not to damage the ribbon wire still connecting the two.

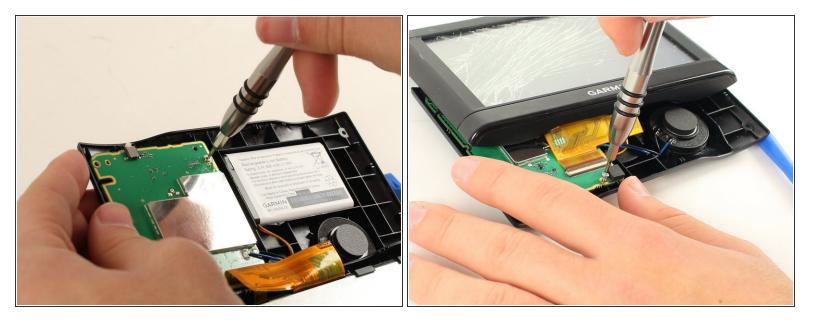
Step 3 — Battery

Using the T5 Torx screwdriver, unscrew the two 5.6mm screws at the top right and bottom right corners of the motherboard.

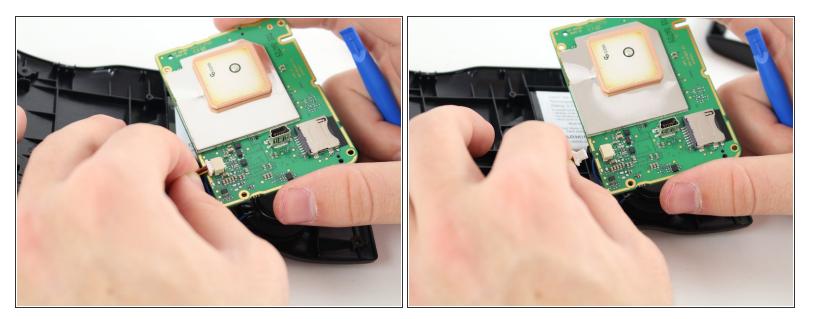
Step 4

• Gently unplug the wire connecting the battery to the small socket on the back of the motherboard.

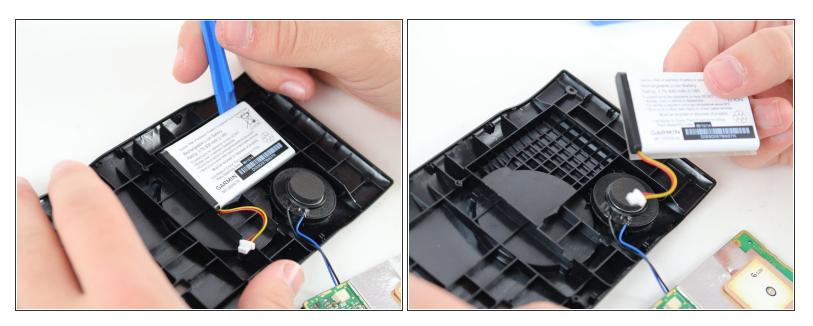
Step 5

- Using a plastic opening tool, pry the battery from the back cover of the device. There may be an adhesive sticker keeping it in place, so you may need to apply some force.
- The battery should now be completely detached from the other parts.

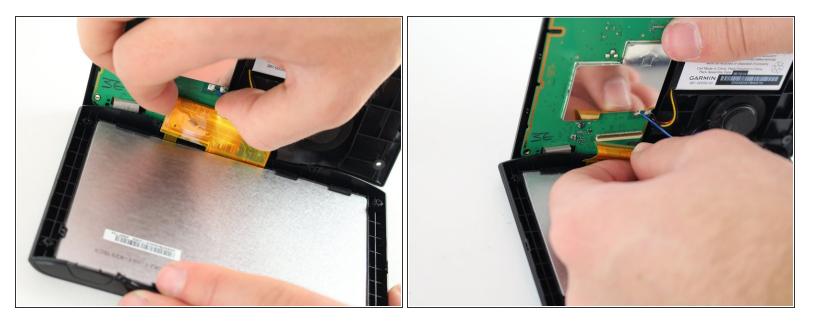
Step 6 — USB Charge Port

- On the motherboard, lift the small plate that holds the orange ribbon wire in place.
- Gently disconnect the ribbon wire from its connection to the motherboard.

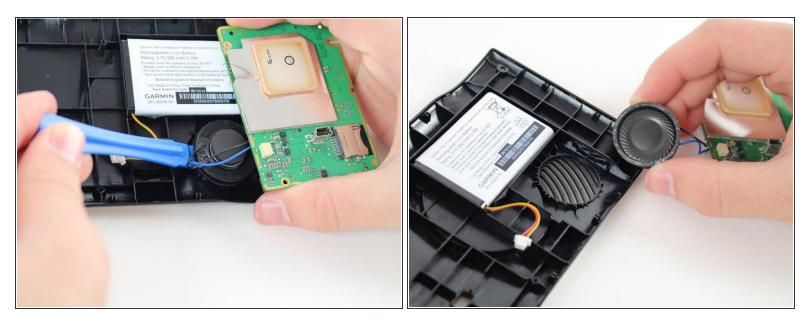
Step 7

- Using a plastic opening tool, pry the speaker from the back plate of the device. There may be a small amount of adhesive connecting the two, so you may need to use a small amount of force.
- The motherboard and USB charge port should now be completely detached from the other parts of the device, and a new one can now be placed.

To reassemble your device, follow these instructions in reverse order.
