# Kenmore Elite HE3 Washing Machine central control unit Replacement

replacing the CCU on a Kenmore Elite HE3 washer

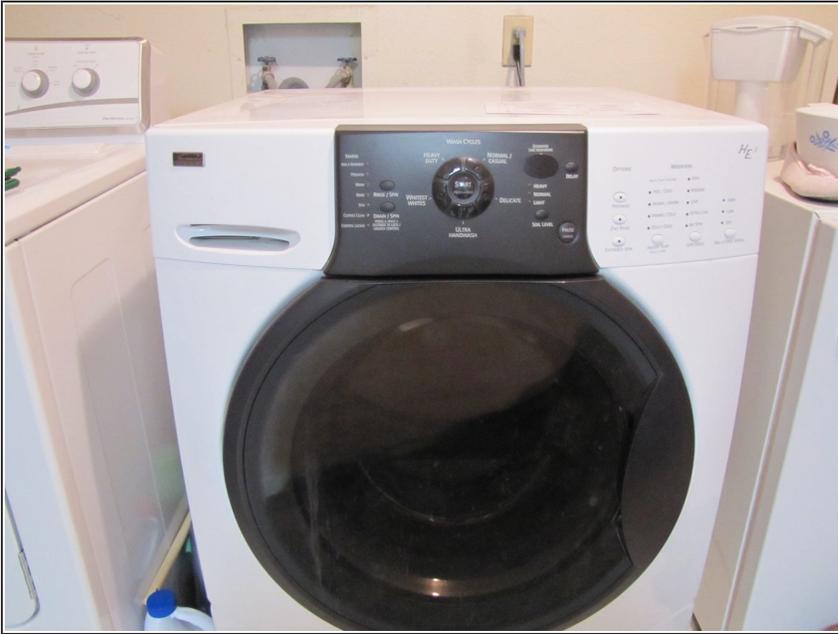
## Step 1 — central control unit

- My 13 year old Kenmore HE3 washer failed to power on the other day. No error codes, no lights. I checked to be sure the breaker had not tripped and that the outlet actually had power. Everything was OK, except the washer simply did not get any power.

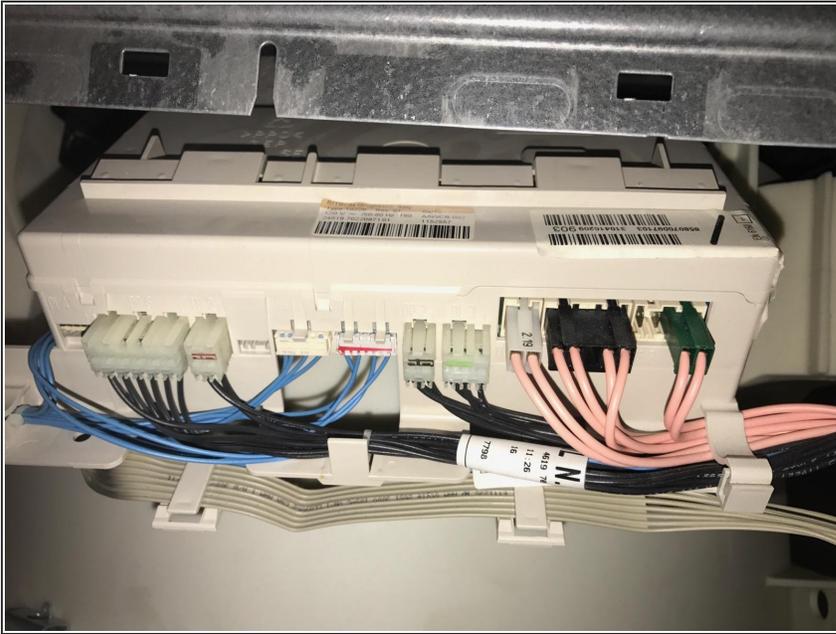
## Step 7

- The CCU looks like the picture here. Now is the time to take pictures of the front side and left side of the CCU to assist in the proper re-assembly after swapping in the replacement part.
- Carefully remove the plugs from their respective connections. Carefully remove the cables from the CCU cable guides, noting their locations for the re-assembly.

- There are three plastic tabs securing the CCU to the rear frame. Use a flat blade screw driver to CAREFULLY lift the edges of the tabs so the CCU can be slowly moved towards the front of the washer.
- Remove the old CCU.

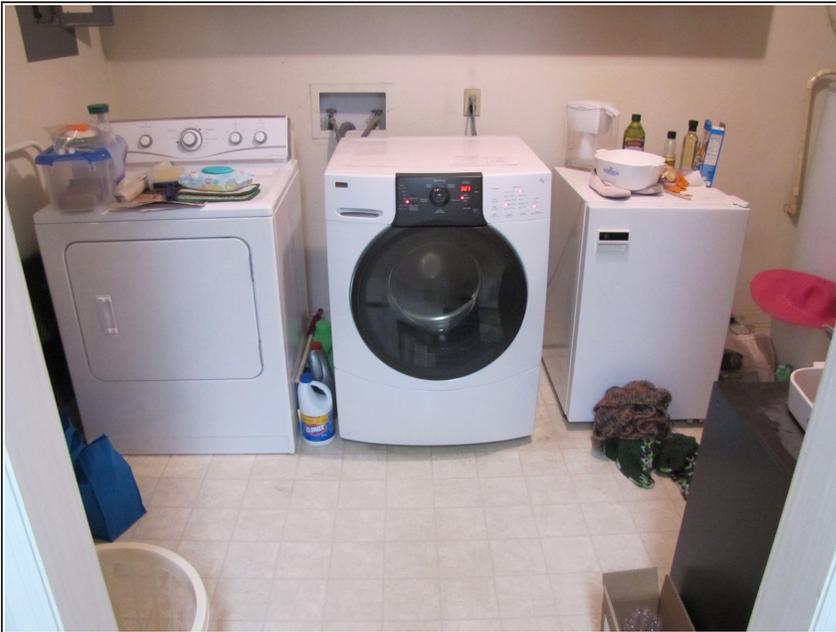
## Step 12

- LIGHTS... CAMERA... ACTION! We have lights on the washer!
- I ran a short cycle, water only, to test. It ran perfectly.
