# Razer Blackwidow Tournament Edition Keyboard Metal Bar on Keys Replacement

This guide is designed to help Razer Users replace the metal bar located on keys.

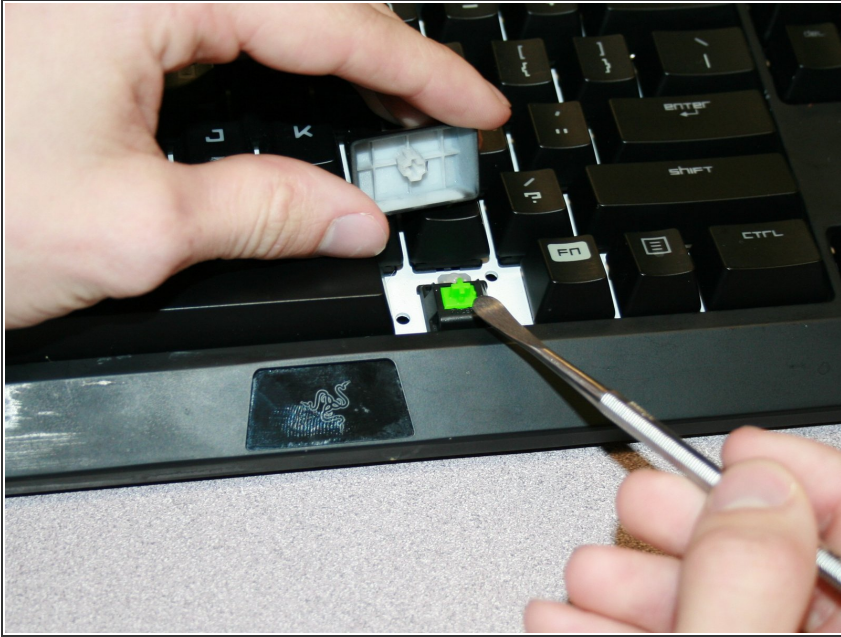
## Step 1 — Metal Bar on Keys

- ⓘ Before you do anything, take a picture of the entire keyboard so as to know where the keys go at the end.
- Gently start to remove the keys surrounding the keys with the bars in them.

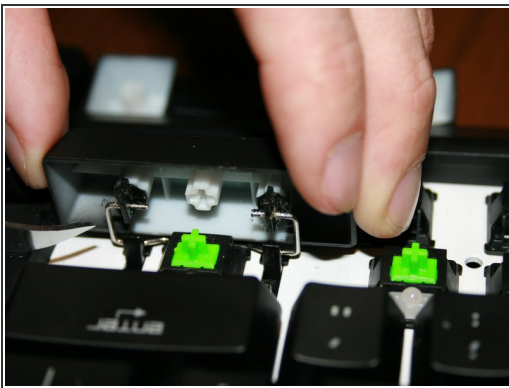
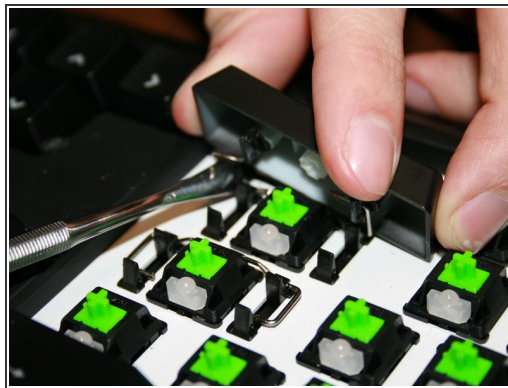
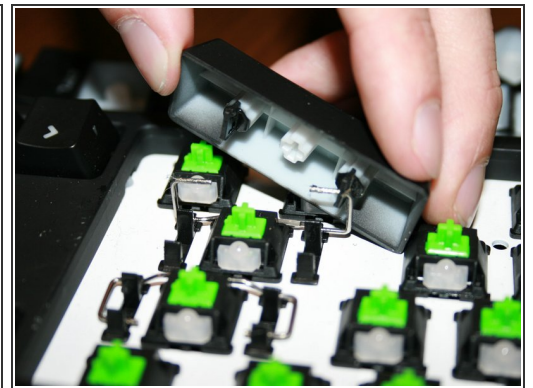
## Step 2

- Move the key itself off of one side of the bar from where it connects to easily allow the other side to be removed as well.
- Another way to do it is to push the bar itself out gently with the metal spudger.

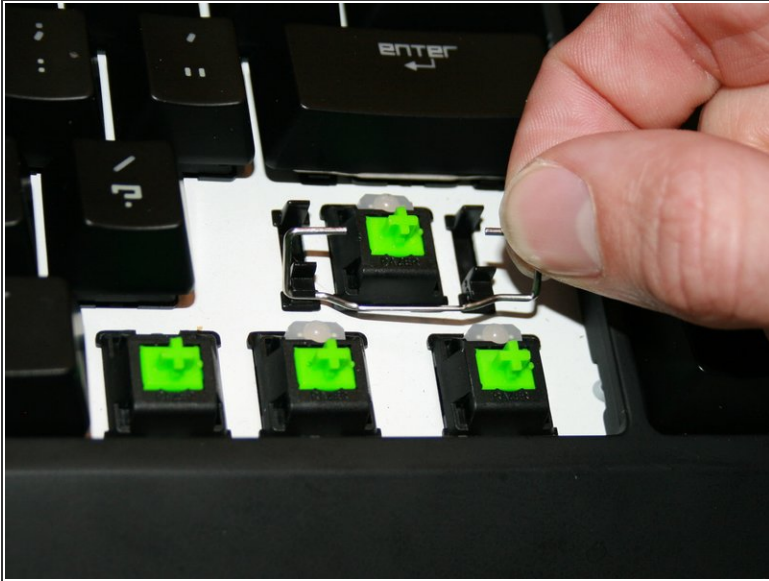
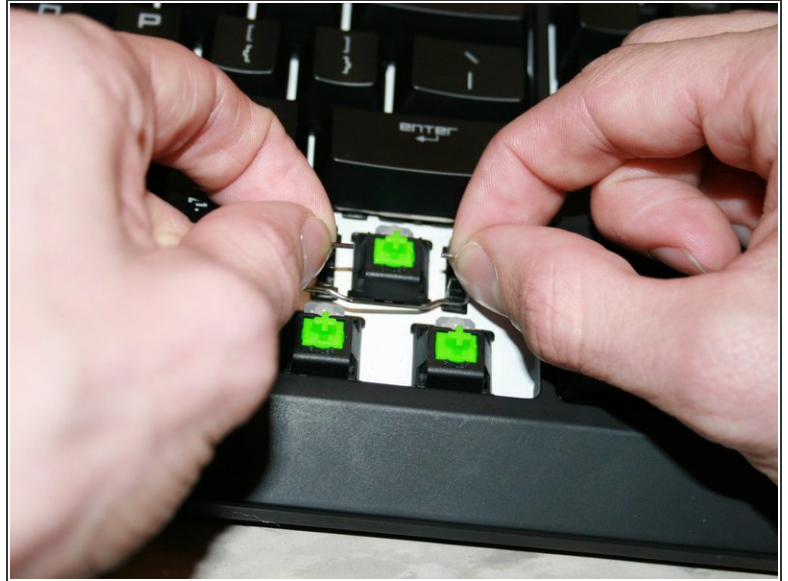
### Step 3

- Gently pop the bar out from its sockets.
- Pop the new bar back into the sockets.

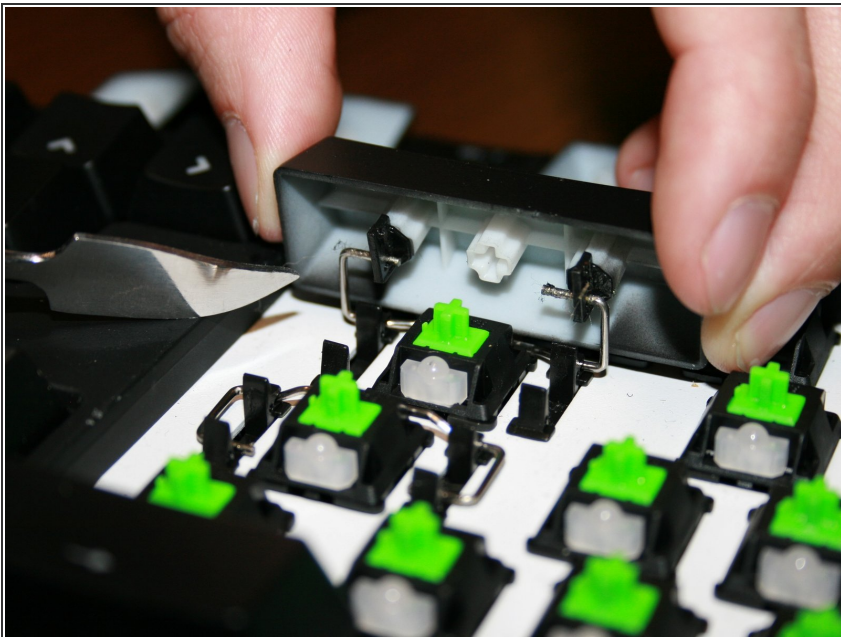
### Step 4

- Gently slide one side of the key into the bar and then use the metal spudger to pop the other side into place.
- ☑ Use the picture from the beginning if necessary to make sure all the keys are in the right place.
