Traxxas Summit Steering Assembly Servo Replacement

This guide will inform a user on the process of replacing a servo in their Traxxas Summit's steering assembly.

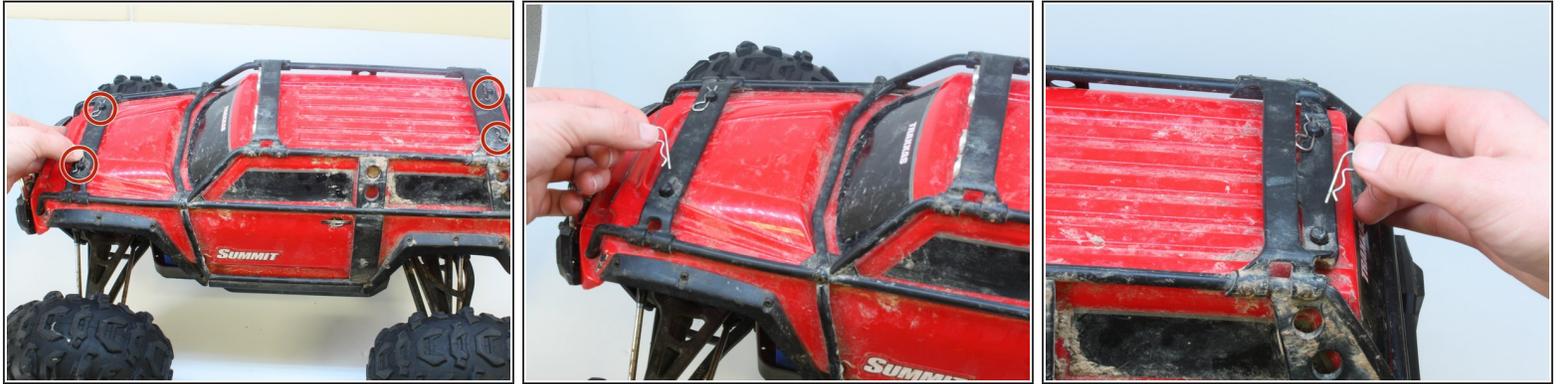
Step 1 — Steering Assembly Servo Replacement

- Remove each of the four pins that hold the shell by pulling them from the posts.

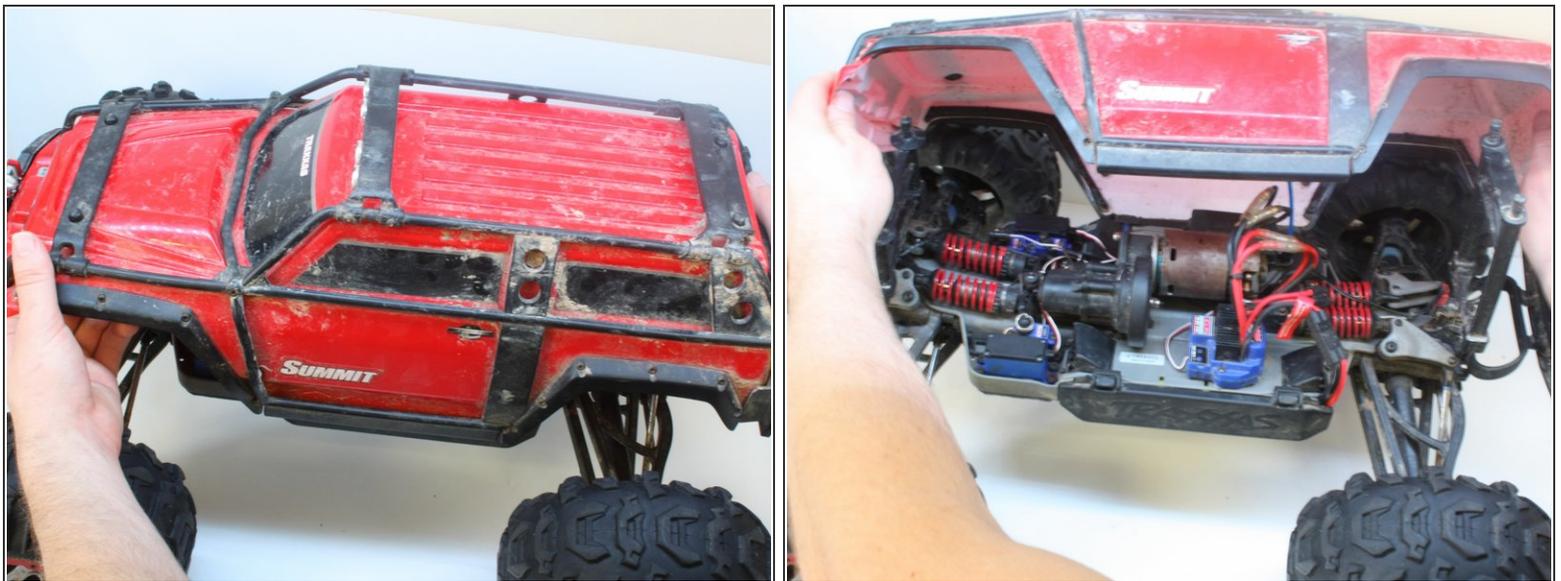
Step 2

- Remove the shell by grabbing it with both hands and lifting upwards.

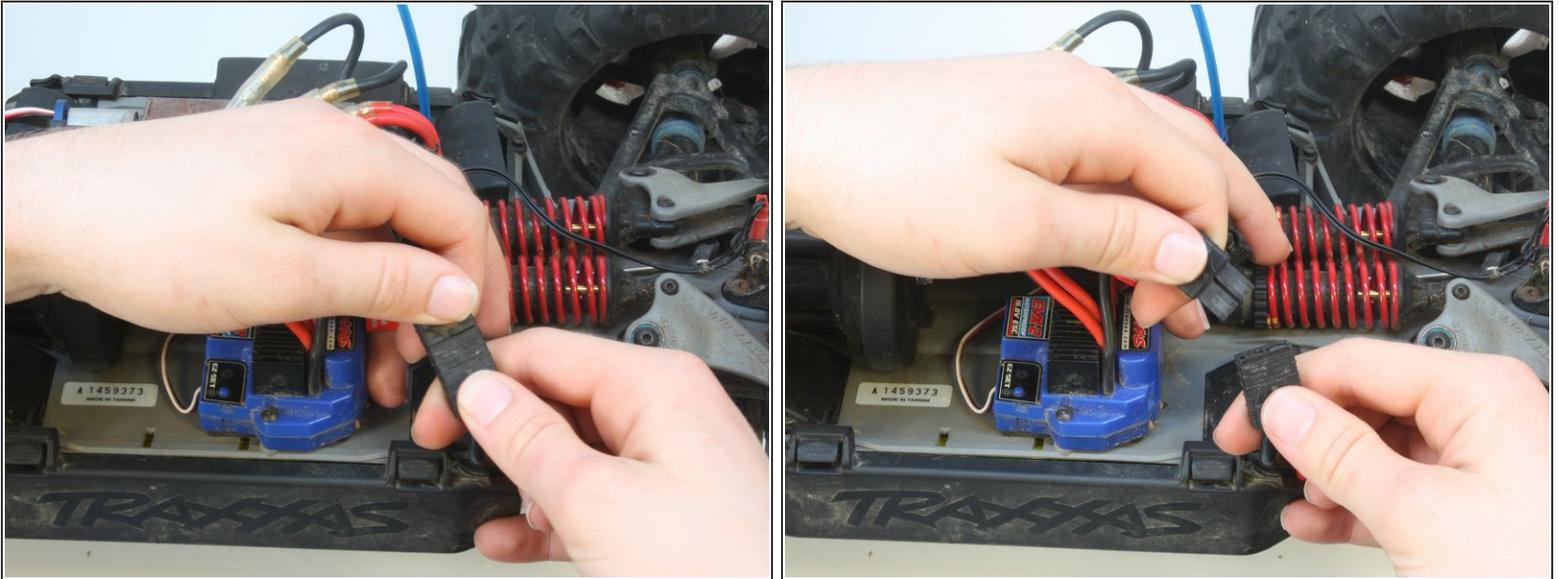
Step 3

- Disconnect the battery from the device by pulling the black plastic connector apart.

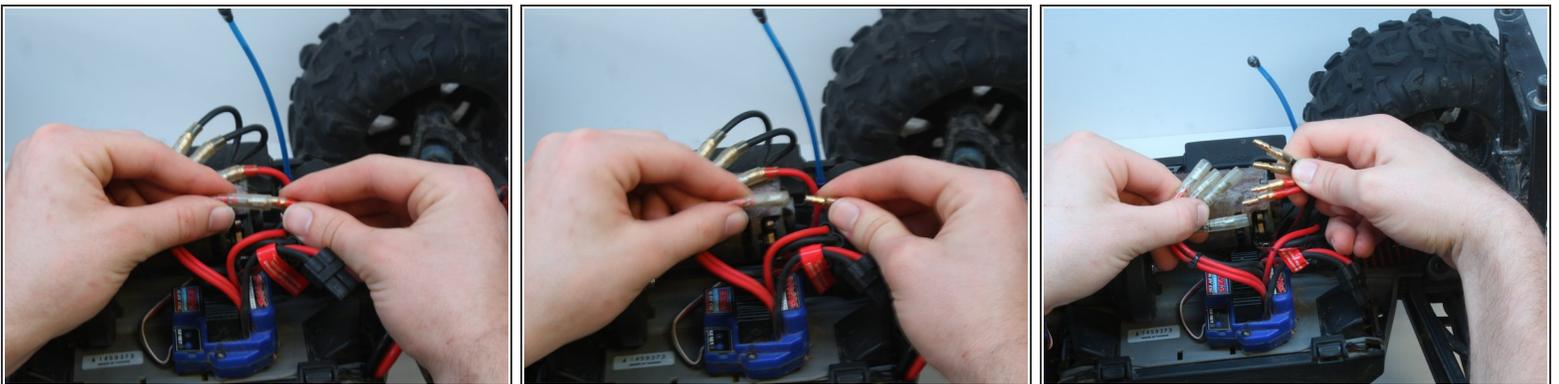
Step 4

- Disconnect the four power cables that connect the motor to the electronic speed control.
 - Grab the connectors by their rubber covered metal ends rather than the wire if possible.

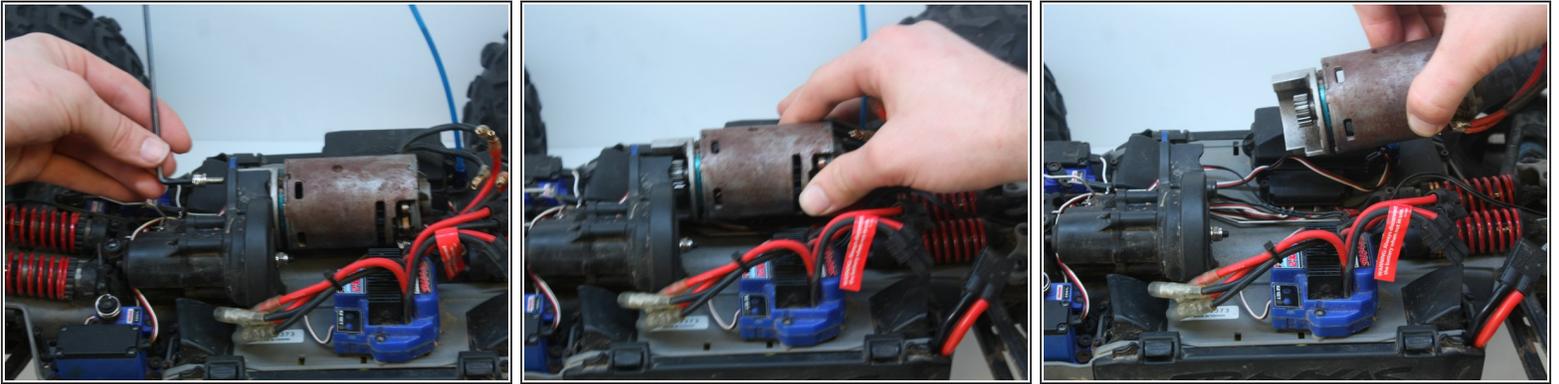
Step 5

- Unscrew the single 15.5mm long retaining bolt from the motor with the 3mm hex key.
- Remove the motor by wiggling back and forth while pulling it to the right and up.

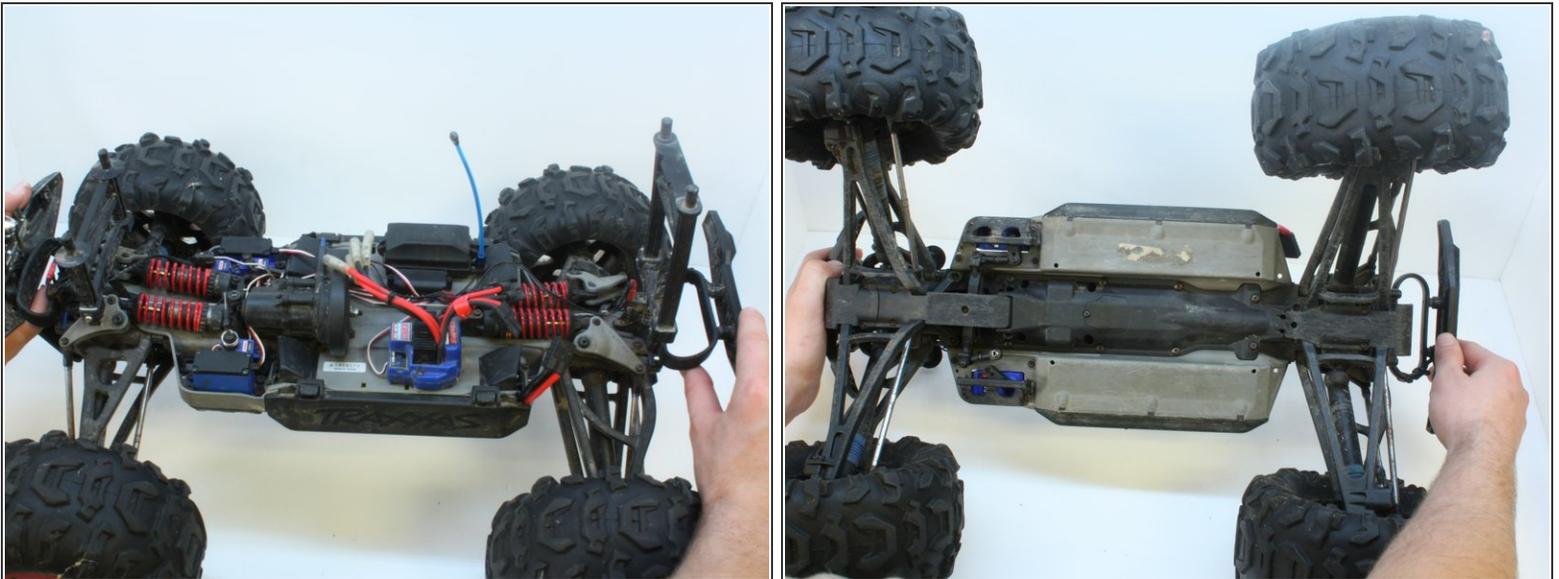
Step 6

- Flip the car on its back to provide access to the steering assembly.

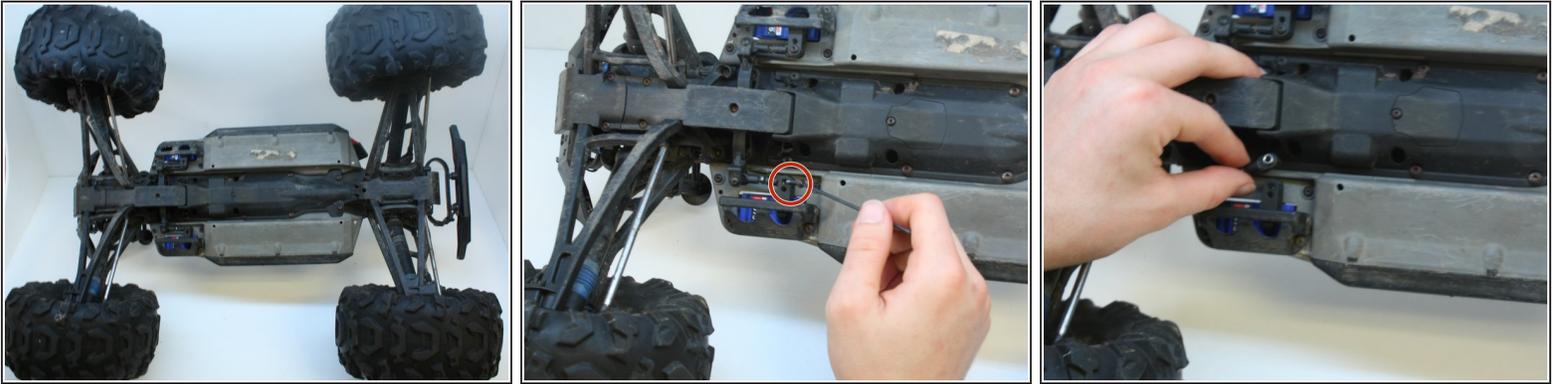
Step 7

- Unscrew the servo arm from the steering assembly by removing the 16.3mm long screw with a 2mm hex key.
- Pull the connecting linkage out of the steering horn.

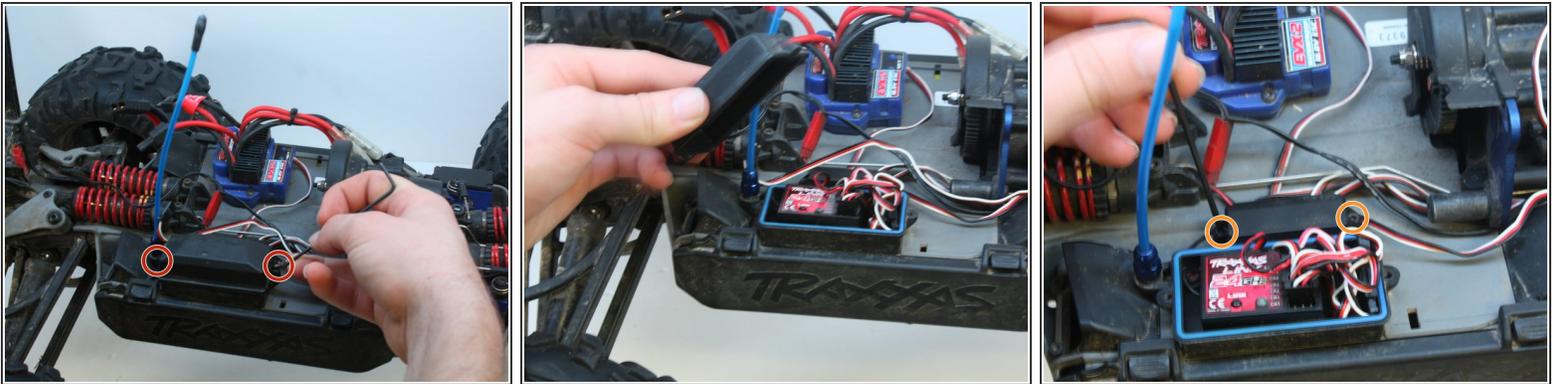
Step 8

- Flip the car back upright.
- Remove the two 7mm long screws retaining the largest wiring cover with the 2mm hex key.
- Take the largest wiring cover off.
- Remove the two 7mm long screws retaining the smaller wiring cover with the 2mm hex key.

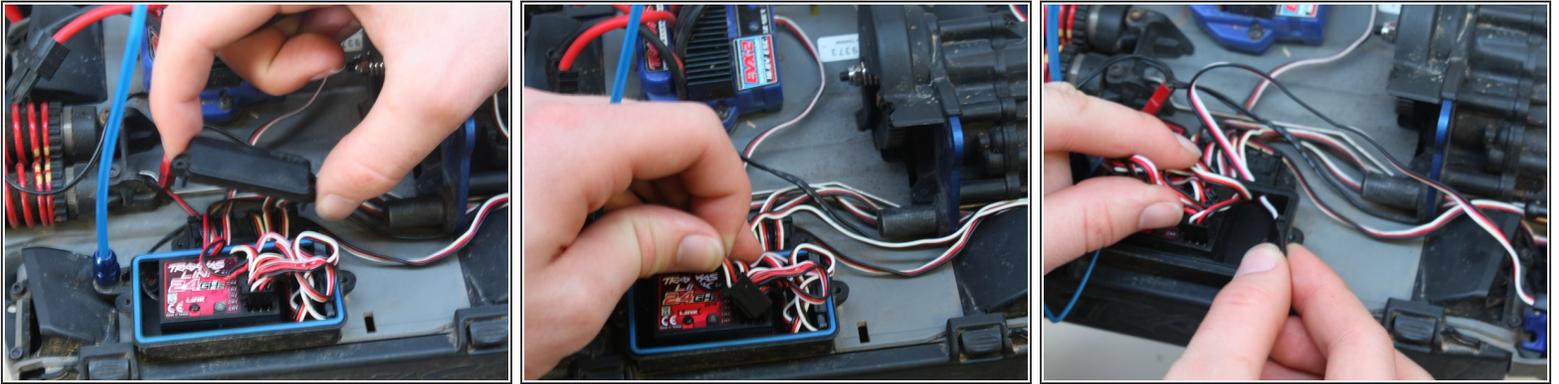
Step 9

- Remove the second wiring cover.
- Pull the servo connector out of the receiver.
- Work the cable out of the receiver box.

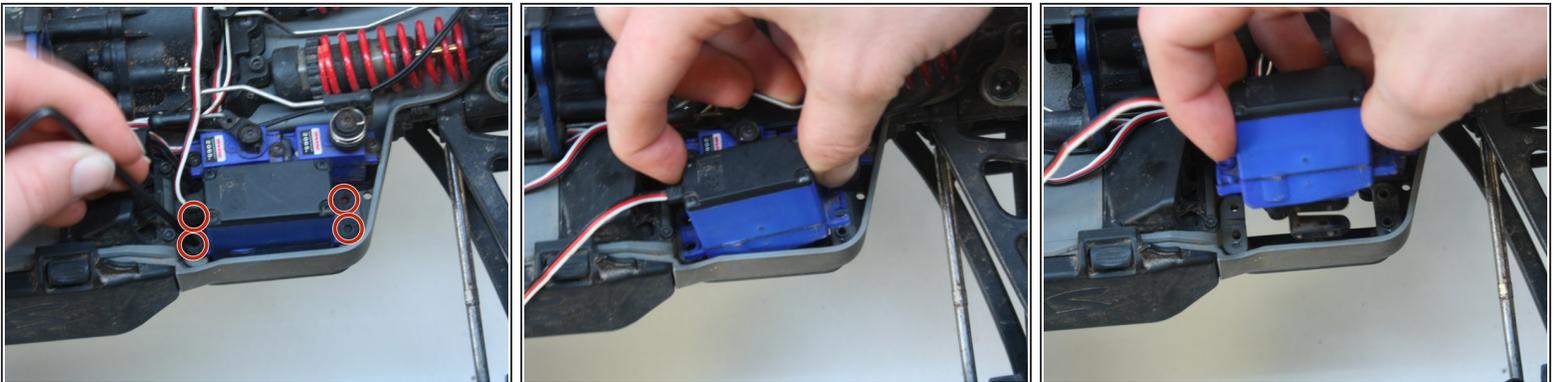
Step 10

- Remove the four 9mm long screws that retain the faulty steering servo with the 2.5mm hex key.
- Pull the servo out.
 - Turning the servo horn by hand may be necessary to fit it through the hole.

To reassemble your device, follow these instructions in reverse order.
