HP Compaq Presario CQ56-110US Repair Wi-Fi Card Replacement

Use this guide to fix wireless connectivity issues by replacing the defective wifi card on the HP Compaq Presario CQ56-110US laptop.

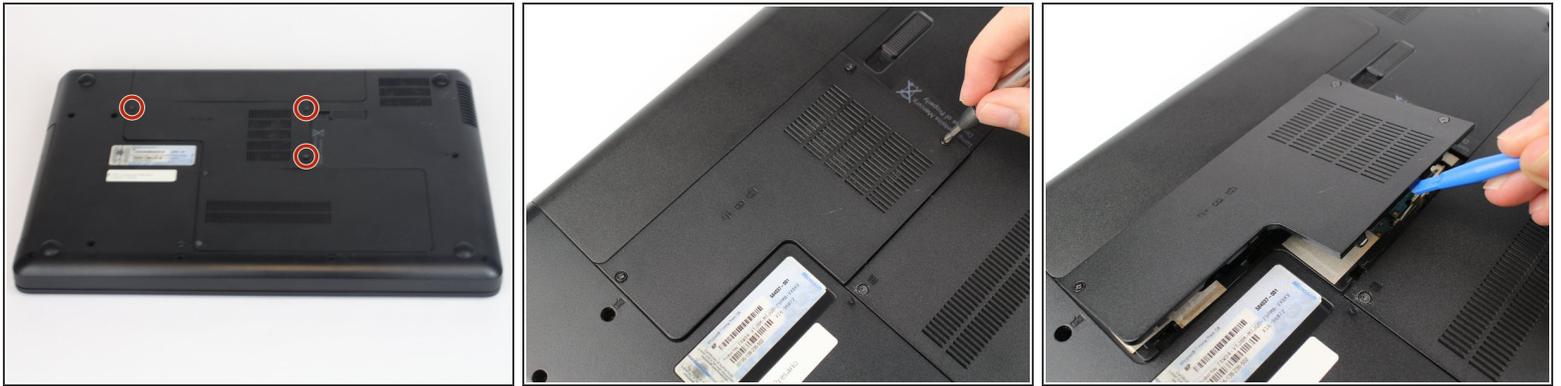
Step 1 — Wi-Fi Card

- Use a Phillips screwdriver with a PH1 bit to loosen the three indicated screws.
- ⓘ The screws do not come free from the panel. They only need to be loosened enough so that the panel can be lifted/pried using a plastic opening tool.

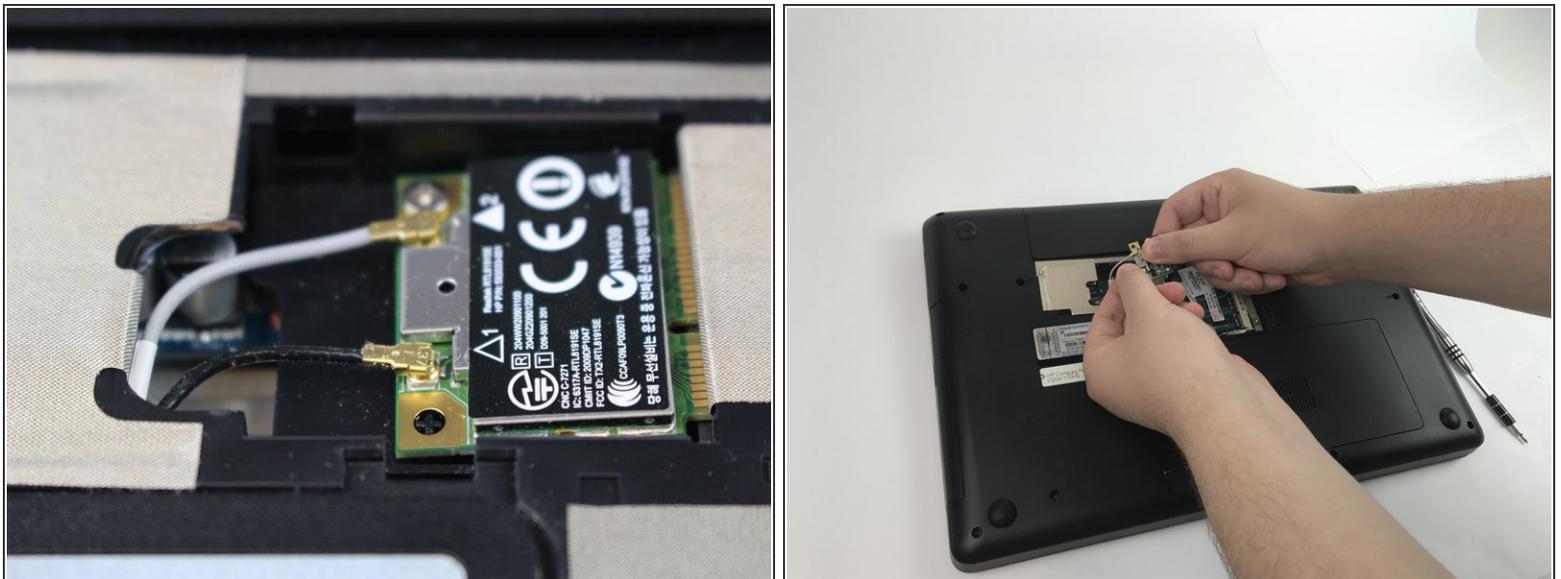
Step 2

- Gently pull the black and white cables to disconnect them from the Wi-Fi card.

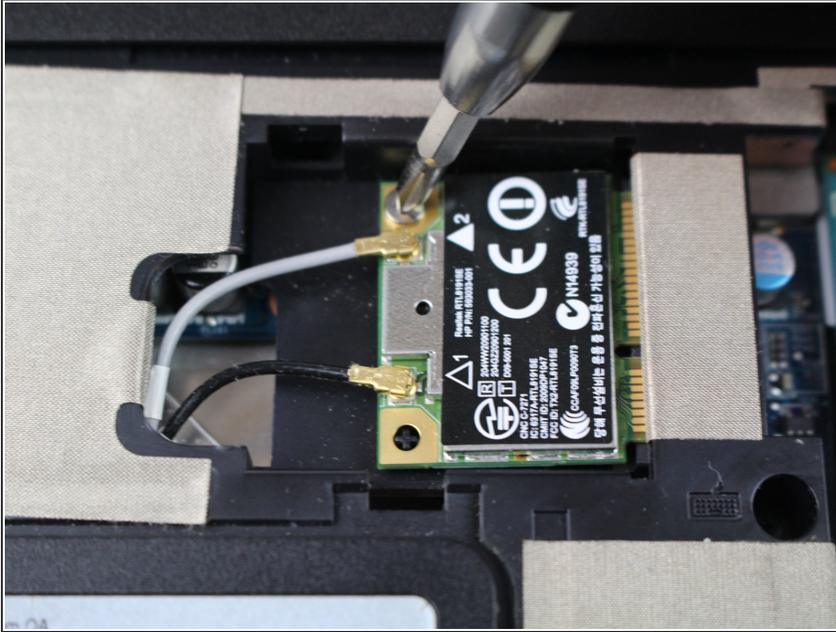
Step 3

- Use the same screwdriver to remove the two 3 mm screws holding the card in place.
