HP Chromebook CB2L Audio Port Replacement

This guide helps one remove and replace the Audio port of the HP Chromebook CB2L.

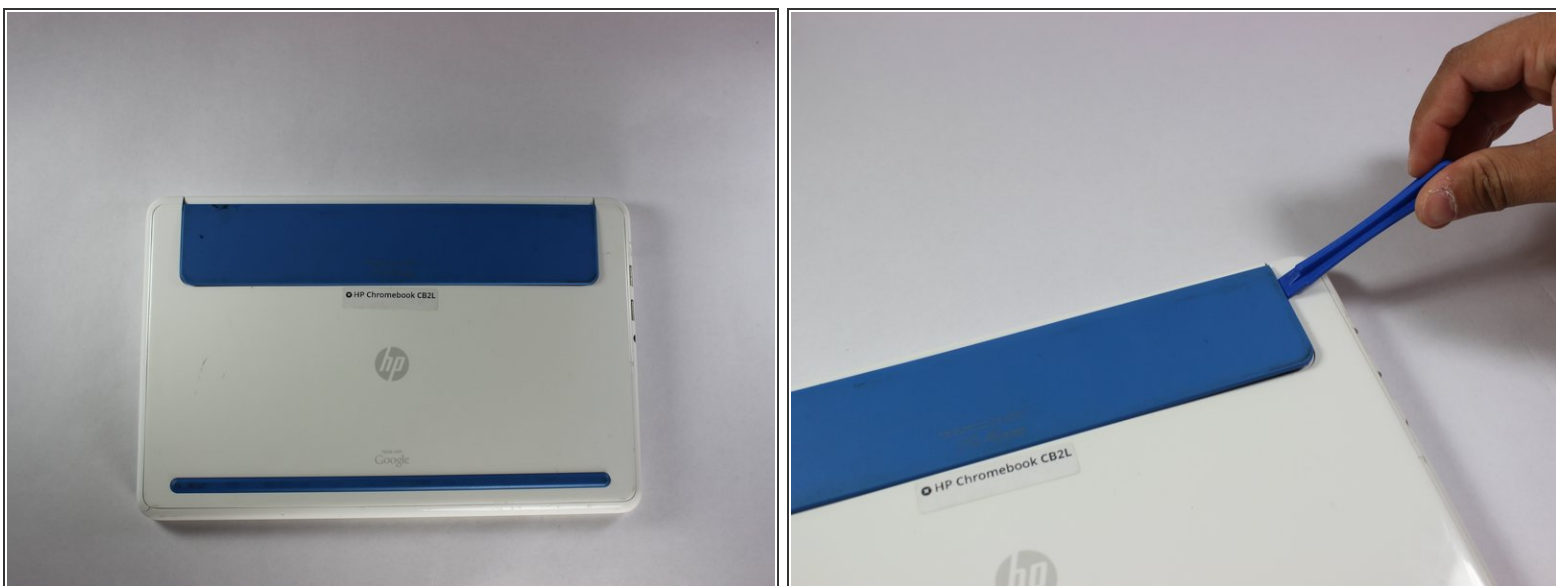
Step 1 — Audio Port

- Flip Chromebook over so that the bottom panel is facing upward.
- Use the plastic opening tool to remove the blue panel.

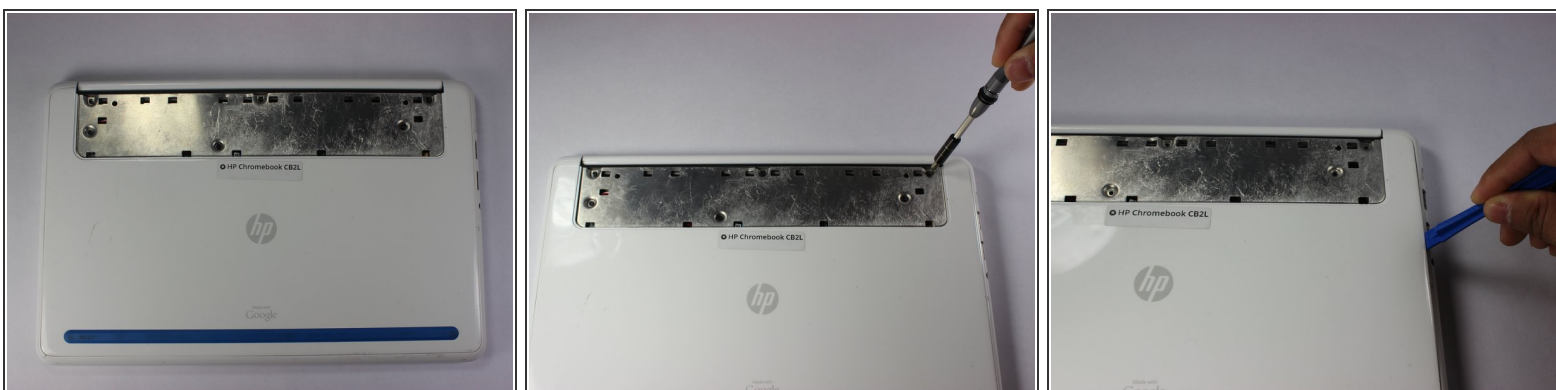
Step 2

- Unscrew the six 1.2mm screws on the metal plate using Phillips #1 screwdriver.
- Lift the white panel by gently prying around the edges using the plastic opening tool.

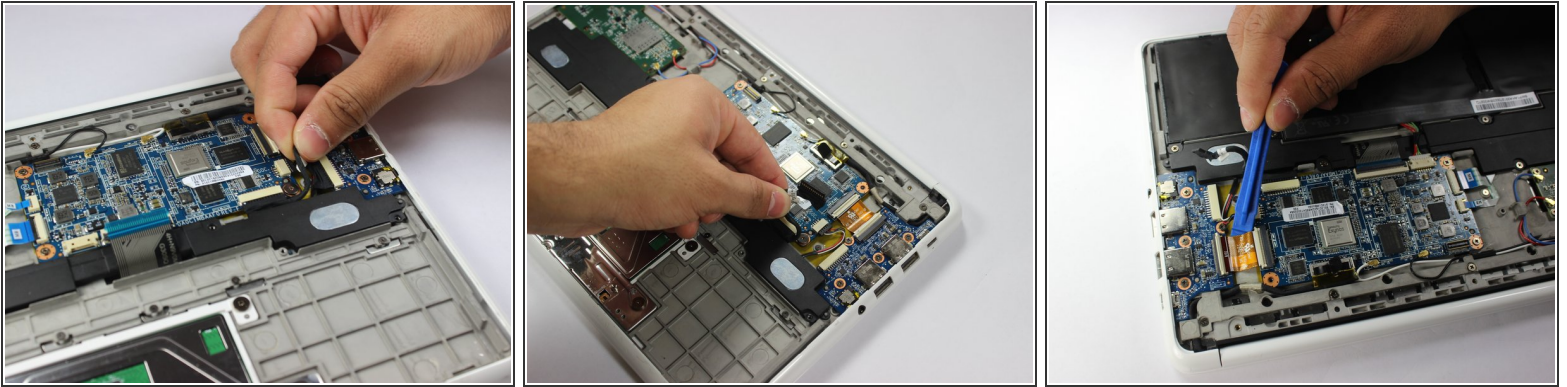
Step 3

- Disconnect the black wire which connects the audio port to motherboard.
- Disconnect the gold strip connecting the audio port to motherboard

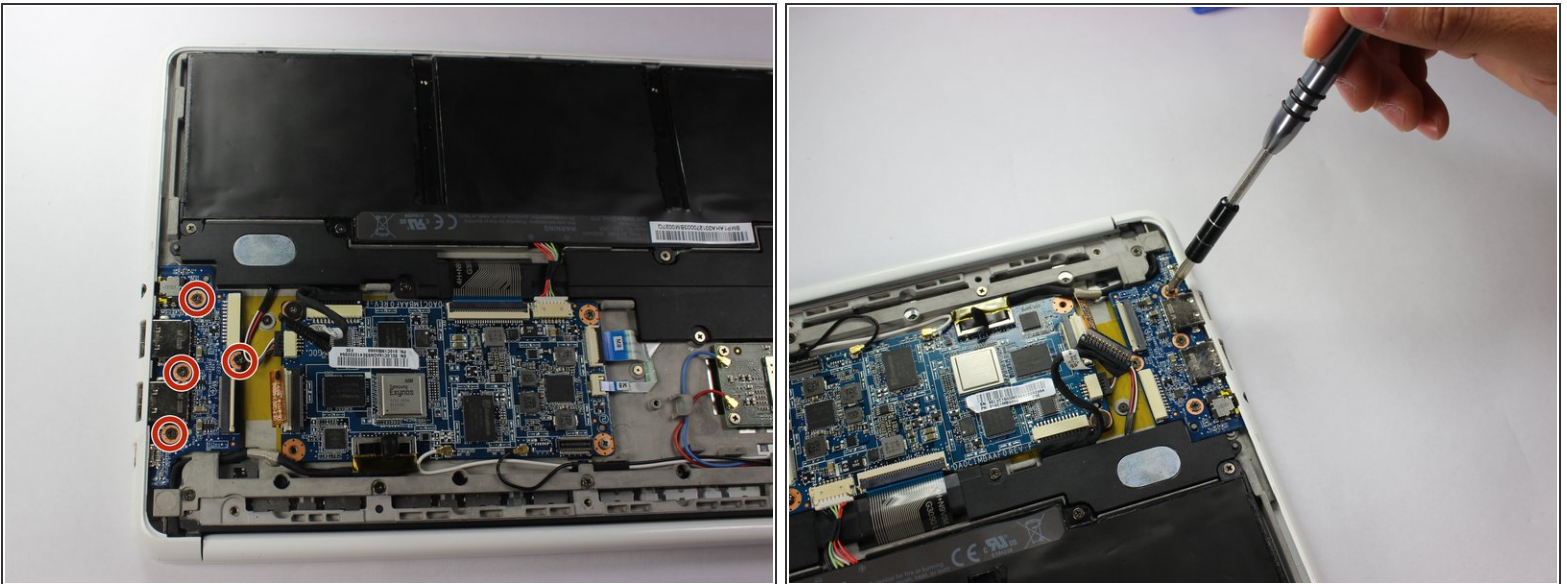
Step 4

- Unscrew four 1.2mm Phillips screws using Phillips #1 screwdriver.

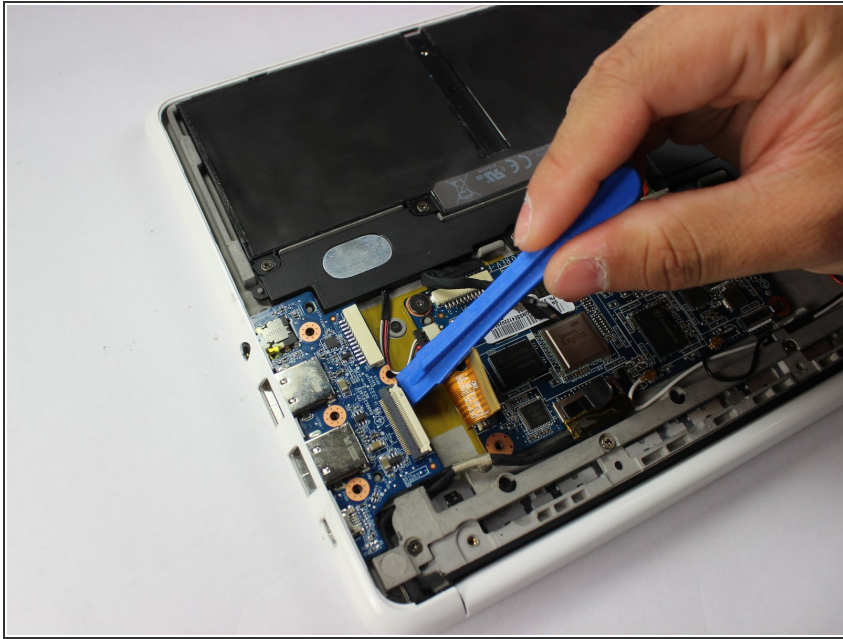
Step 5

- Using the plastic opening tool remove the audio port from the back panel.
