Sony BDP BX350 Disc Tray Replacement

This guide is used when a disc gets stuck inside of the disc assembly and the disc tray will not eject. Do not put the disc back in the disc assembly when you complete the guide and follow the disc assembly replacement guide to replace the disc assembly. Make sure that the device is unplugged before starting the guide.

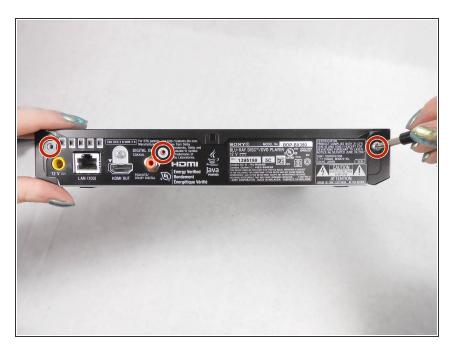
Step 1 — **Disc Assembly**

Remove the three 10mm Philips head screws on the back of the player.

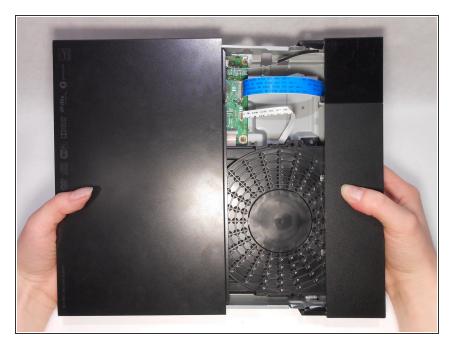
Step 4

- Completely separate the front cover and the metal back cover from the grey casing.
- The inner components should all be completely exposed after opening.

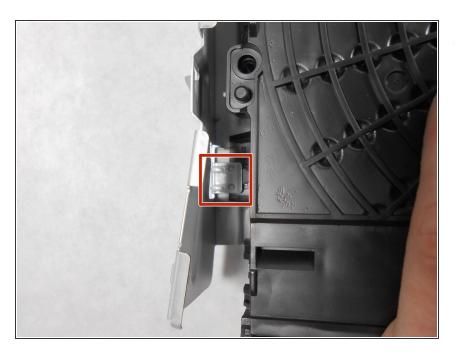
Step 6

Pull the disc assembly out from under the metal tabs on the main casing.

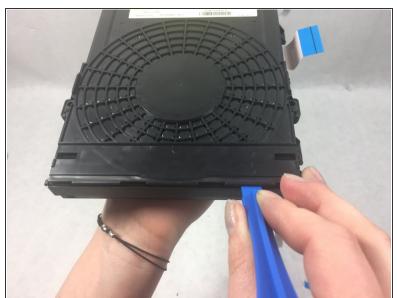
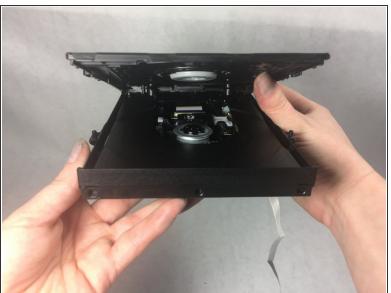
Lift front until back separates.

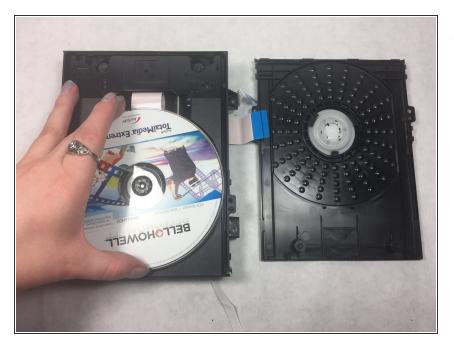
Step 10

Remove disc from disc tray.
