Kenwood KDC-BT565U CD Drive Replacement

This guide shows you how to replace the internal CD drive found in the Kenwood KDC-BT565U.

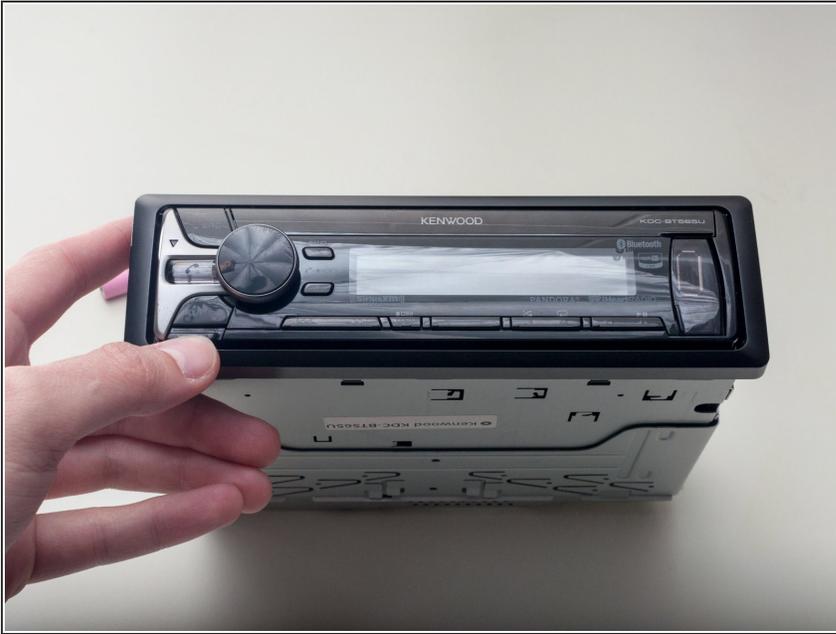
Step 1 — Face Plate

- Press the eject button on the bottom left corner of the face plate.

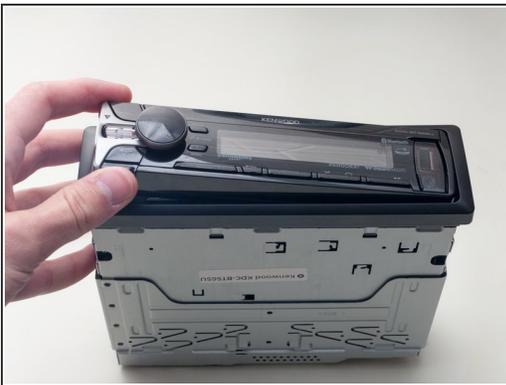
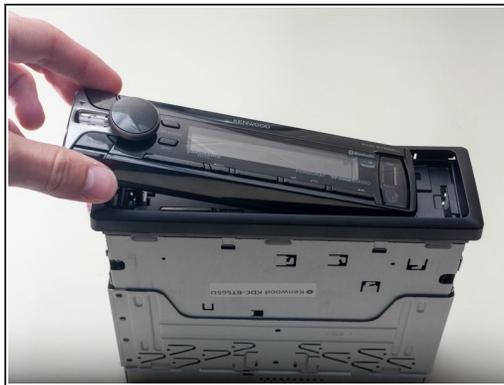
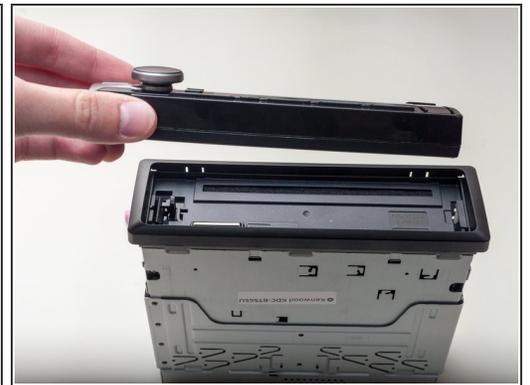
Step 2

- Begin by slightly lifting the face plate out from the side located by the release button.
- Slide towards the side of the eject button, *then* completely lift out.

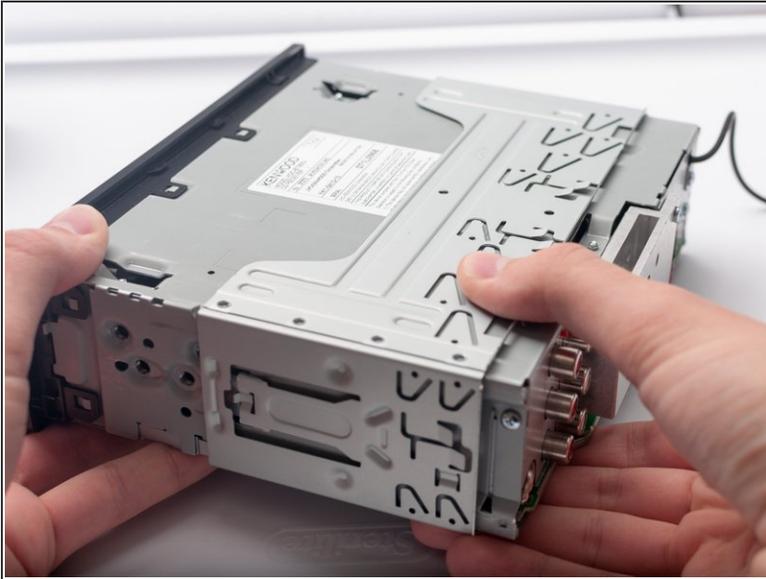
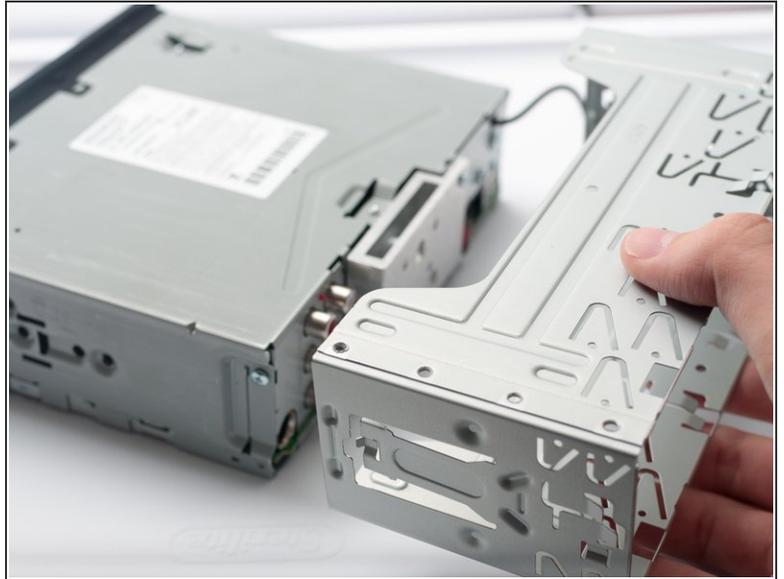
Step 3 — Metal Sleeve

- Grasp the outer metal sleeve with one hand and the front of the unit with the other.
- Slide the sleeve back until it comes off the unit.

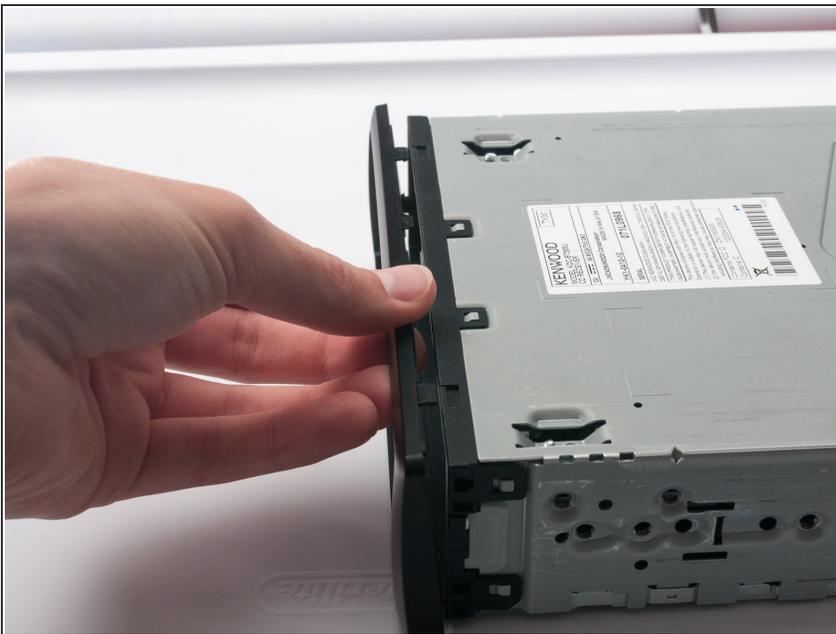
Step 4 — CD Drive

- Remove the thin frame from the front of the device. This can be done by first unsnapping the top pegs and then the bottom ones.

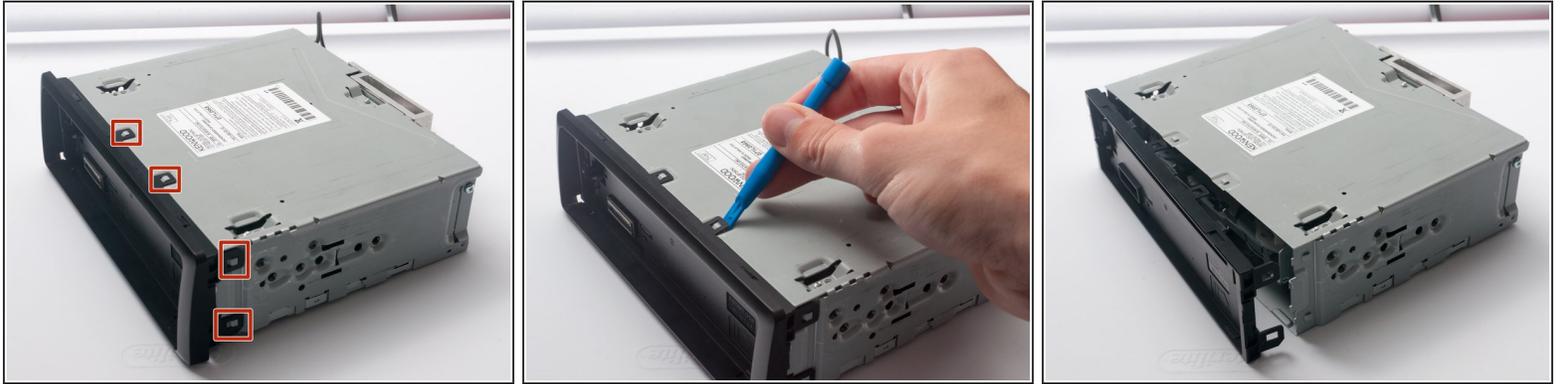
Step 5

- Lift the clasps of the tabs around the edges by using a plastic opening tool or spudger.

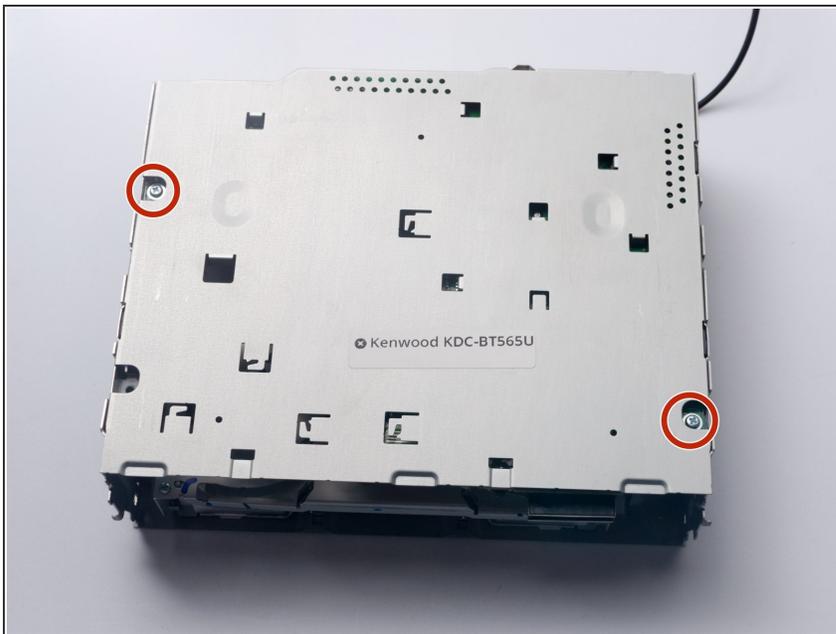
Step 6

- Remove the two 5.5mm Phillips #0 (PH0) screws on the bottom of the unit.

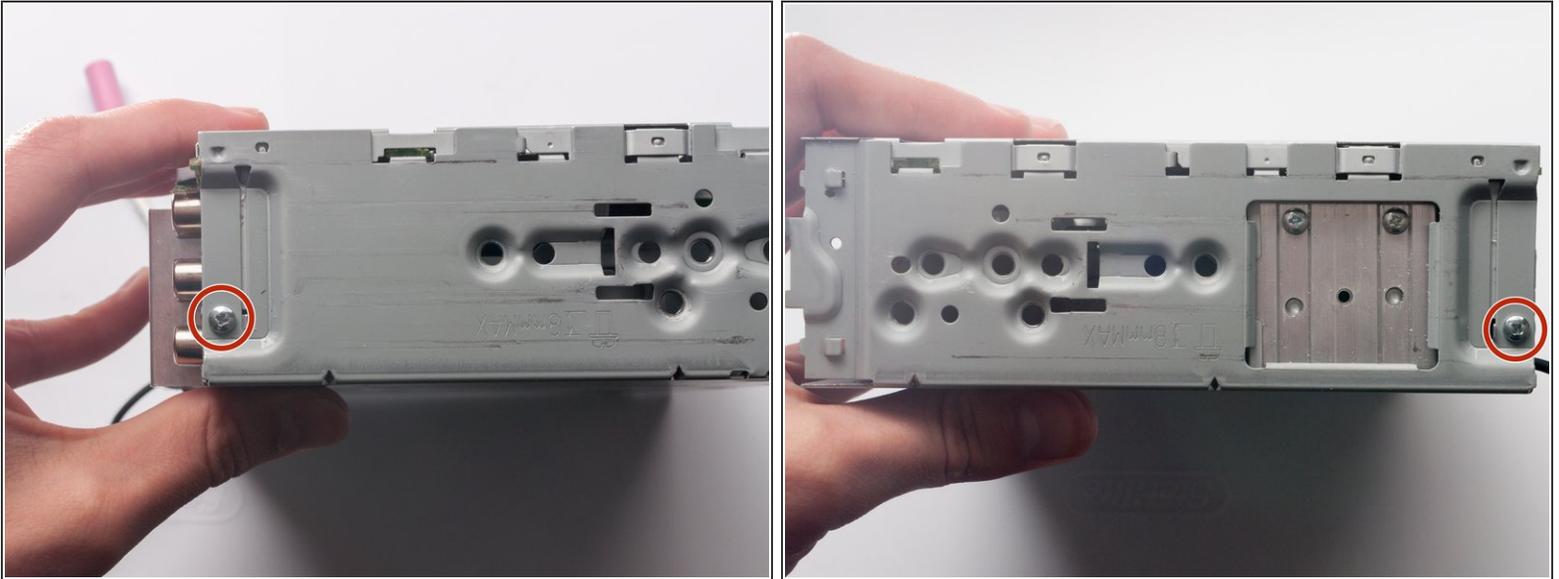
Step 7

- Remove the two 6mm Phillips #0 screws from the side of the unit.

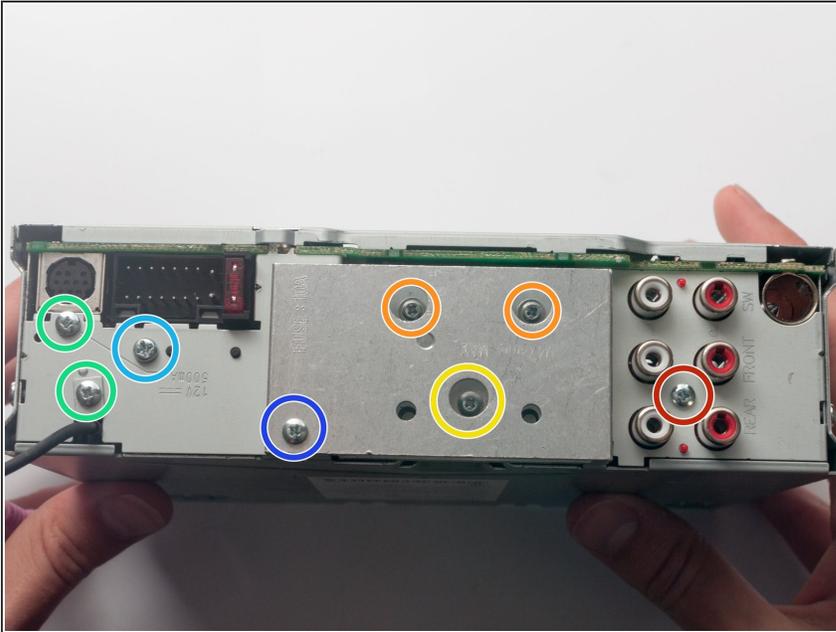
Step 8

- Remove the 7.5mm Phillips #0 screw in between the red and white RCA inputs.
- Remove the two 13.5mm Phillips #0 screws towards the top of the aluminum block.
- Remove the 10mm Phillips #0 screw towards the bottom of the aluminum block.
- Remove the two 6mm Phillips #0 screws found above the microphone mount and below the circular port.
- Remove the 7.5mm Phillips #0 screw next to the large rectangular power connector.
- Remove the 10mm Phillips #0 screw that resides above the aluminum block.

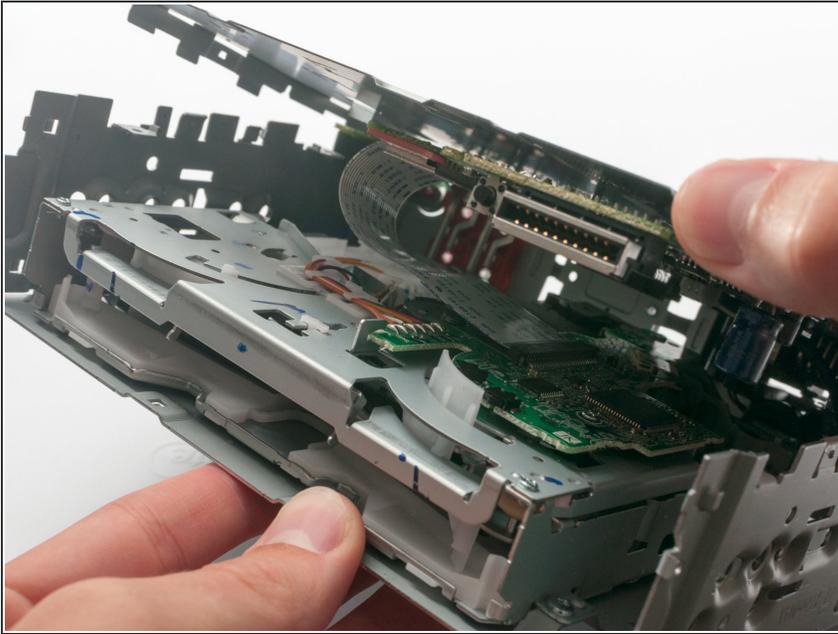
Step 9

- Separate the top and bottom metal housings of the unit carefully.
- ⚠ There is a connecting ribbon that links the two halves. Too much force could rip and irreversibly damage the ribbon.

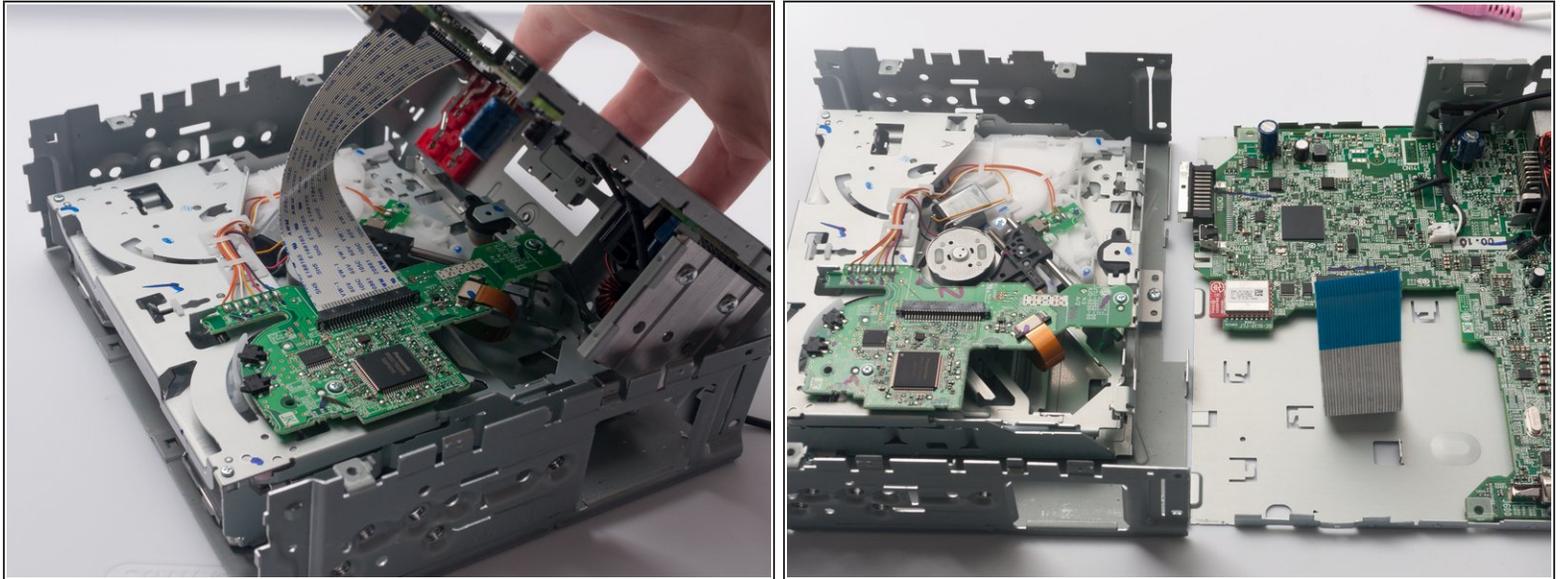
Step 10

- Carefully pull the ribbon out of the connector found on the bottom half of the unit (the bottom half has the CD drive).
- To remove the ribbon, grip the black base connector with one hand and the base of the ribbon with the other. The ribbon will have a blue, reinforced section close to the base (seen in second picture) which makes it easier to pull.

To reassemble your device, follow these instructions in reverse order. Be careful when reattaching the new CD drive's ribbon to the motherboard. The ribbon can be bent easily.

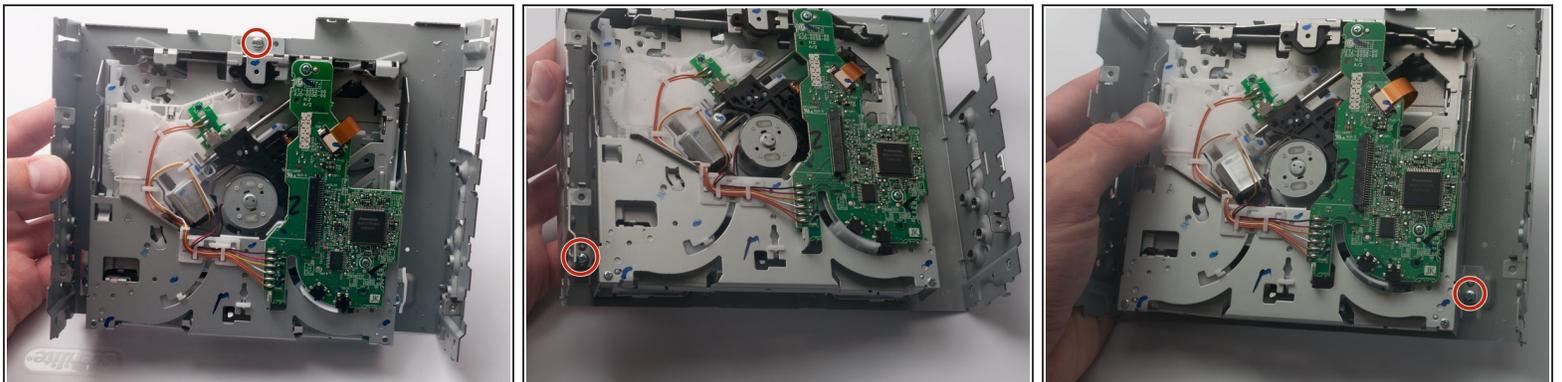
Step 11

- To fully unmount and replace the CD drive, remove the three 6mm Phillips #0 screws that hold the drive to the housing.
