# iRobot Roomba 860 Side Wheel Assembly Replacement

This guide provides instructions to remove the side wheel assembly if the iRobot Roomba 860 is unable to move or the wheels no longer spin

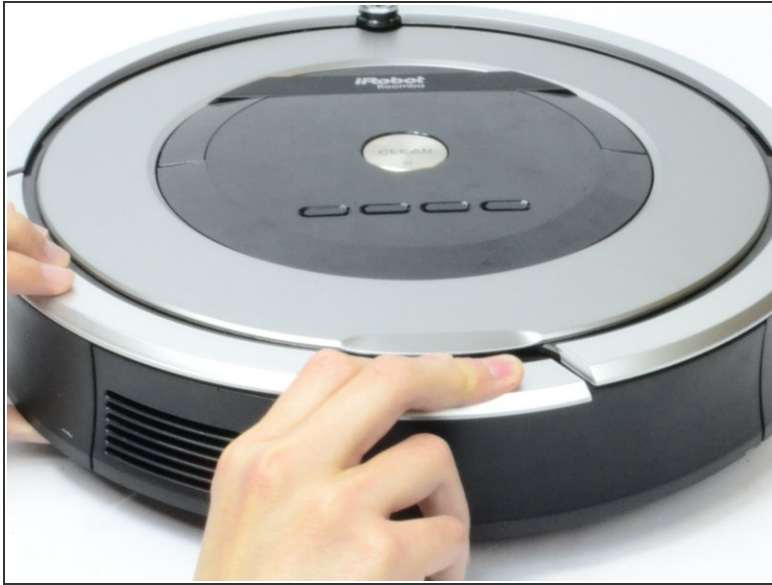
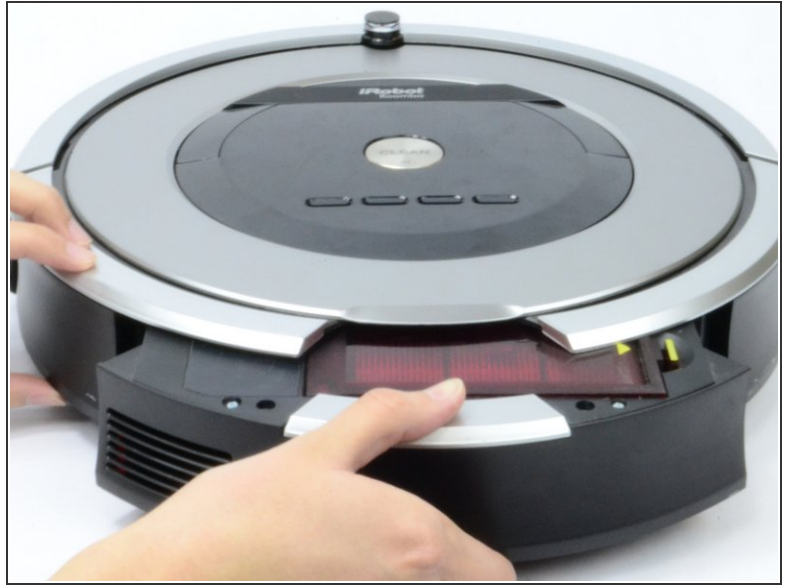
## Step 1 — Debris Extractors

- To remove the debris extractor, first begin by removing and emptying the trash bin.
- Push down and pull out on the silver button located on the top of the Roomba in the back.
- The trash bin should then slide out.

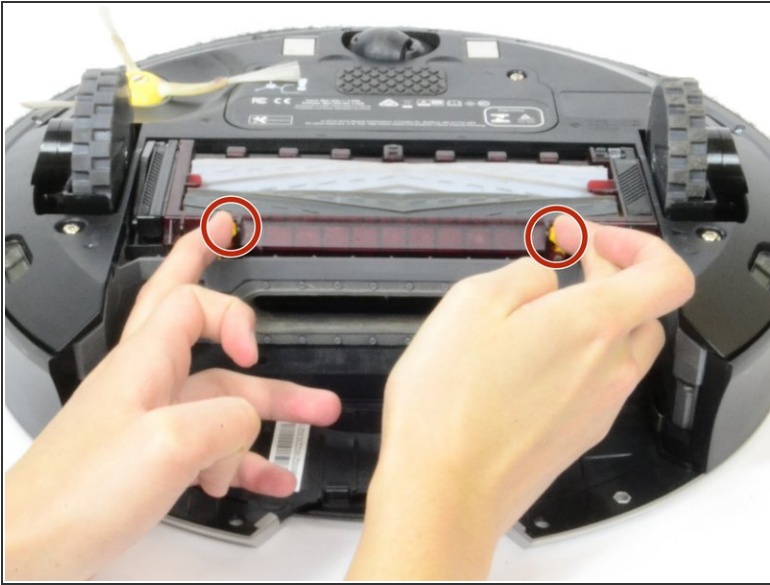
## Step 2

- With the Roomba upside down, locate the two yellow buttons by the extractor.
- To open the flap holding the extractors in place, pinch the two yellow buttons together towards the center and pull up on the flap at the same time

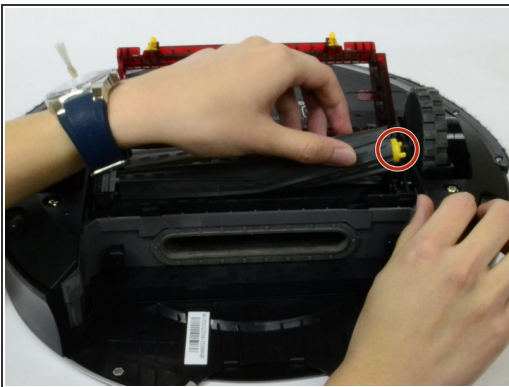
## Step 3

- Once the flap is open, grab the yellow end of the dark gray extractor and pull up slightly.
- After lifting it up about an inch, pull it out towards one of the side wheels.
- The extractor should slide out with ease. Repeat the same procedure for the light gray debris extractor.
