Lenovo 100s Chromebook-11BY Webcam Replacement

This guide will show how to remove and replace the webcam for the Lenovo 100s Chromebook-11BY.

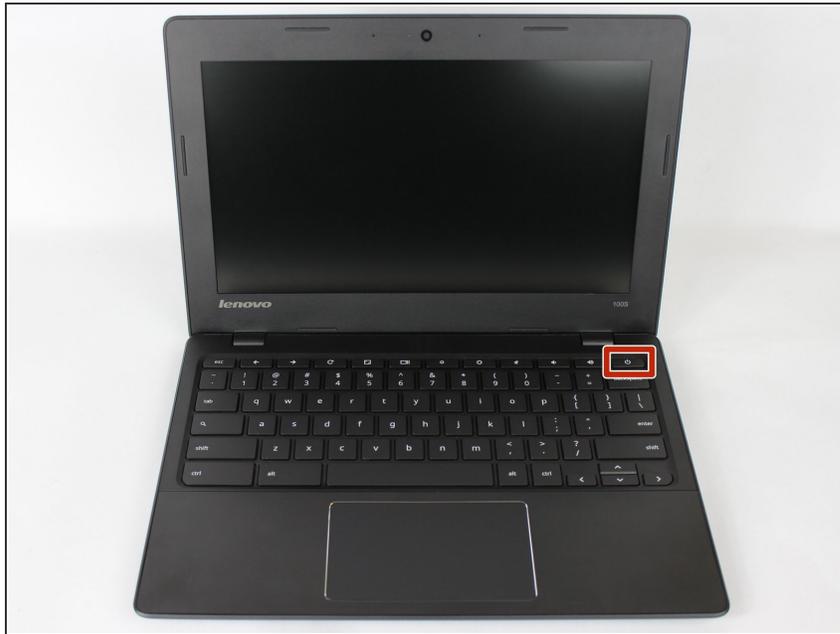
Step 1 — Webcam

- Ensure your device is turned off and unplugged.

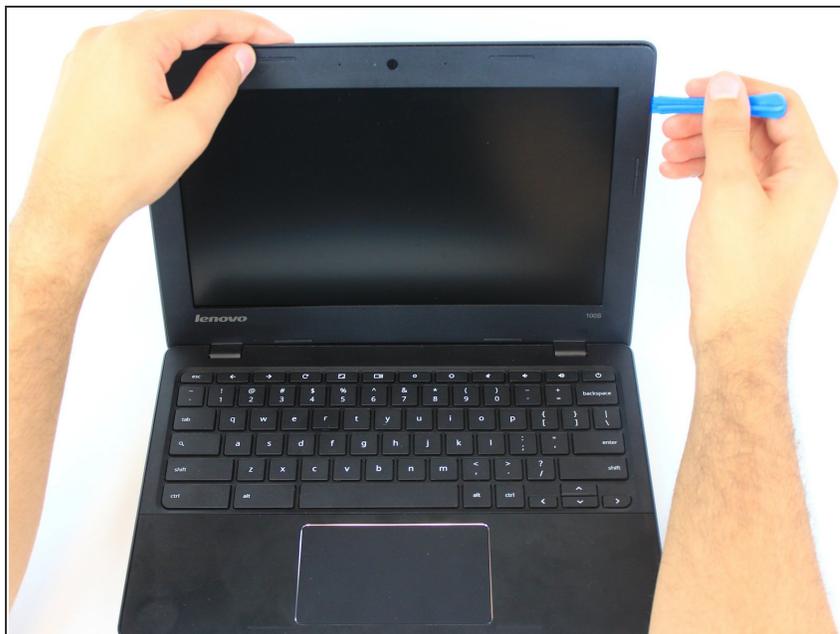
Step 2

- Use the plastic opening tool on the recessed notch to gently pry each side of around the screen up.

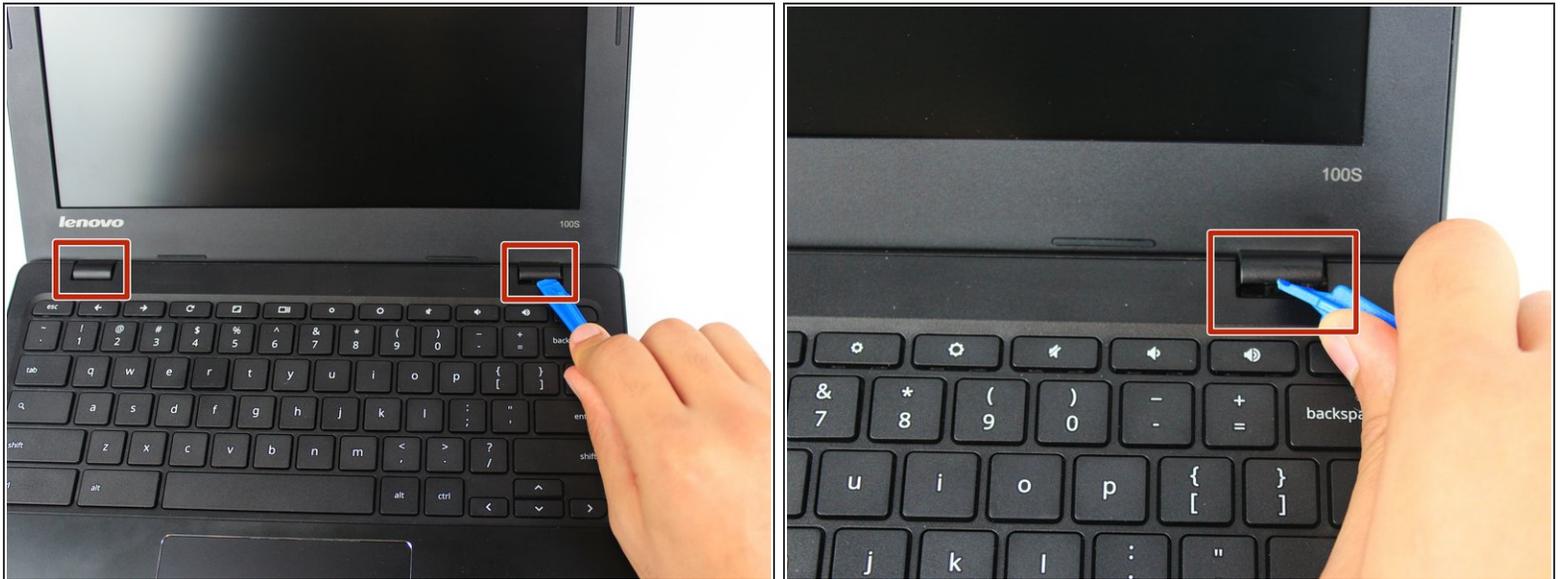
Step 3

- Carefully pry up and underneath both the (left & right) hinges of the screen cover.

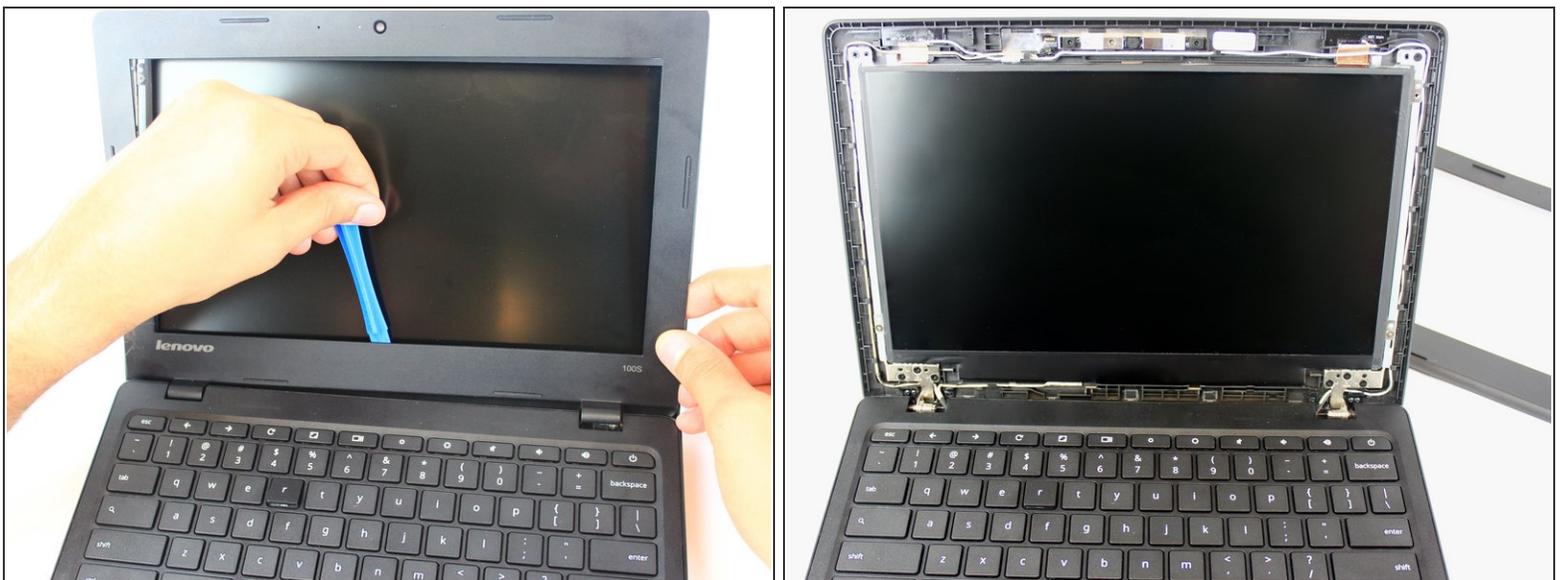
Step 4

- Use the plastic opening tool on the inside of the screen plate and again on the sides to gently remove it.

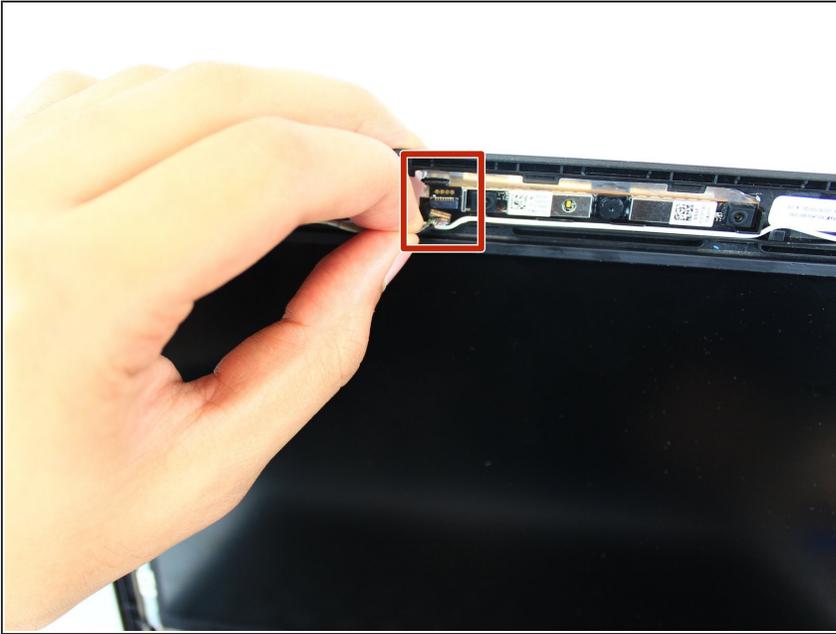
Step 5

- Gently unplug the wire connecting the webcam to the laptop.

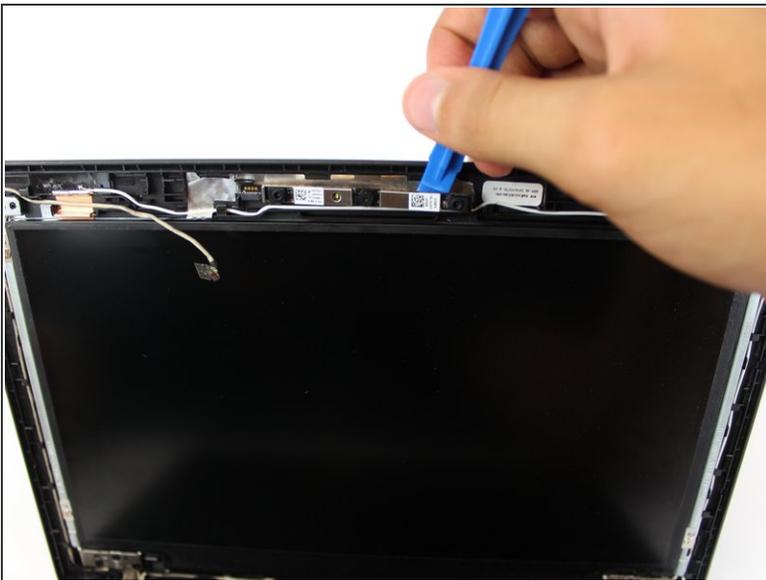
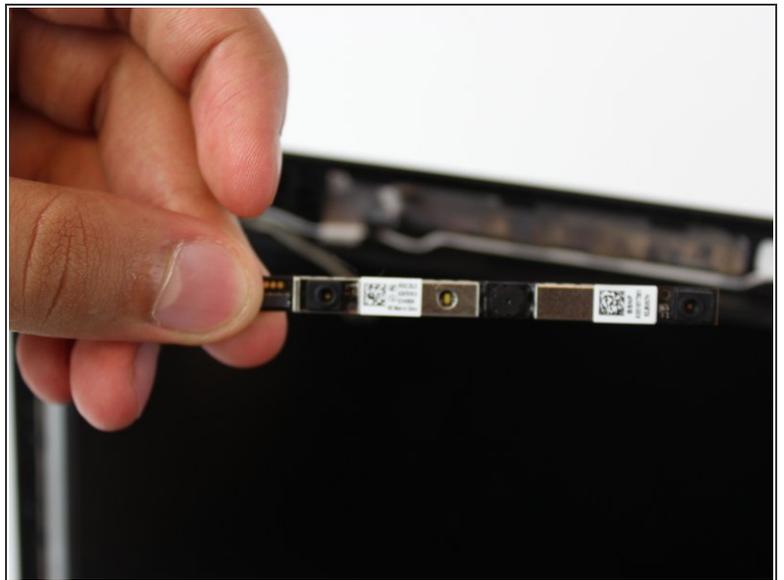
Step 6

- Using the plastic opening tool, gently lift the webcam panel from the screen. Then remove it.

To reassemble your device, follow these instructions in reverse order.
