Apple 3.5 Drive External Floppy Drive Teardown

This guide will show the disassembly down to the bare internal drive and other components of the Apple 3.5 Drive.

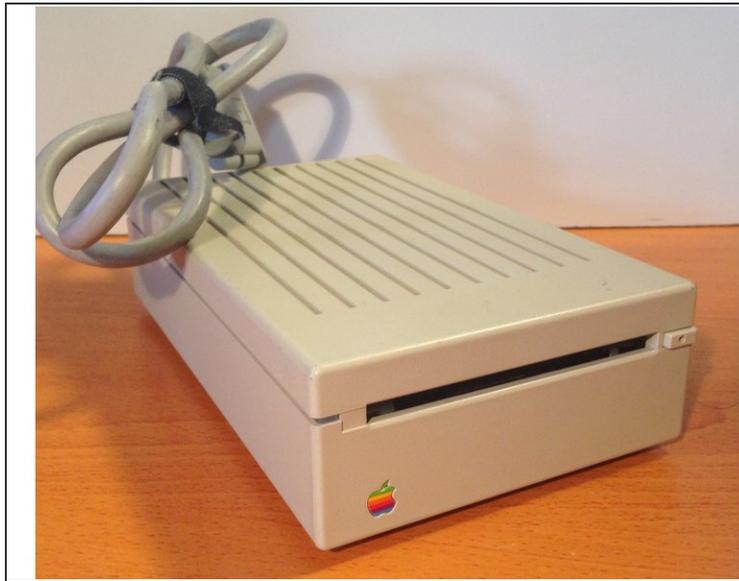
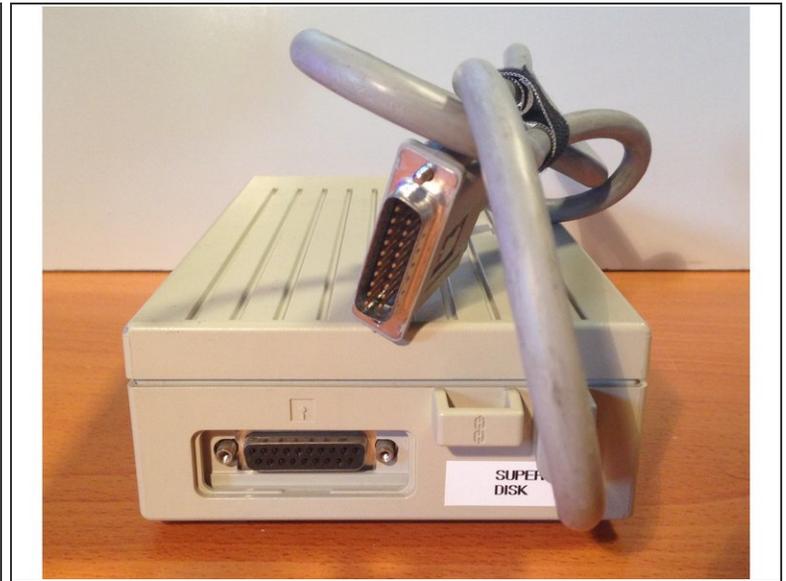
Step 1 — The Apple 3.5 Drive

- On front from left to right it has an Activity LED, the floppy slot, and a soft eject button to engage the electronic eject function of the floppy drive.
- The eject button has a hole at its center through which the user can insert a paperclip to manual eject a stuck floppy.
- At back from left to right is the pass through 19-pin connector for daisy-chaining more drives, a plastic loop for a kensington lock, and the hardwired cable for plugging into the computer or earlier drive in the chain.
- When new this drive came with a plastic cover over the daisy-chain port. It is very rare to find a drive that still has this cover, though if one is present it can be removed with a flat tip screw driver.
- [IMPORTANT]Apple floppy drives should never be connected or disconnected while the computer is on as it can damage the floppy controller on the computer's logic board.

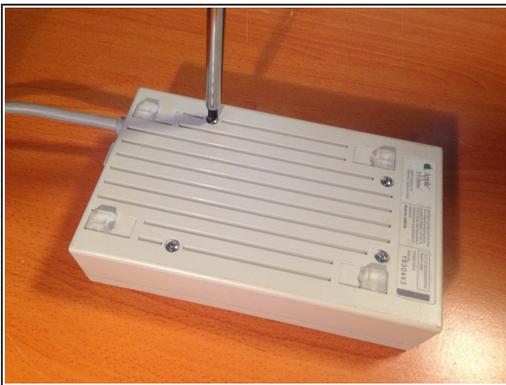
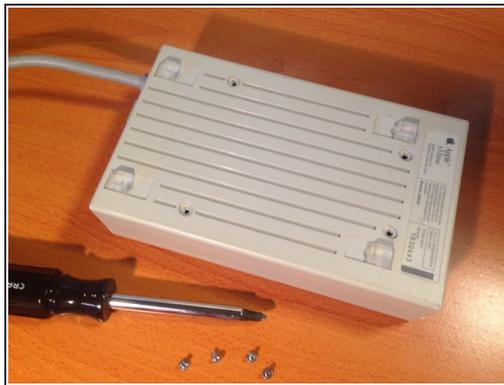
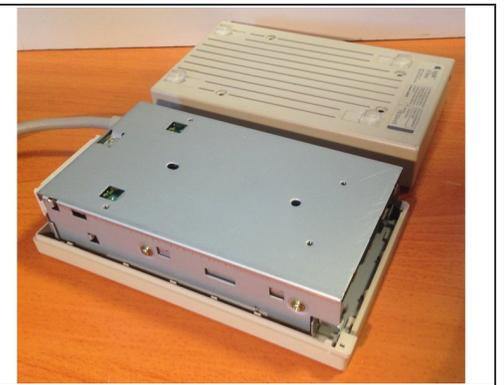
Step 3 — Opening the Case

- Flip the drive upside down.
- Use the #2 Philips screw driver to remove the four screws from the bottom.
- Hold down the drive cable while lifting up on the bottom of the case to open the drive.

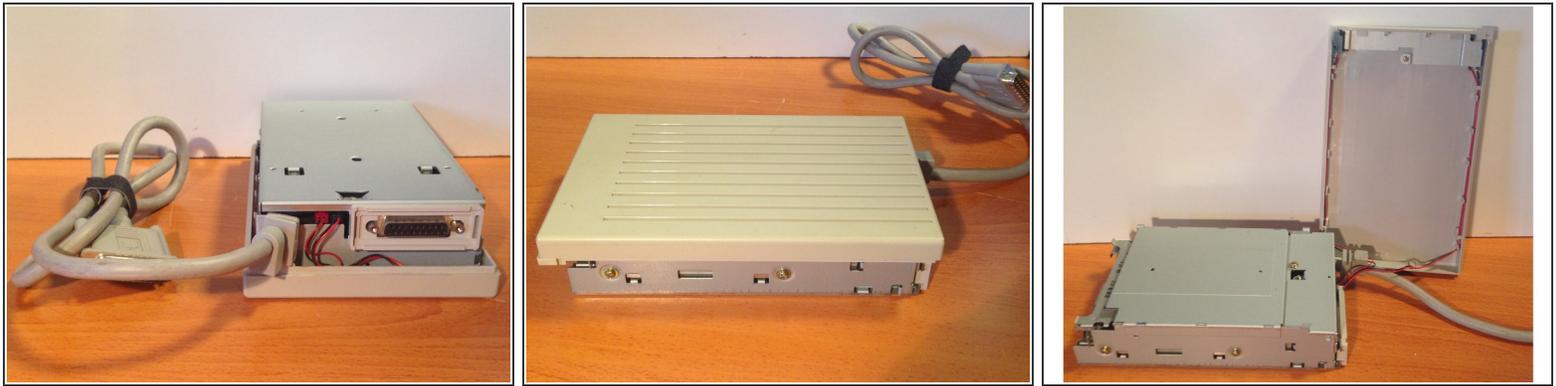
Step 4 — Removing the Case Top

- Take the metal chassis in one hand and the case top in the other and slide the top forward to release the chassis from the tabs on the case top.
- Place the case top next to the metal chassis.
- Be careful not to strain the wires leading to the activity LED and the soft eject button. Do not attempt to disconnect these wires yet.

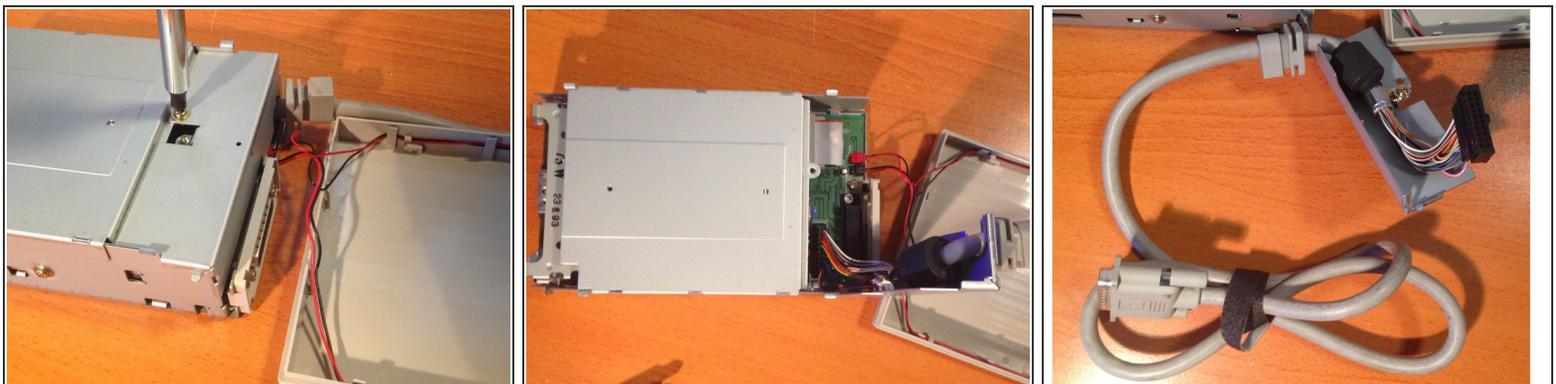
Step 5 — Removing the Rear Chassis Cover and External Cable

- Use a #2 Philips to remove the screw holding the rear chassis cover in place.
- Pull the rear cover up to one side.
- Grip the cable connector firmly and pull up to disconnect.
- You may disconnect the cable from the rear cover by using a #2 Philips to unscrew it.

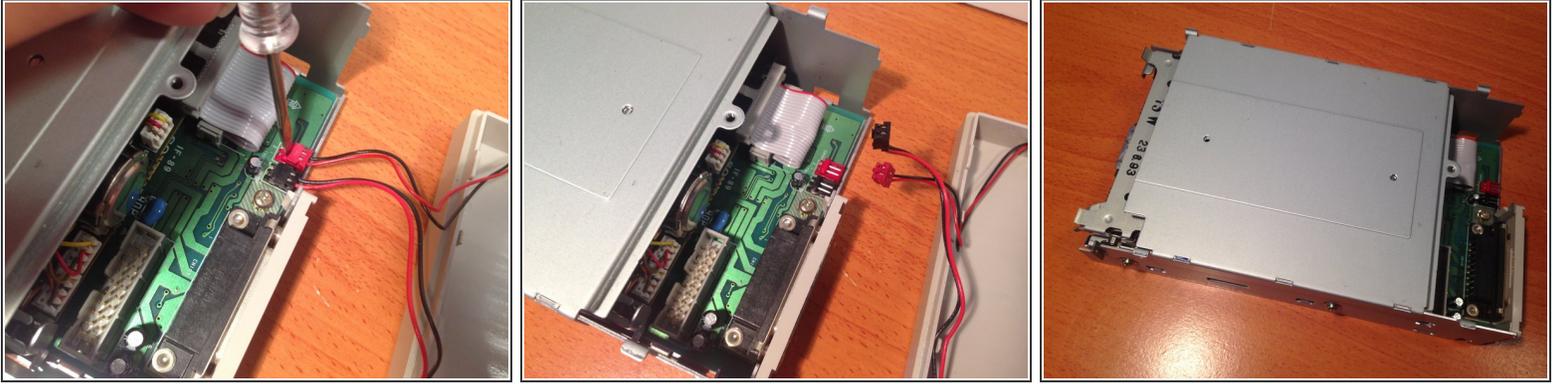
Step 6 — Disconnecting the Eject Button and Activity LED Cables From Main Board

- Use a small jewelers flat tip screw driver to gently pry the cable ends from their connector headers.
- Red header is the Activity LED
- Black header is the Eject button

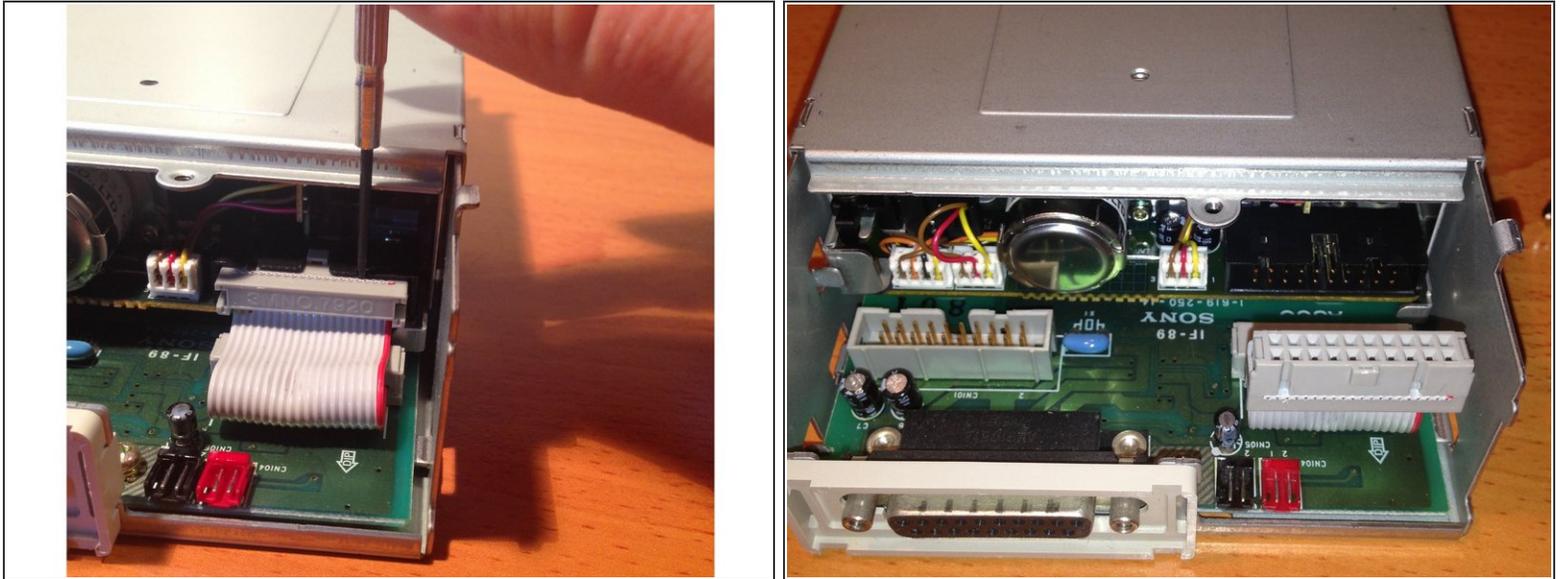
Step 7 — Disconnecting the Internal Floppy Cable

- Insert a small Jewelers flat tip into the two slots on top of the internal floppy connector to gently pry the cable from the connector.
- You can lean the screw driver against the metal chassis for leverage.
- Be sure to alternate the screw driver from end to end of the connector while prying it out to avoid damaging the connector header.

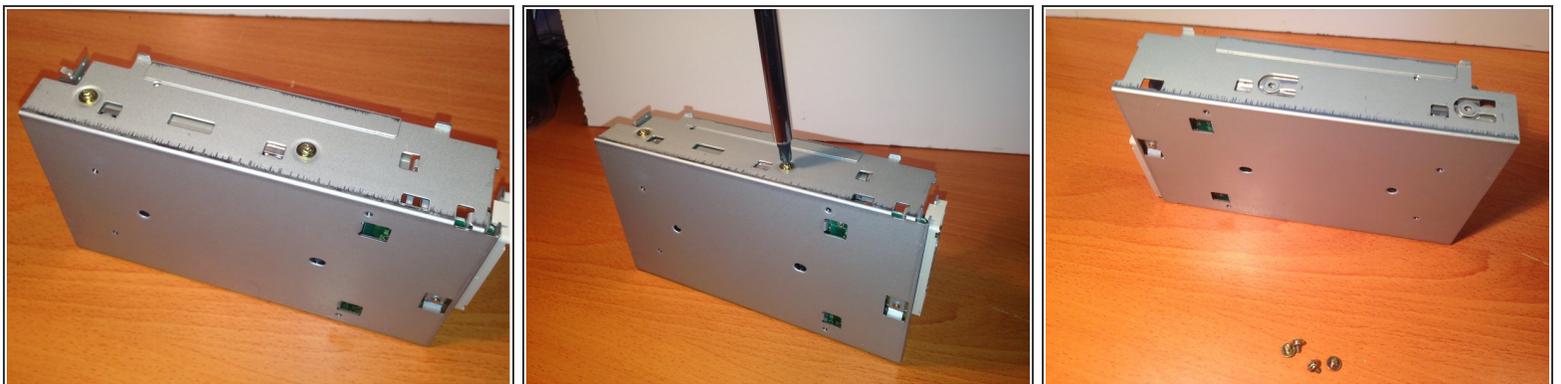
Step 8 — Unscrewing the Floppy Mechanism From Chassis

- The floppy mechanism is held the chassis with two screws on either side.
- Use a #2 Philips to remove the four screws.

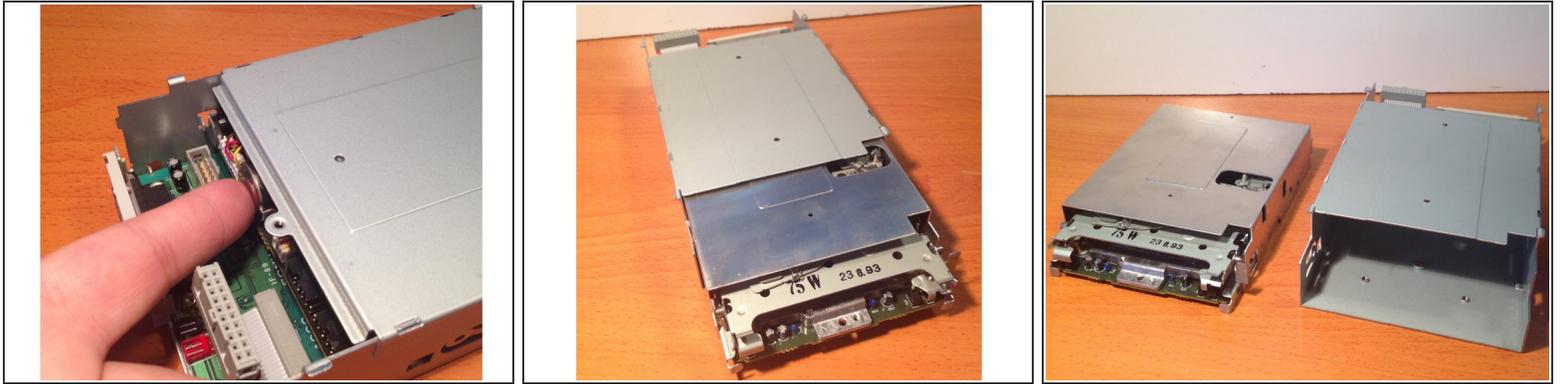
Step 9 — Removing the Floppy Mechanism From the Chassis

- Slide the drive mechanism out the front of the chassis by pushing it in the back and then pulling it out the front.

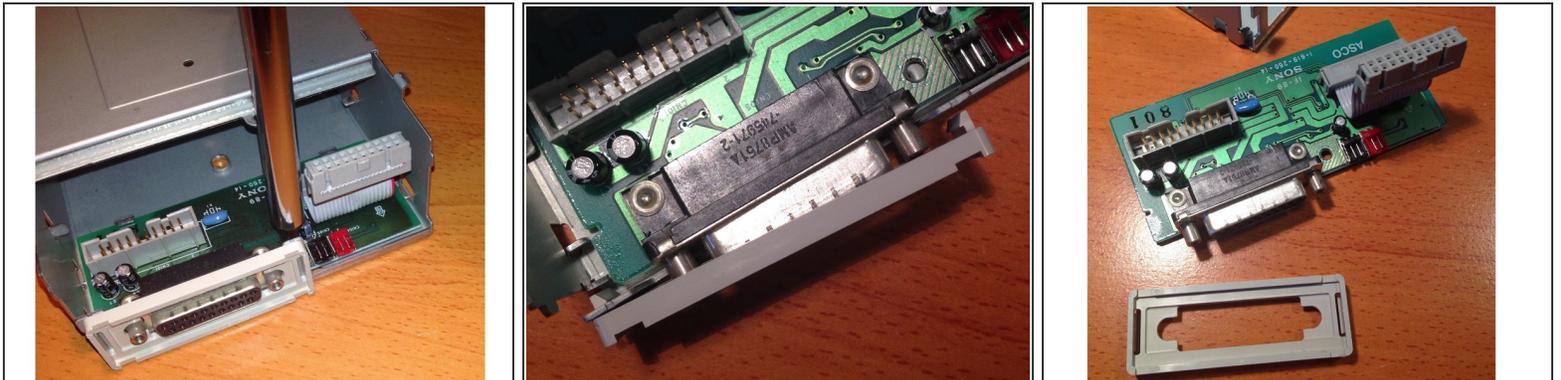
Step 10 — Removing the Main Board From the Chassis

- Use a #2 Philips to remove the one screw holding the board in place.
- Unclip the bezel from the daisy-chain port.
- Tilt the board up and out.

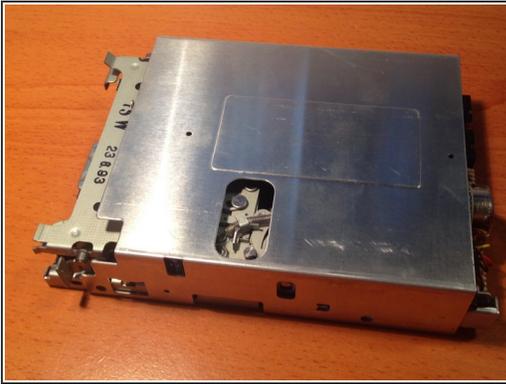
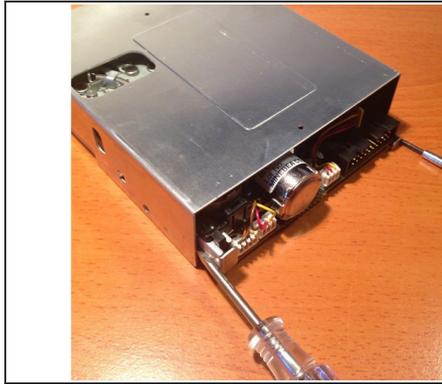
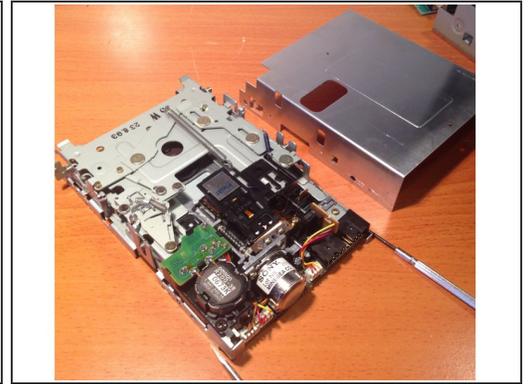
Step 11 — Removing the Top Cover From Floppy Mechanism

- Insert a flat tip jeweler's screw between the drive and top cover on either side of the rear of the mechanism.
- Lift the rear of the top cover up and pull the top cover back, off the drive.
- This Apple 3.5 drive had its original Double Density 800K mechanism replaced with the later High Density 2.0MB/1.44MB mechanism, so yours may appear slightly different.

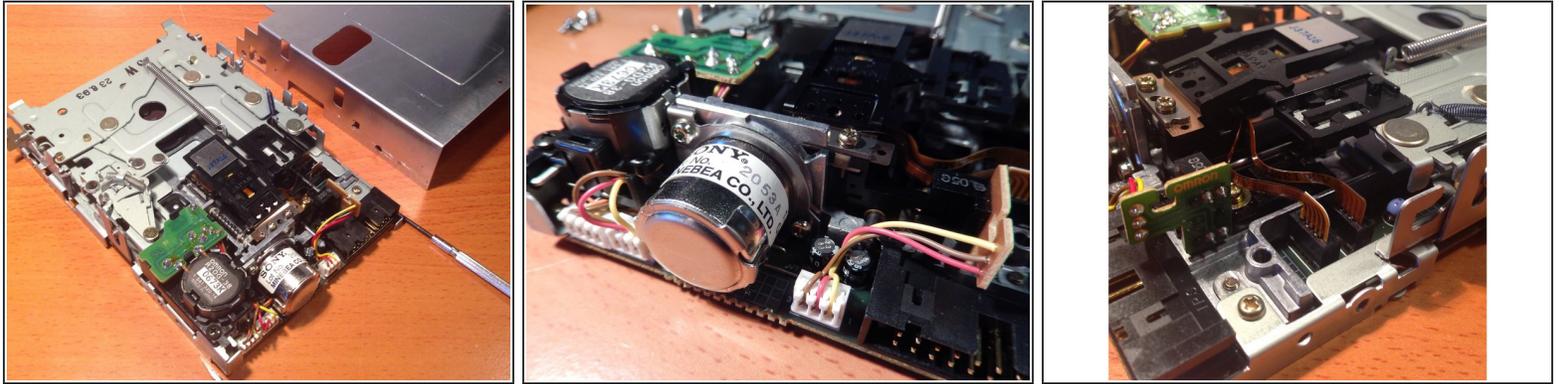
Step 12 — Basic Overview of Floppy Drive Mechanism and Typical Failures

- The floppy mechanism consists of a PCB with drive rotating motor, stepper motor for the read/write head, motor for drive eject/auto insertion, chassis, and floppy sled/eject/insertion/ mechanism.

- [IMPORTANT] Attempting to remove the read/write head from the drive mechanism chassis will ruin alignment and it is not possible to correct without special equipment.

- The drive can fail to insert or eject floppies if the grease/lubricant on the tray and it's moving parts has become caked up with dust or hardened over time.

- At the right rear of the drive is the Omron branded eject/insert motor and an assembly of gears related to it. This can fail if gears connected to it have cracked or the lubricant has hardened. If further disassembled, it can be cleaned out, and 3D printed replacement gears for this are available [online for order](#). Teardown author has no affiliation with seller.

- The screw gear which moves the read/write heads forward and backward can have its threads blocked by hardened lubricant. This can be cleaned up and relubricated much in the same way as the drive tray parts.

- Old lubricant can be loosened up and removed using lighter fluid as a solvent, dripping it into the joints of moving parts being careful not to drip it inside onto the PCB and wiping away what can be reached. Tooth picks and cotton swabs can be used to clear out tight spaces.

- Afterward, a lubricant like white lithium grease can be used to moving parts with a toothpick and a cotton swab, being careful not to get excess anywhere but where it is absolutely needed.

- If the main PCB of the mechanism is to be removed for repair/recap it is important to make sure all connector headers and flex circuit cables are disconnected. It is important to be especially careful when disconnecting flex circuit cables for the read/write head as they can be easily cracked.

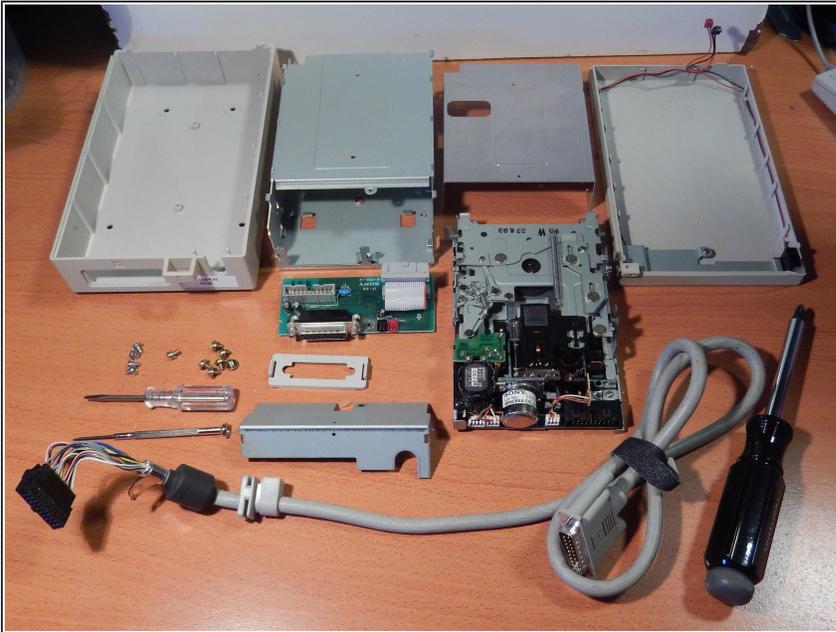
Step 13 — Apple 3.5 drive External Drive Parts Breakdown

- All parts disassembled.
