Geberit toilet flush (old model) replacement of the seal

A running cistern can waste a lot of water - a repair is urgently needed. Actually, this can have two causes: either the seal at the outlet of the box is leaking (the bell seal), but more often the seal at the inlet valve is defective, this case is described here.

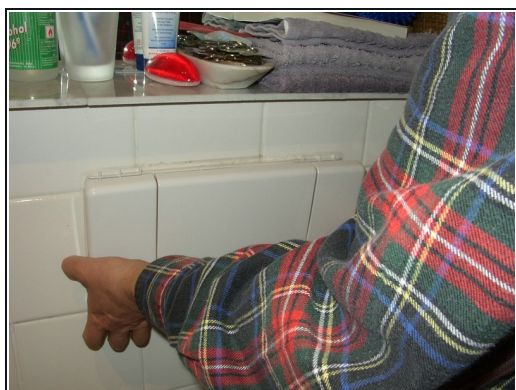
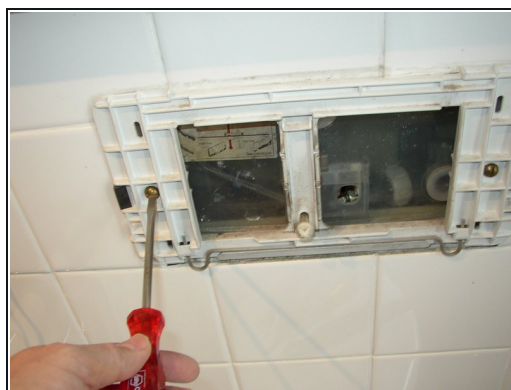
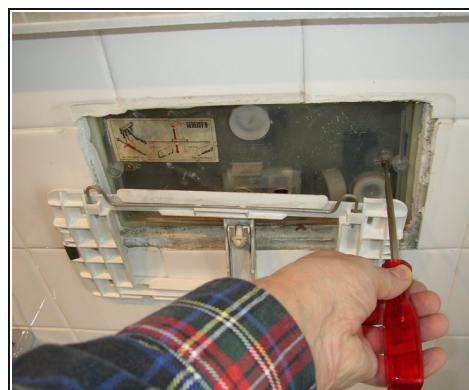
Step 1 — Remove cover (flush-mounted model)

- Lift pressure plate from bottom to top, then remove
- first unscrew the outer frame
- then the inner cover. Carefully pull away to the front.

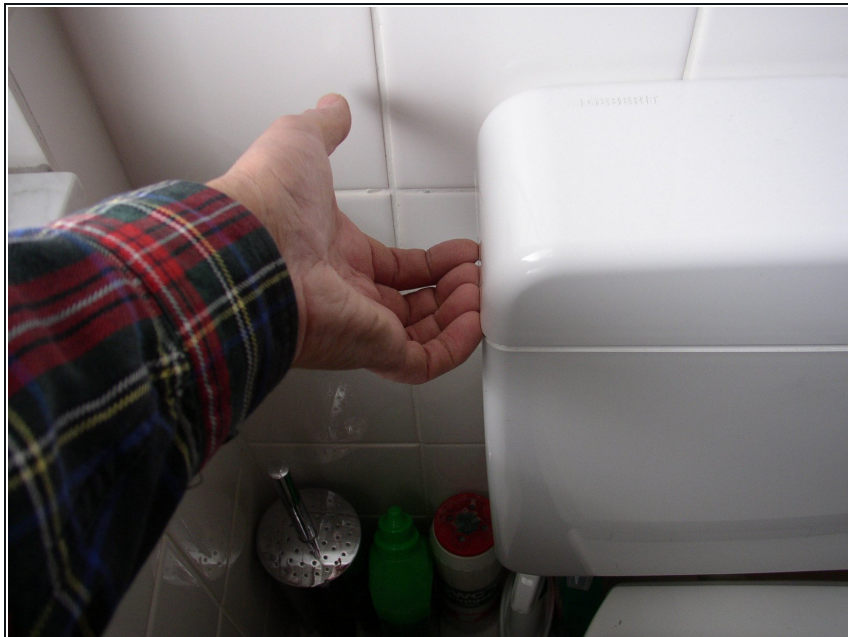
Step 2 — Surface model

- Grab left and right and pull up quite vigorously.

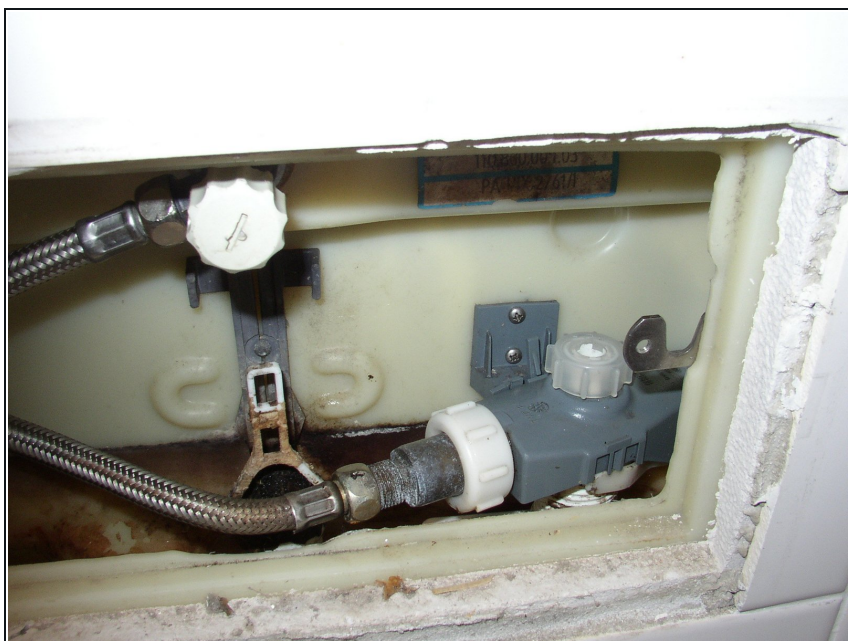
Step 3

- ⚠ Be sure to turn off the water inlet, e.g. at this corner tap.

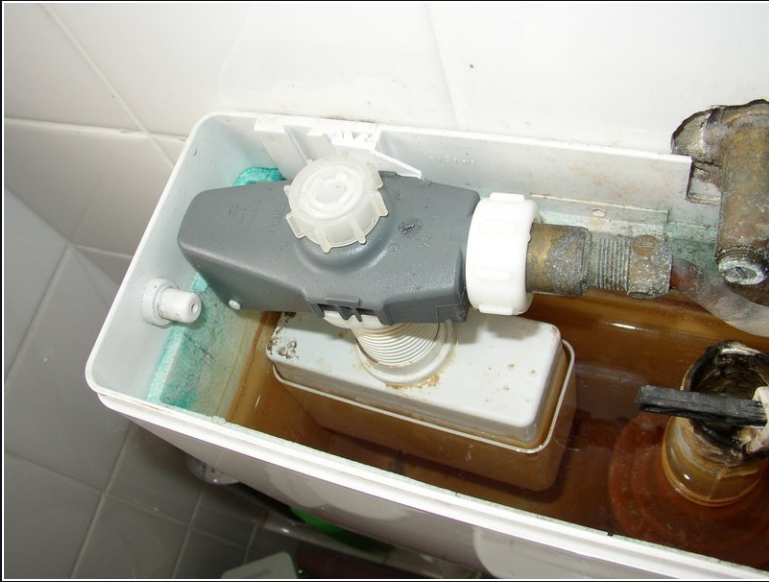
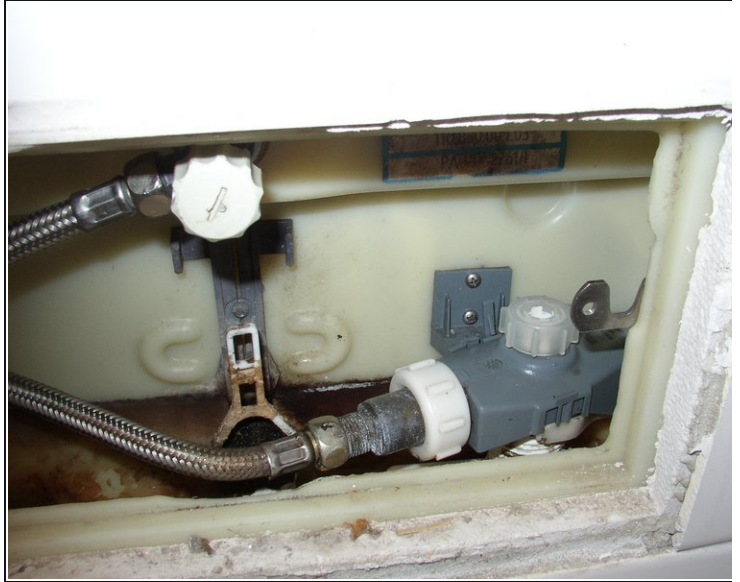
Step 4 — The valve

- The filling valve. Photo 1 with the surface box.
- Photo 2 shows the valve in the flush-mounted box.

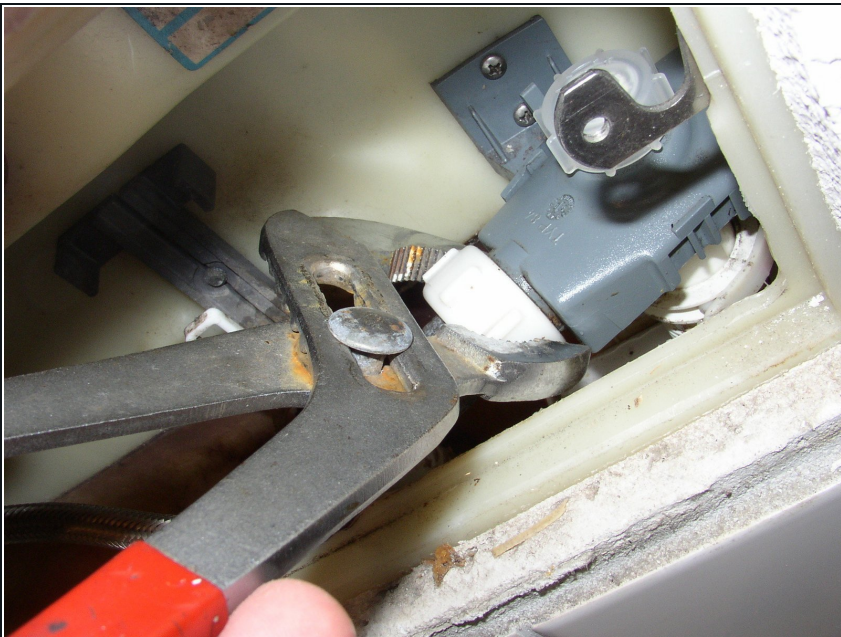
Step 5 — Disconnect water inlet

- With a water pump pliers, you loosen the union nut on the valve. So it is separated from the water inlet.
- Remove the hose slowly so that no part falls out.

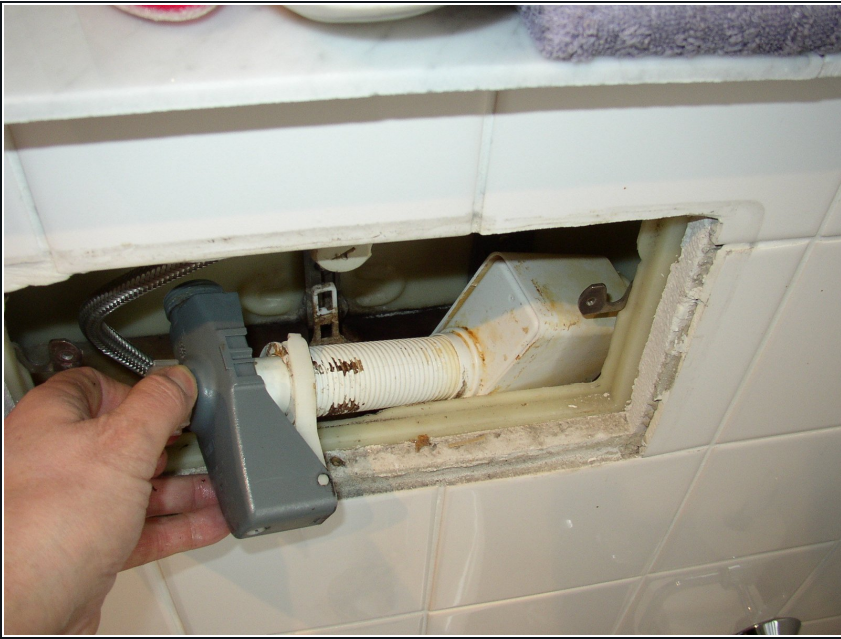
Step 6 — Lift out the valve

- With the surface-mounted box you can simply push the valve upwards.
- With the flush-mounted box, lift the valve upwards and set it aside. then push on the upper part until the float releases.
- Now you can lift out the parts.

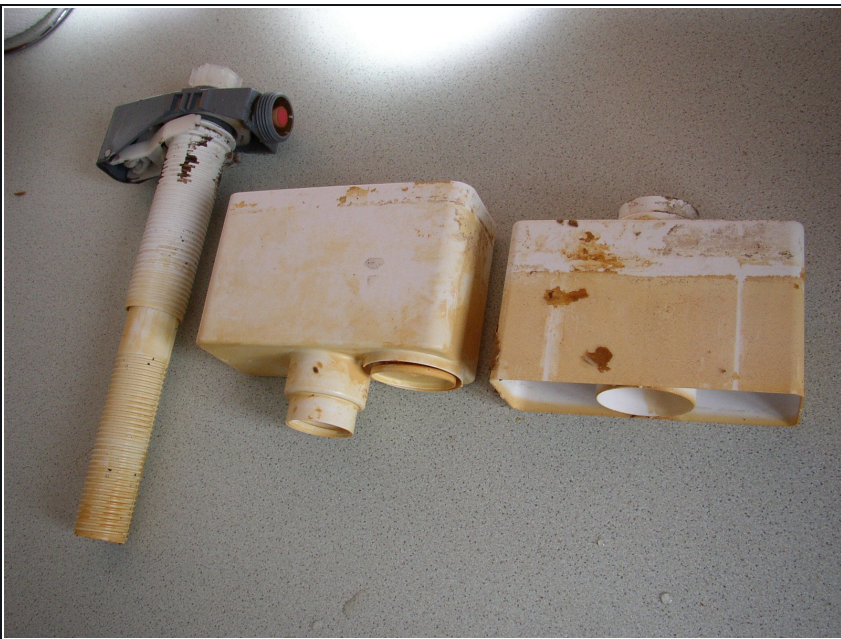
Step 7

- Here you can see the parts of the valve. The seal is the red dot!

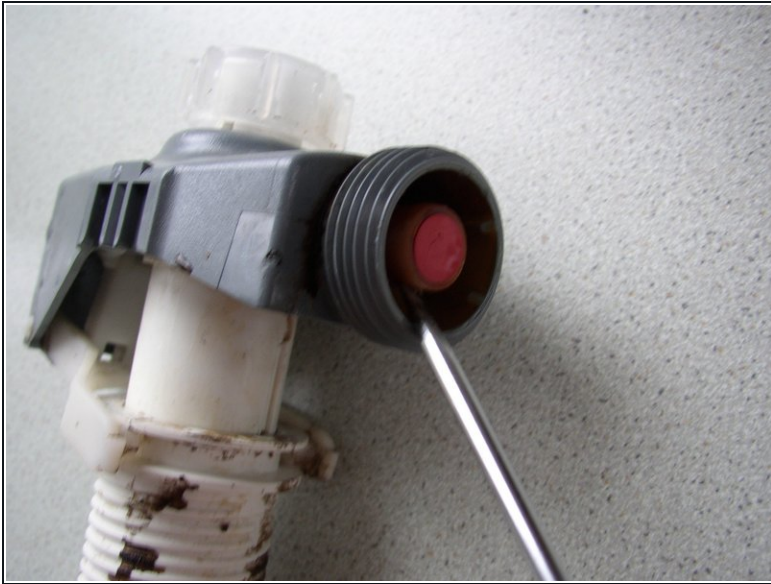
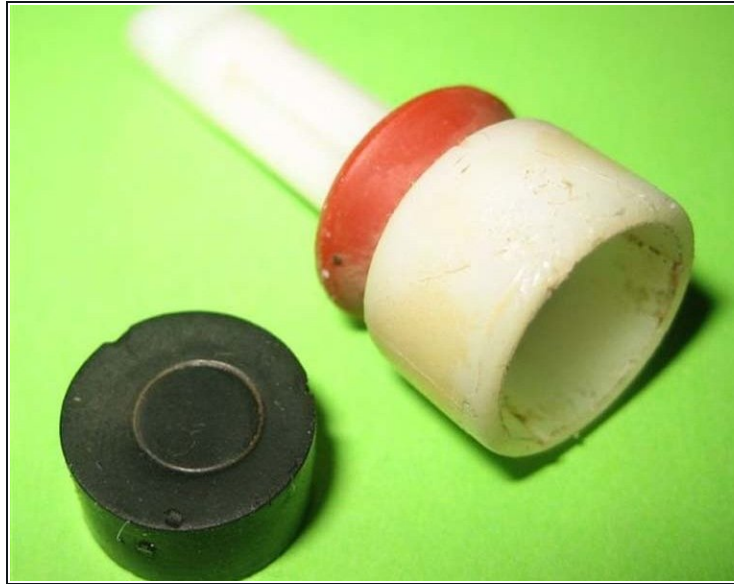
Step 8

- Now the seal has to be removed and replaced. It is sometimes difficult to find out. Try a small screwdriver.
 - Figure 2 shows a defective seal (here black). Clearly a ring is pressed into it.
- i** If the seal is still elastic, you can just flip it over. A new seal is really not expensive.

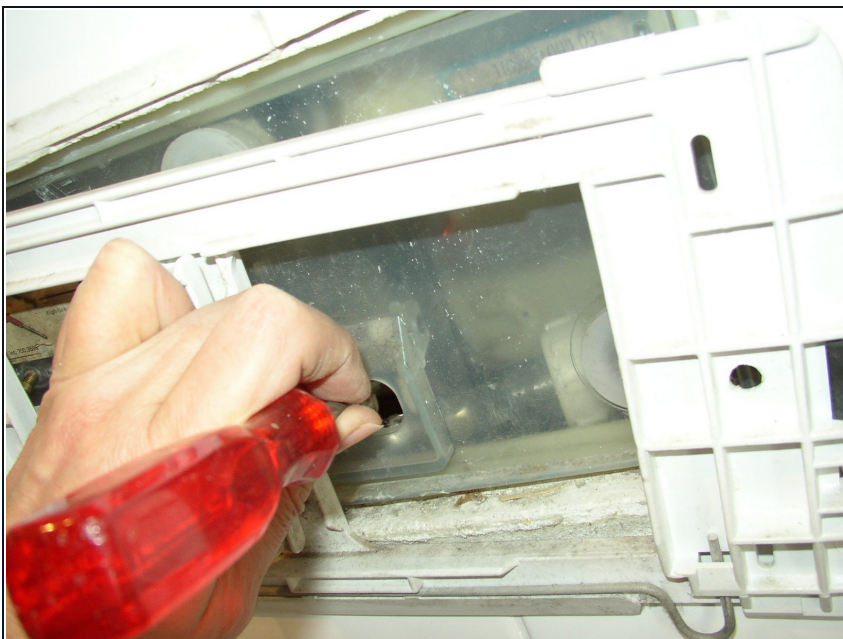
Step 9

- When reassembling you have to make sure that the release lever engages correctly again. Use a screwdriver if necessary.
