Sony PS-LX300USB Drive Belt Replacement

Audio distorted? Turntable platter not turning? Replace your drive belt.

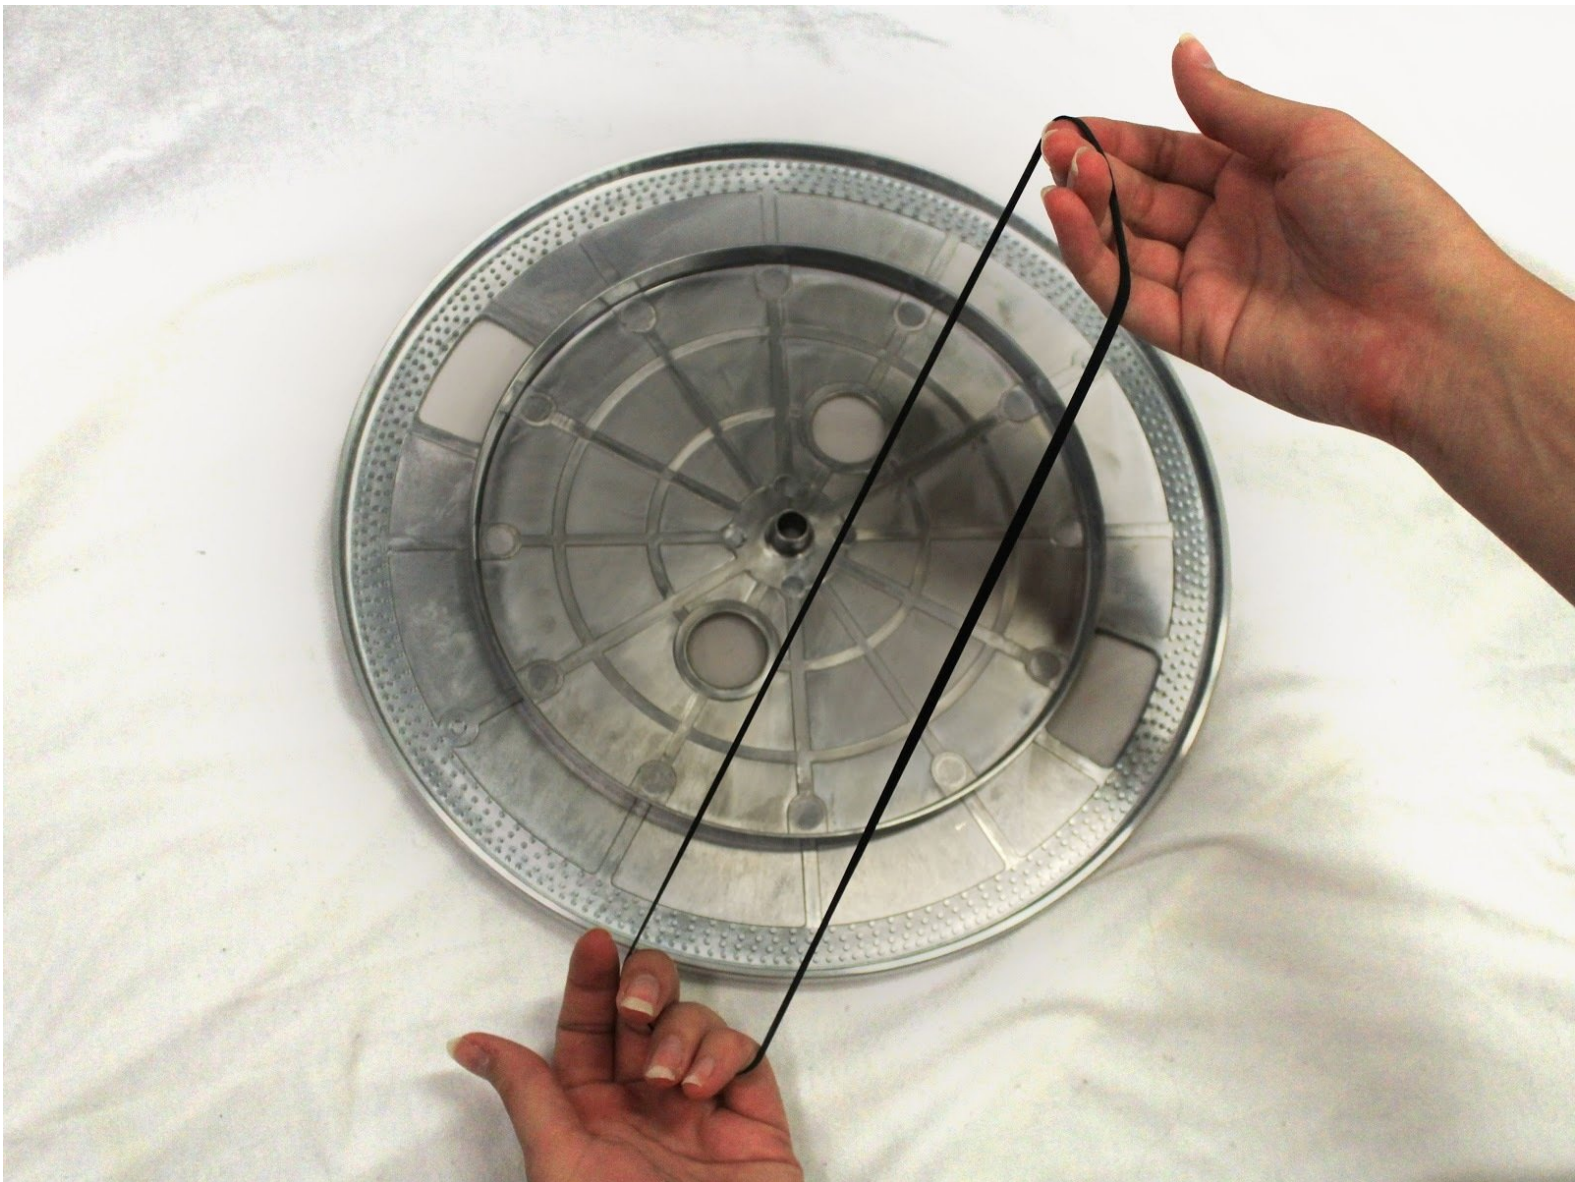
Audio distortion and an inability to get your turntable to turn are signs that you need to replace your drive belt. This can be due to it wearing out or breaking over time. This replacement doesn't require any tools. Everything that you will remove should come off easily, and it will only take a short amount of time.

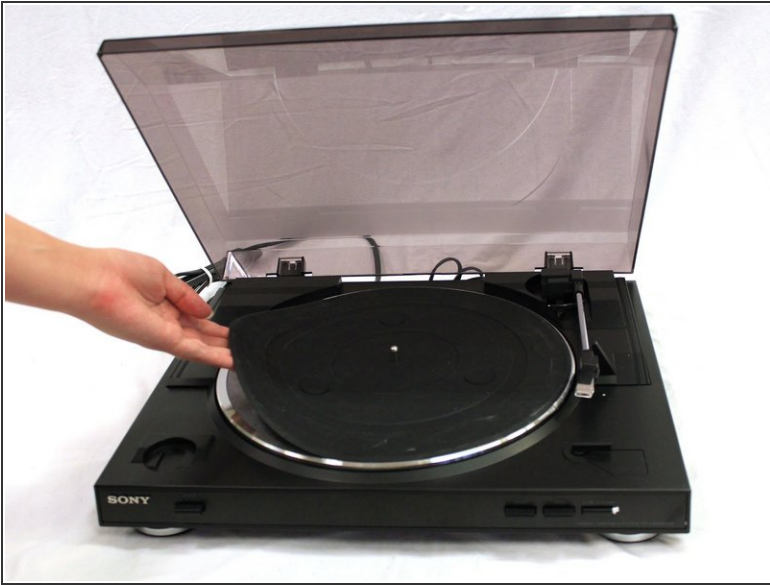
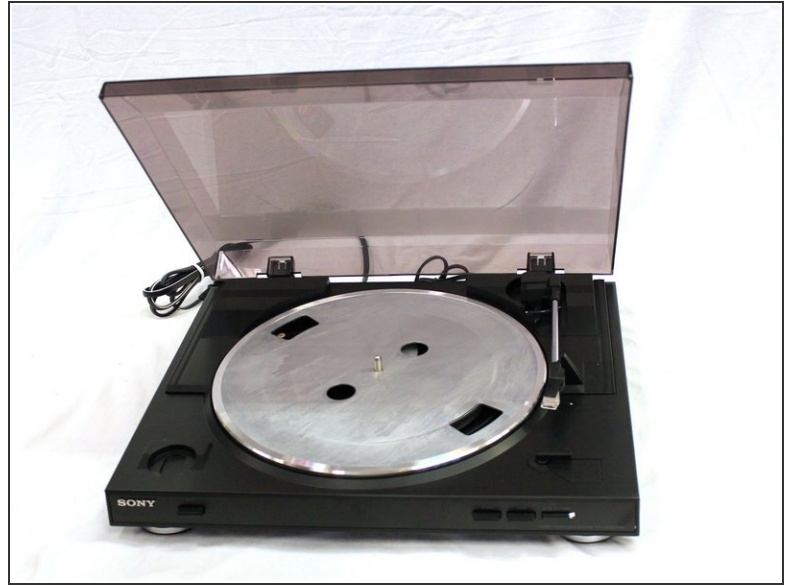
Step 1 — Drive Belt

- Lift the rubber mat, and put it to the side. It should be easy to remove, because it simply rests on a metal platter without anything securing it down.

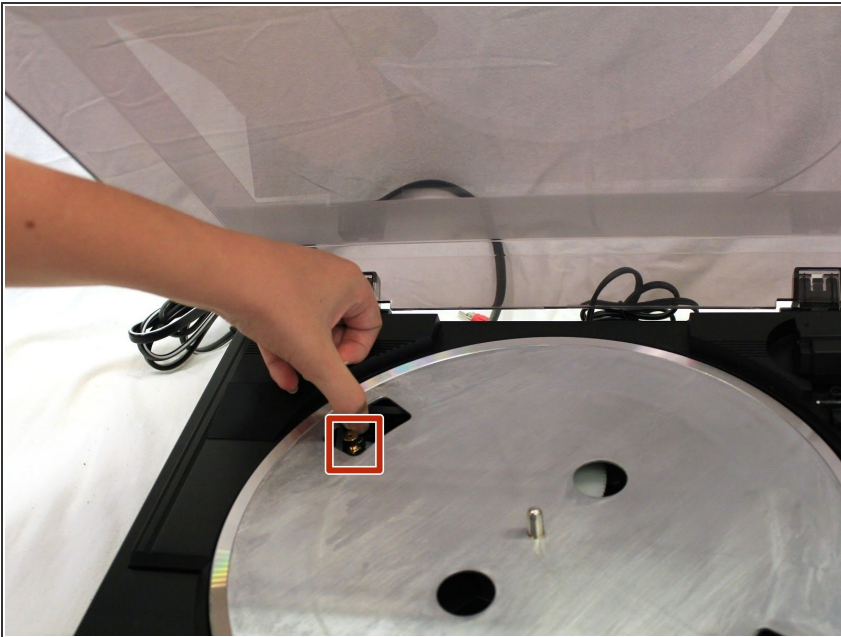
Step 2

- Turn the platter so that the motor pulley can be seen through one of the two outer holes in the platter.
- If the drive belt is hooked around the motor pulley, unhook it.
- ☑ When reassembling to device, don't forget to hook the new drive belt to the motor pulley.

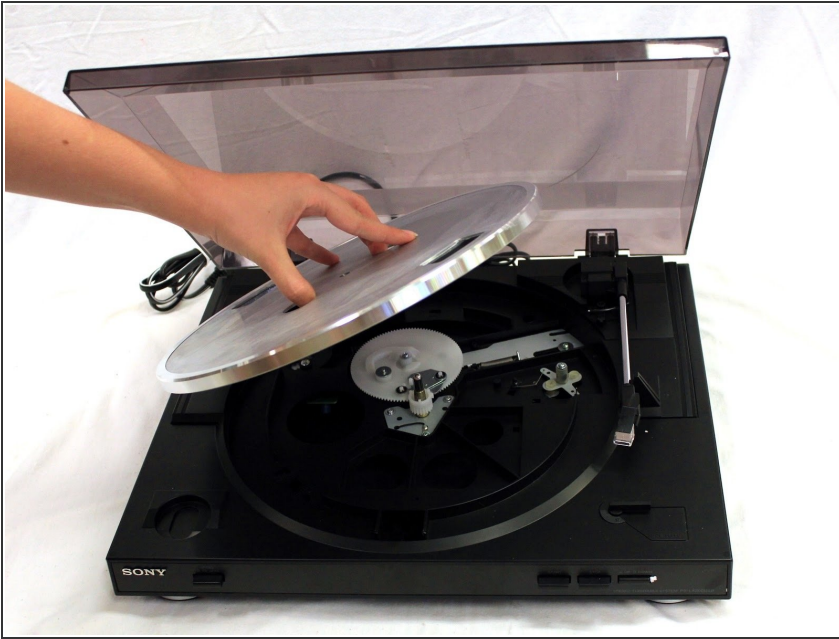
Step 3

- Grasping the platter by its two inner holes, lift it upwards.
- ⓘ Removing the platter may take a small amount of force. If the pulley is unhooked and the tone arm is safely to the side, don't fear using a small amount of force in lifting the platter.
- ⚠ If you haven't yet unhooked the drive belt, the motor pulley and the belt could sustain damage.

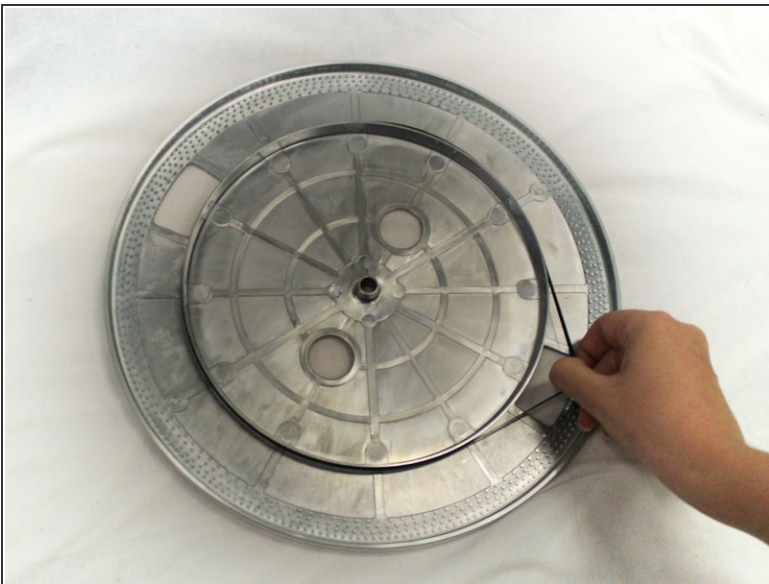
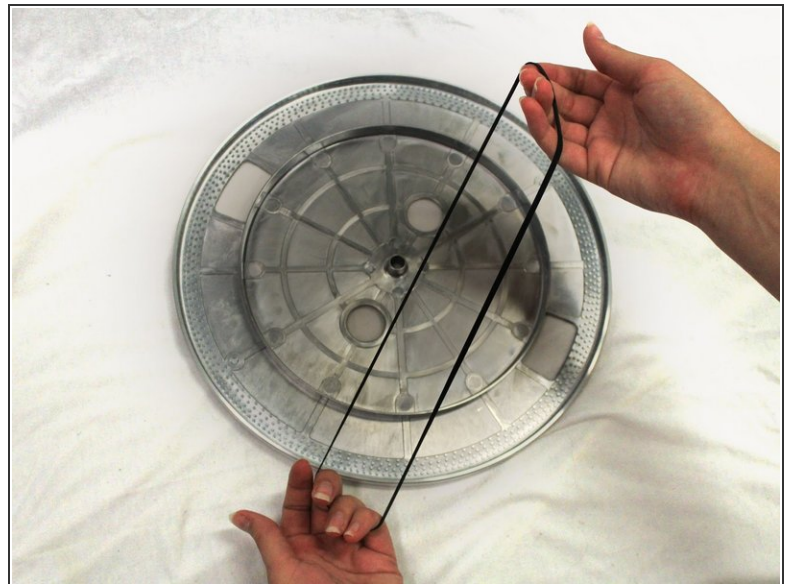
Step 4

- Peel the drive belt from the inner ridge of the metal platter and put it to the side.
- ⓘ Sometimes, the drive belt can fall off the platter during deconstruction. If this is the case, simply take it out of the device wherever it is.

To reassemble your device, follow these instructions in reverse order.
