# Alienware 17 R2 Screen Replacement

One of the causes for a blank or pix-elated screen could be because it is cracked. In this guide, we will show you how to replace your screen.

Written By: Luis Garcia

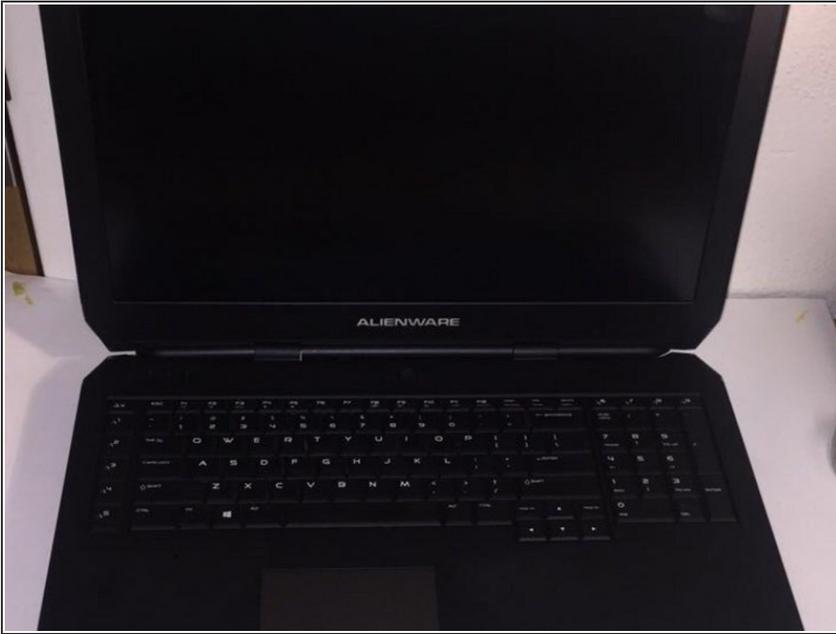
## Step 1 — Display

- Put the laptop on a hard surface.
- Make sure that the Alienware is not plugged into any power source.
- First, we need to unplug the battery.

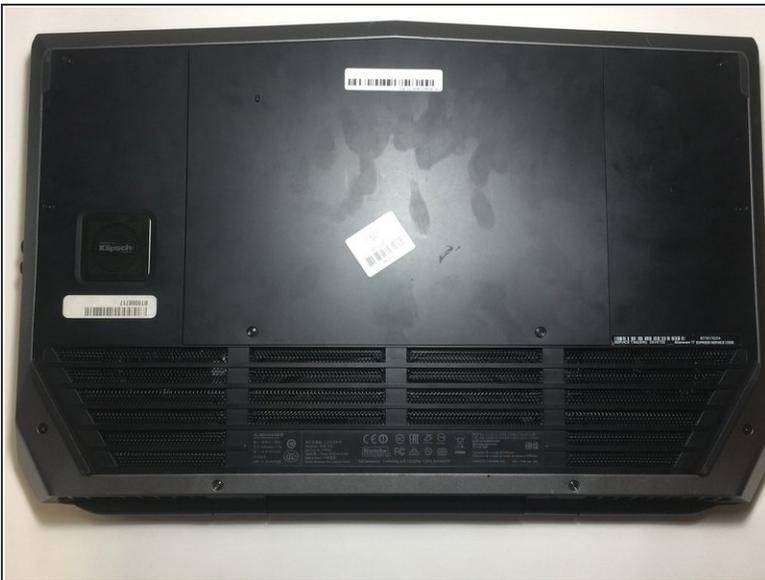
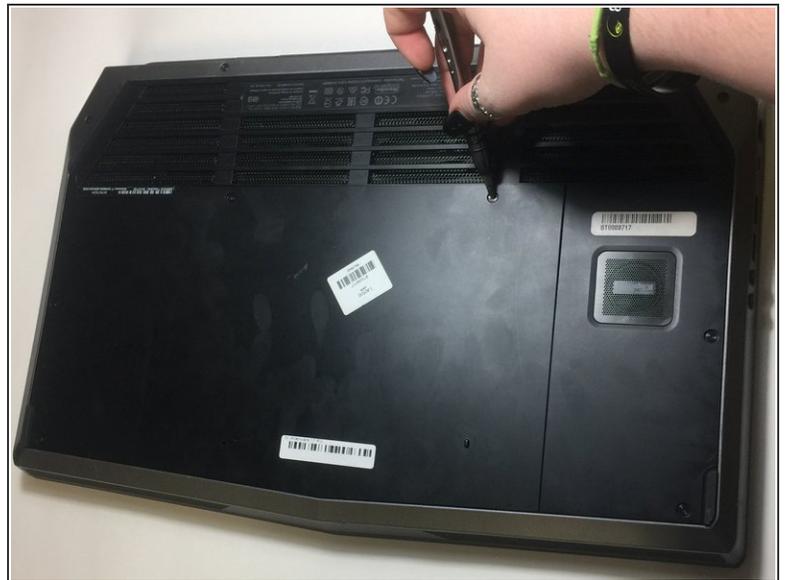
## Step 2

- To unplug the battery, turn the computer upside down.
- Remove the two 4mm screws from the plastic covering protecting the inner part of the laptop.

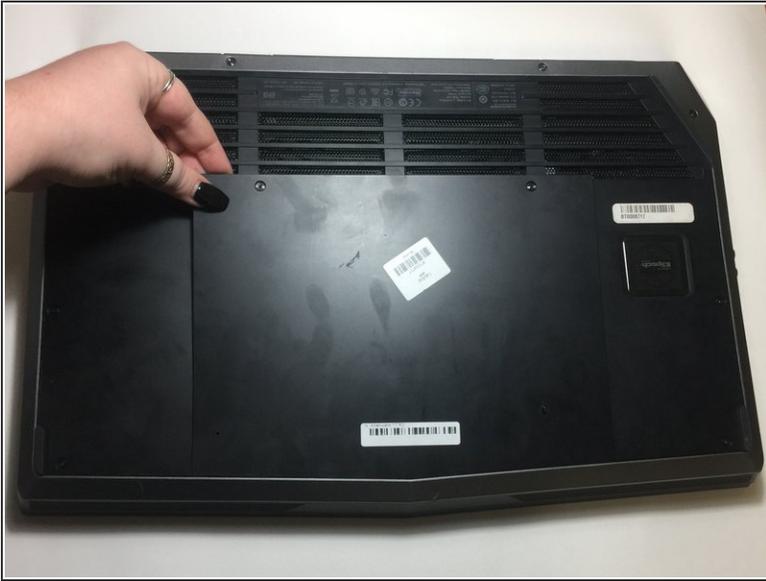
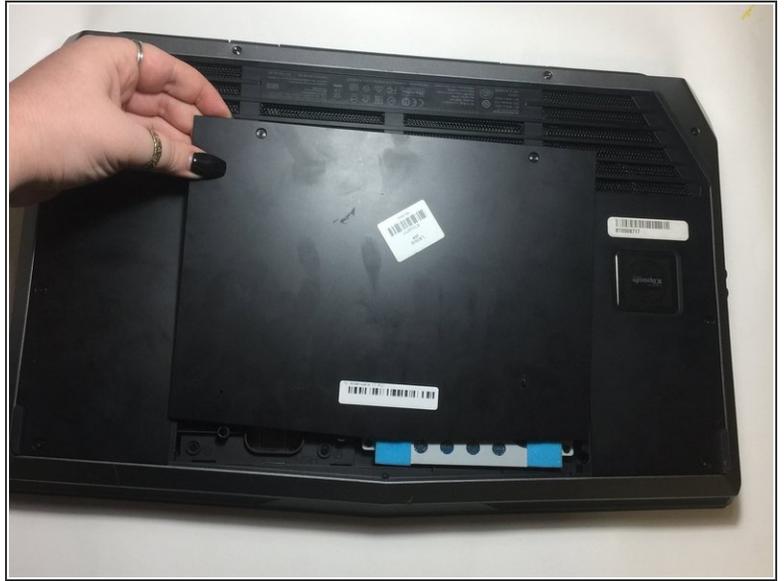
### Step 3

- Gently, pull the cover up and slide it off.

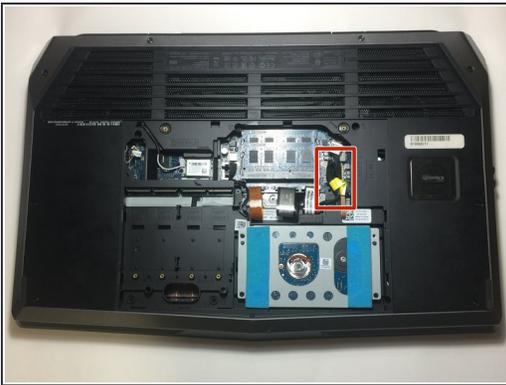
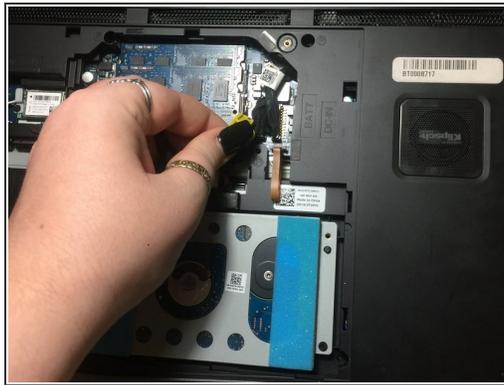
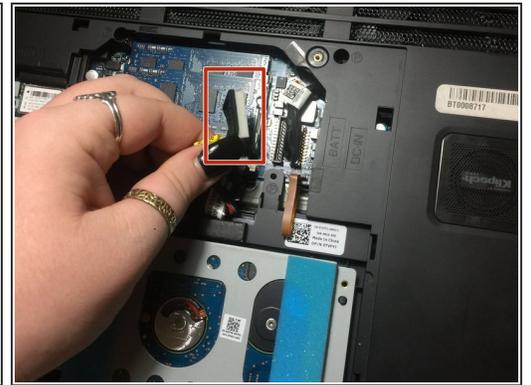
### Step 4

- Now, you are going to look for a yellow tag.
- Unplug the black wire that has the yellow tag.
- This will successfully disconnect your battery.

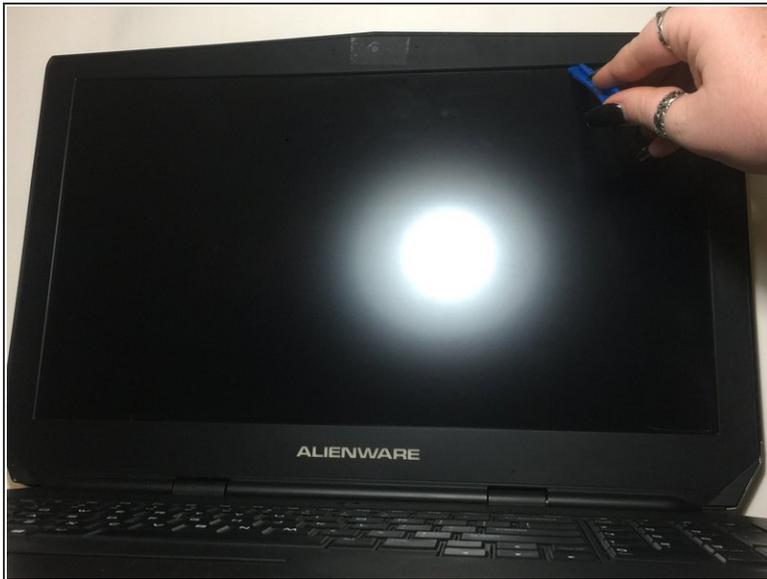
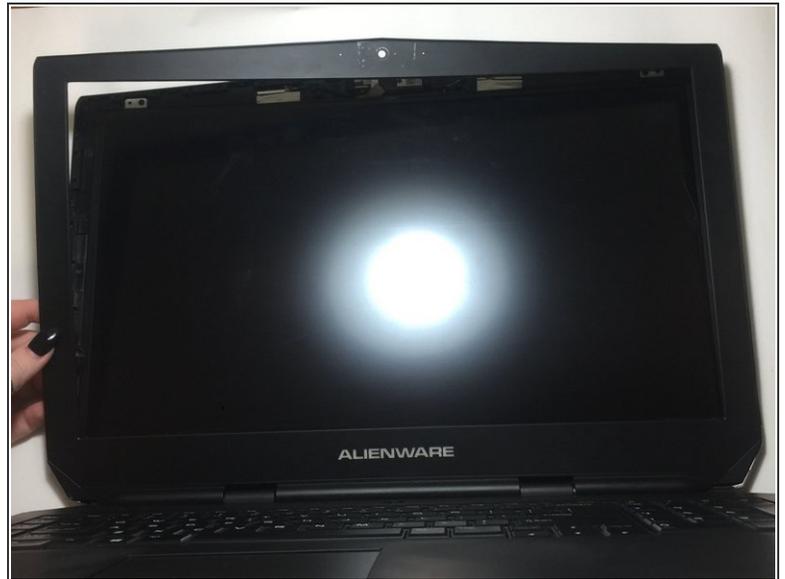
## Step 5

- Using the plastic opening tool, gently remove the black plastic casing from the LCD screen.
- Run the opening tool along the inner side of the computer where the screen and the plastic covering meet.

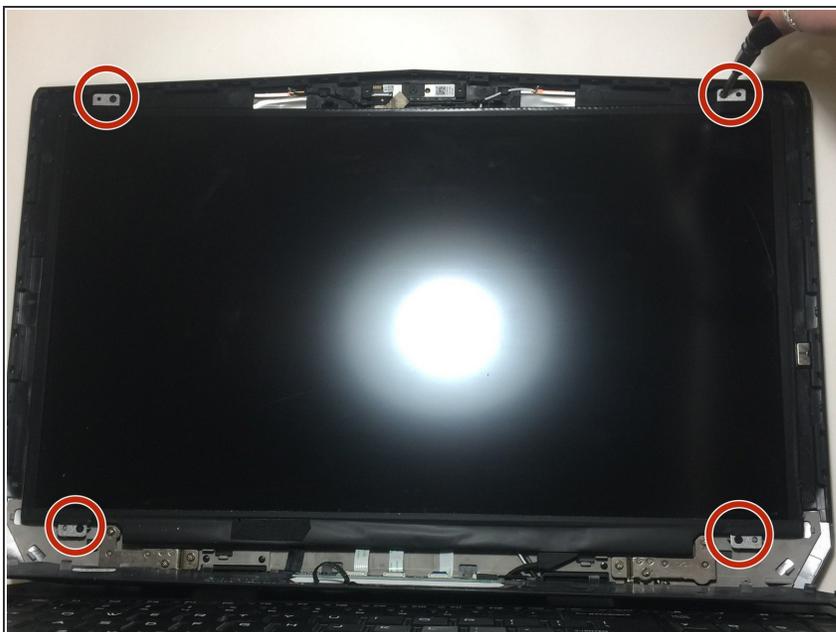
## Step 6

- Now you will unscrew the 2mm screws on the top and bottom side of the screen.

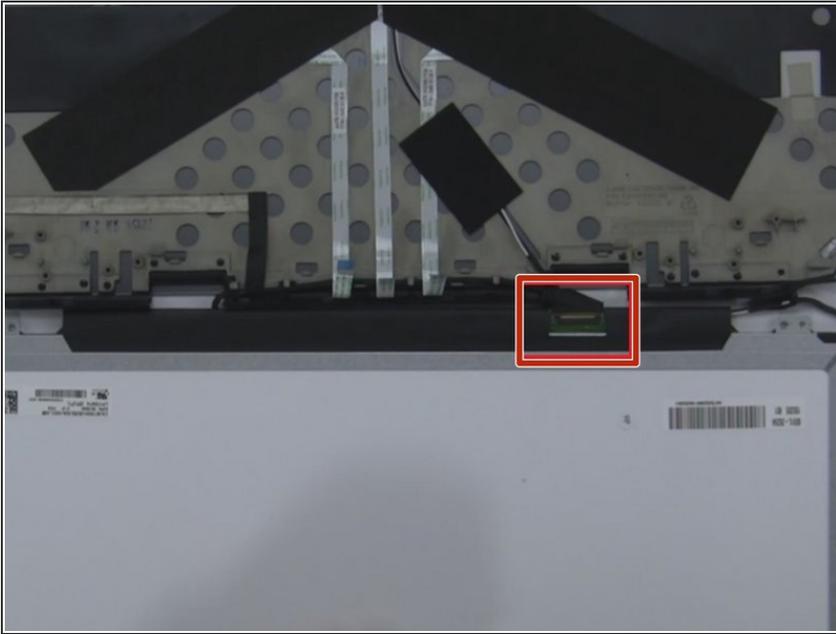
## Step 7

- Tilt the screen forward towards the keyboard.
- Disconnect the plug that is connecting the screen to the main body.

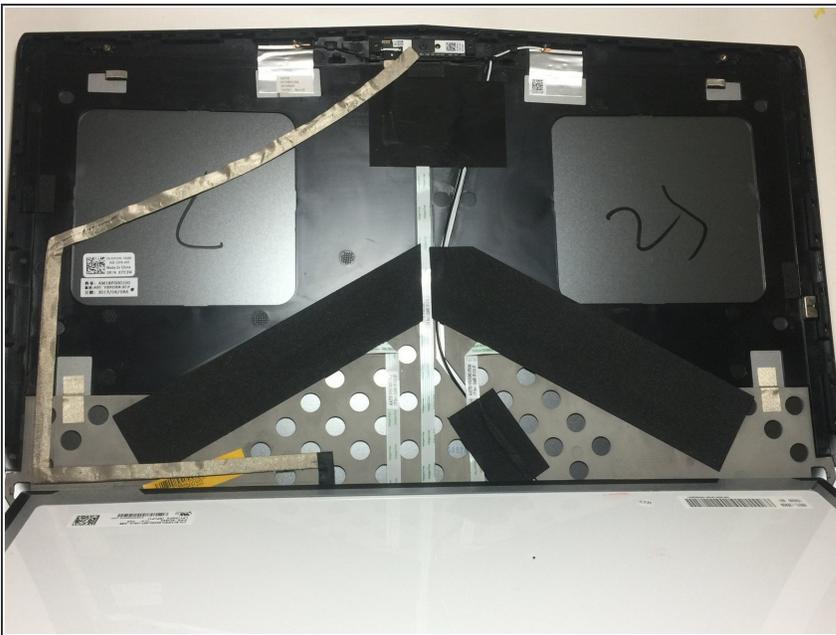
## Step 8

- Gently, lift the display away from the laptop.

To reassemble your device, follow these instructions in reverse order.
